Village at Indian Creek

**15371 River Vista Drive
North Fort Myers, FL**

10/5/2023

Roof System Condition Evaluation Report

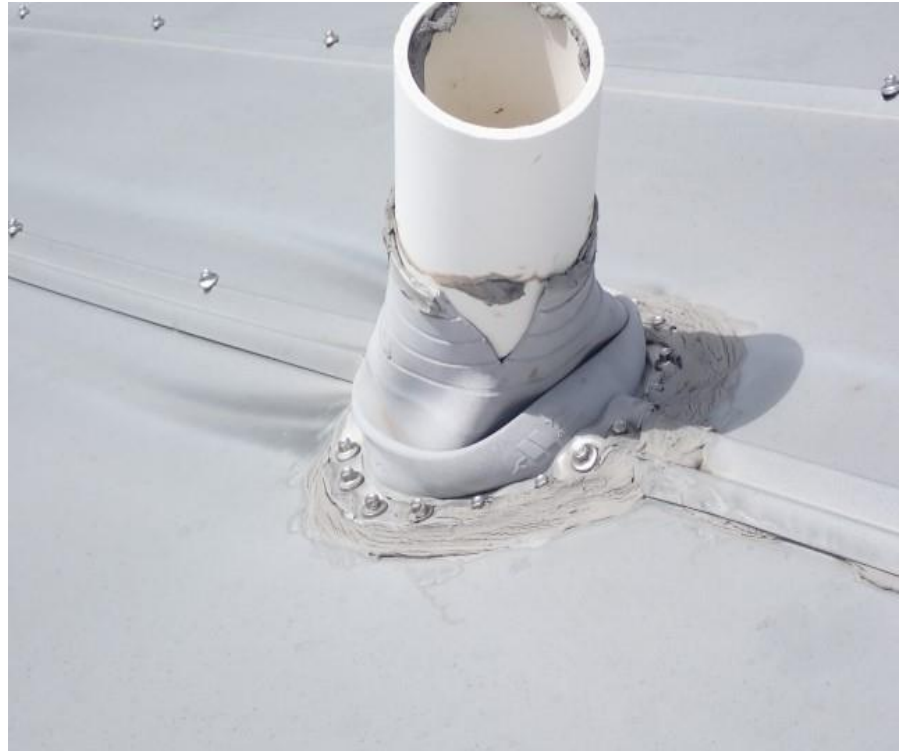
13. Deficiency #1 - Deteriorated pipe flashing detail

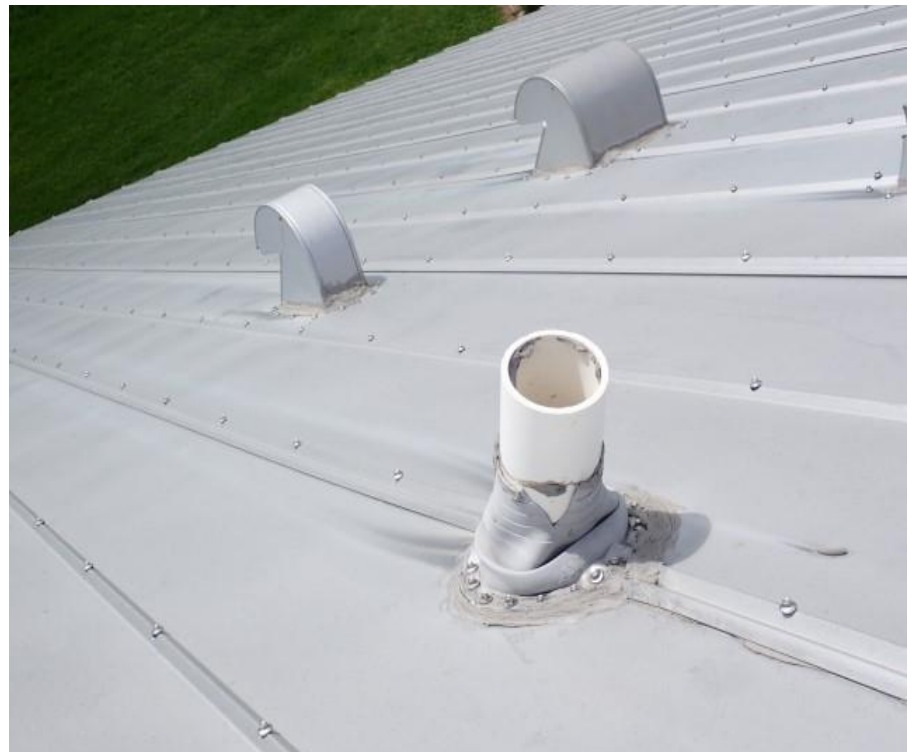
14. Deficiency #1 - Deteriorated pipe flashing detail

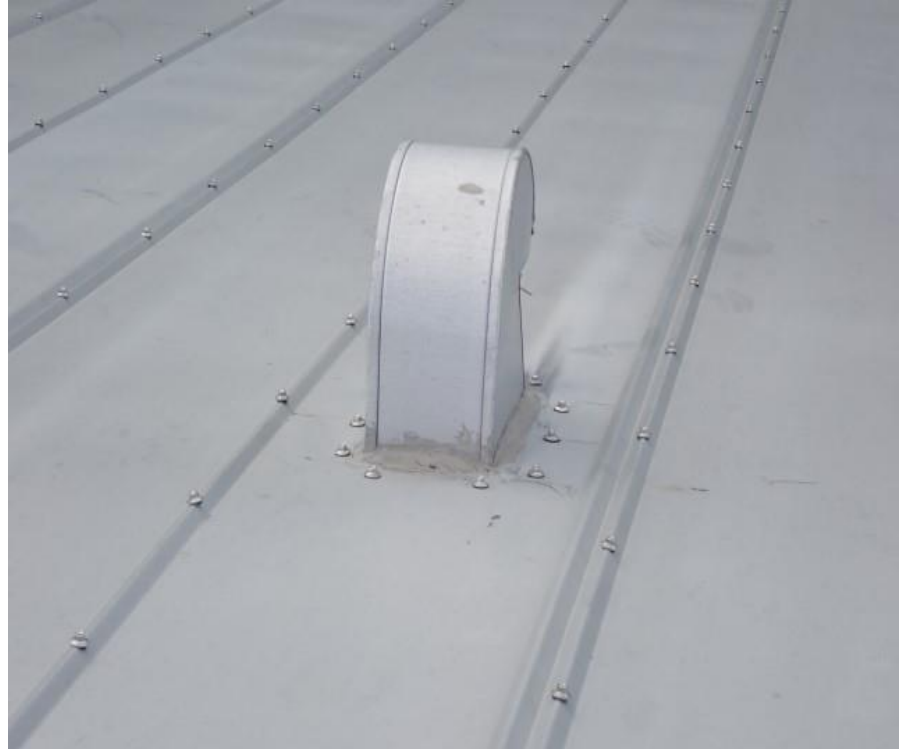
15. Deficiency #2 - Deteriorated previous sealant repairs at penetration flashing

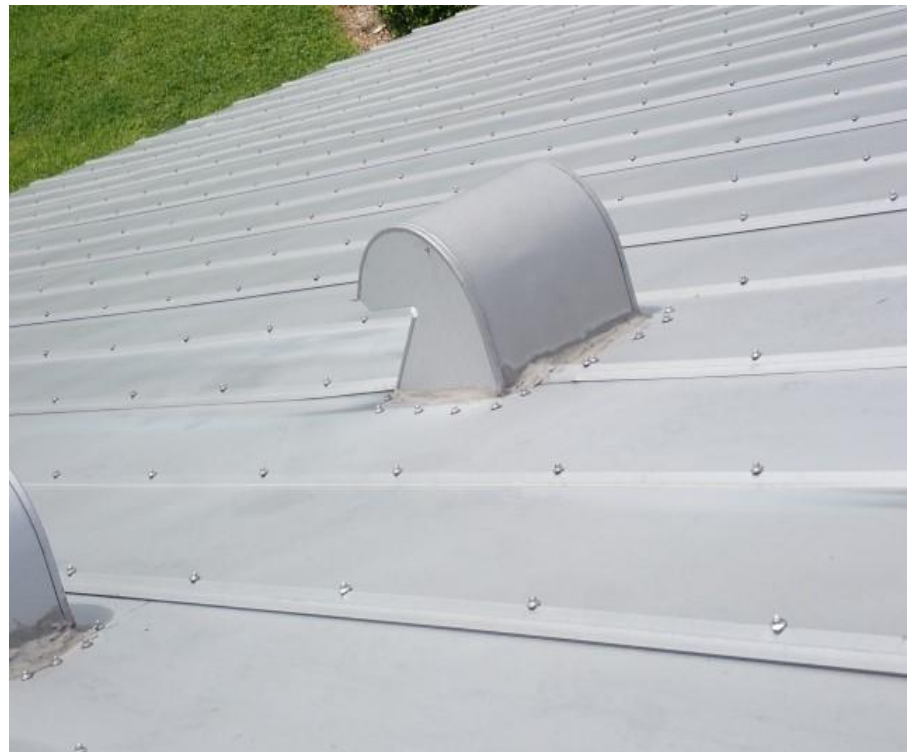
16. Deficiency #2 - Deteriorated previous sealant repairs at penetration flashing

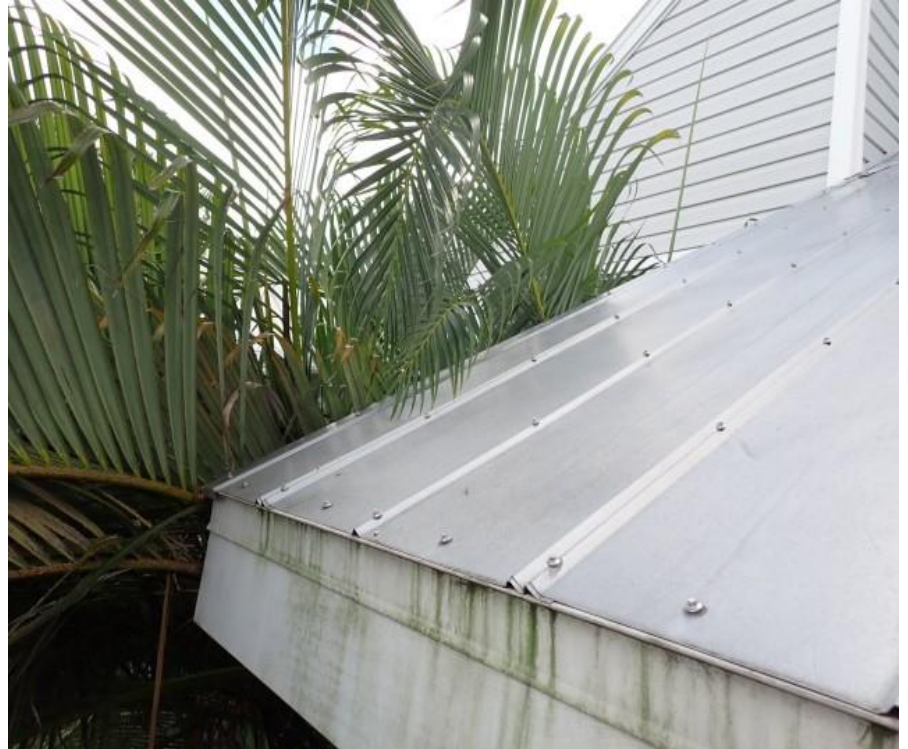
17. Deficiency #3 - Tree limbs /
branches overhanging roof surface

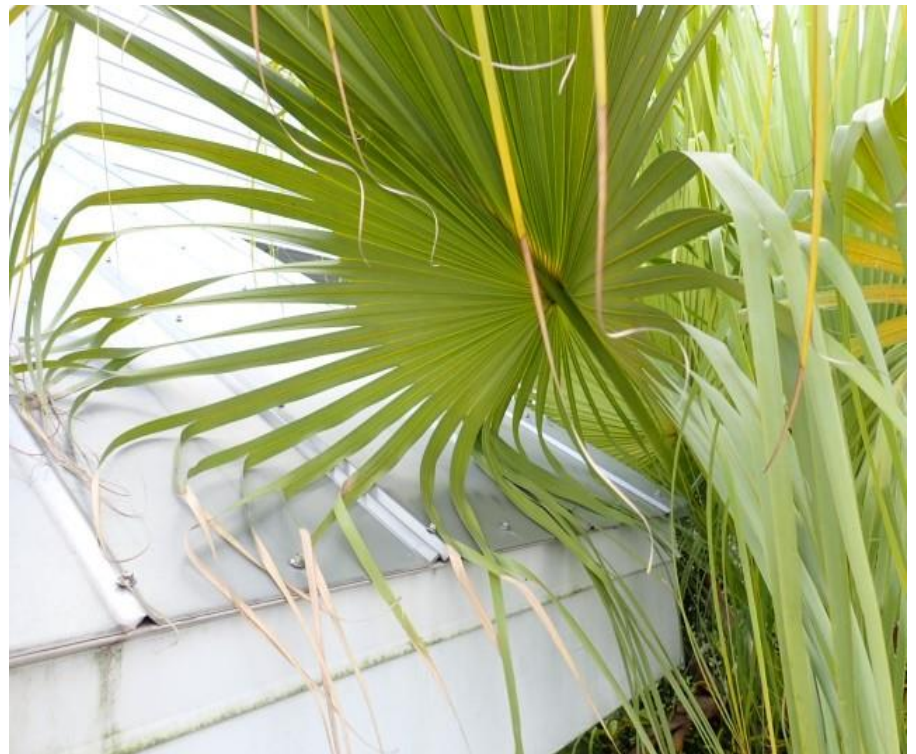
18. Deficiency #3 - Tree limbs /
branches overhanging roof surface

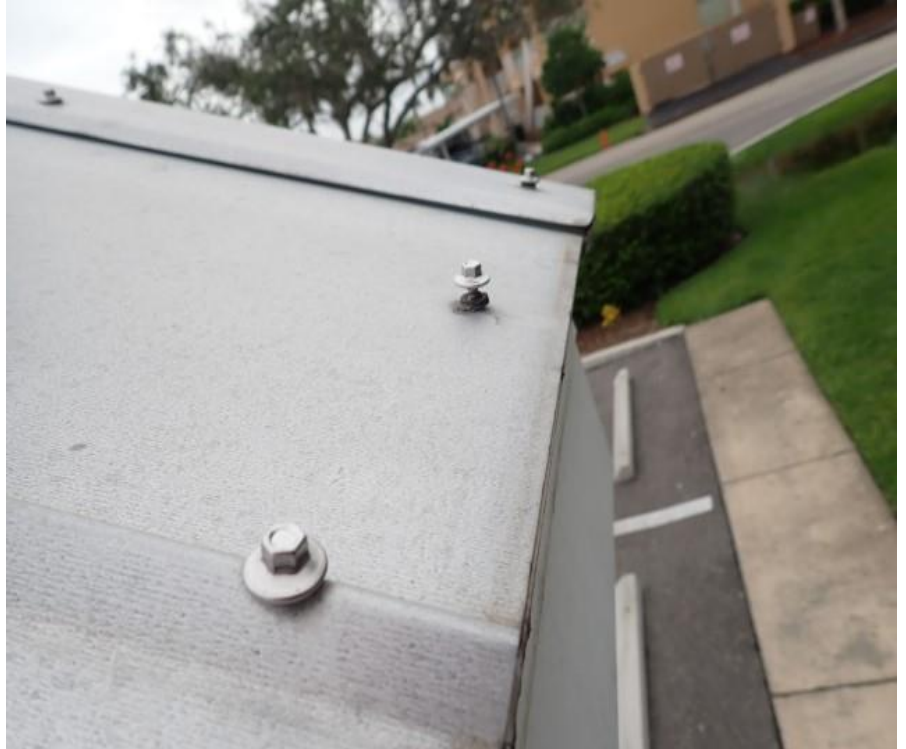
4	M	Loose, missing or rusted fasteners or deteriorated neoprene washers	2	\$50.00	\$100.00
		Remove and replace loose or rusted fasteners with new oversized hex head fasteners with neoprene bonded washers	Ea

19. Deficiency #4 - Loose, missing or rusted fasteners or deteriorated neoprene washers

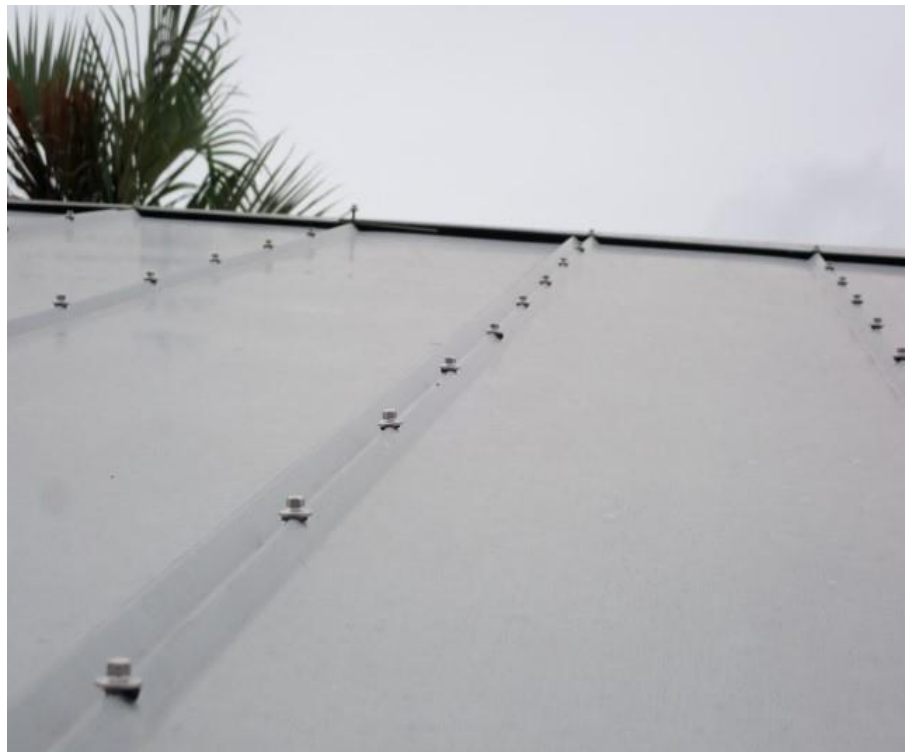
20. Deficiency #4 - Loose, missing or rusted fasteners or deteriorated neoprene washers

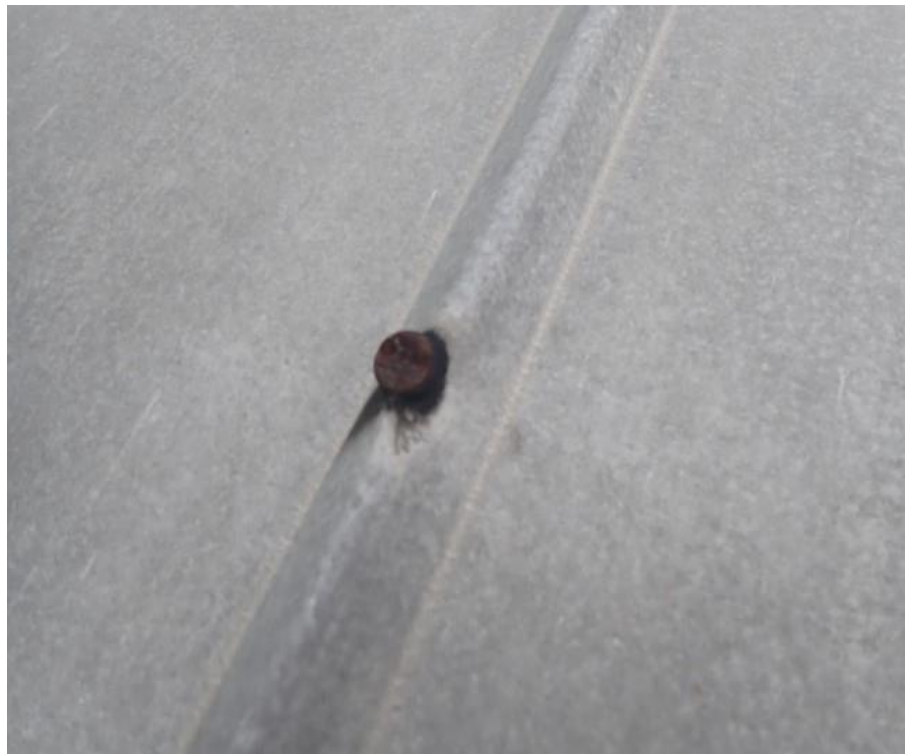
18. Deficiency #1 - Rusted fasteners

Deficiency #2 - Improper fasteners
(nails) used for primary securement
of metal panel assembly

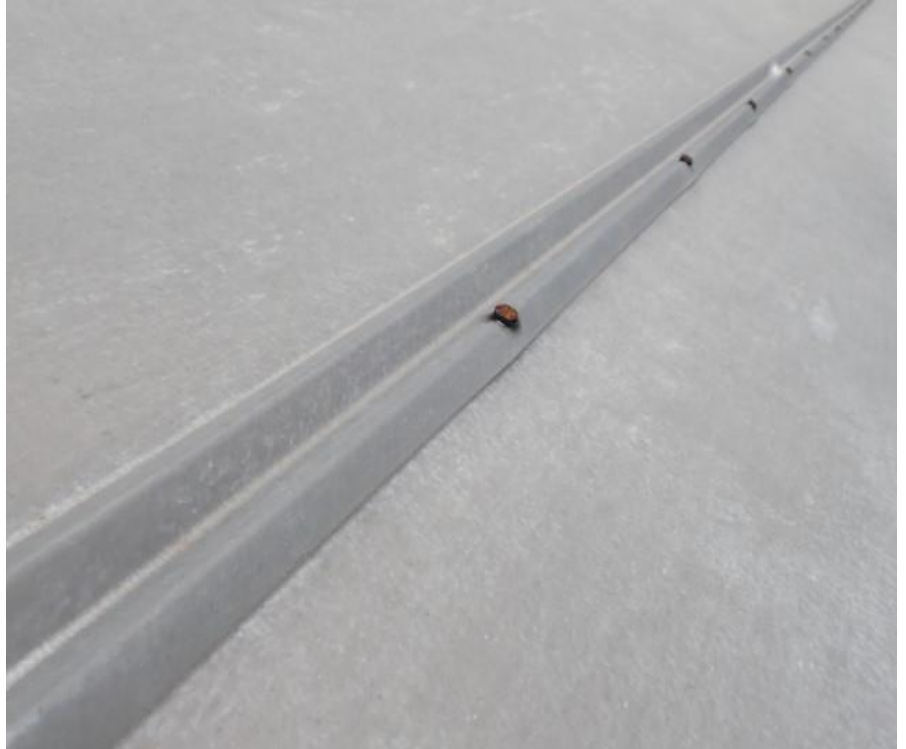
19. Deficiency #1 - Rusted fasteners

Deficiency #2 - Improper fasteners
(nails) used for primary securement
of metal panel assembly

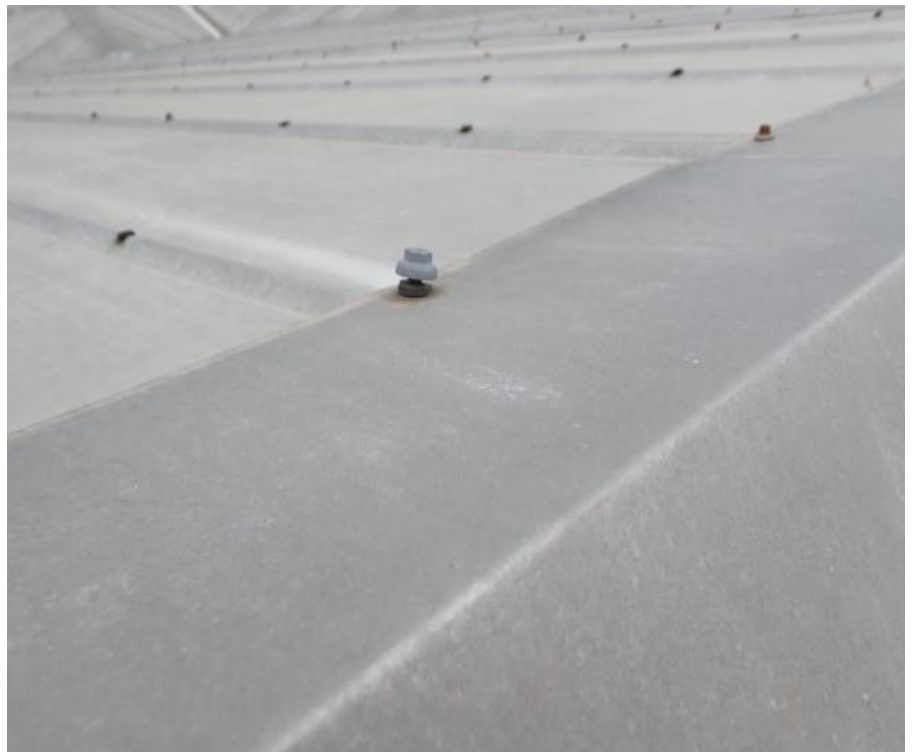
20. Deficiency #1 - Rusted fasteners

Deficiency #3 - Loose fasteners

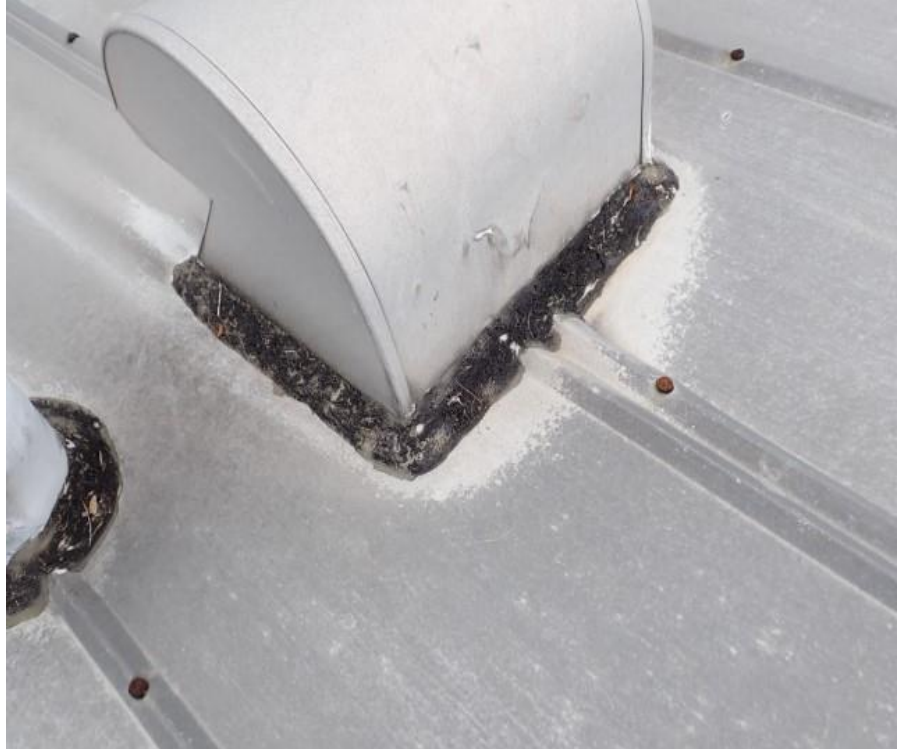
21. Deficiency #4 - Deteriorated previous sealant repairs at penetration flashing

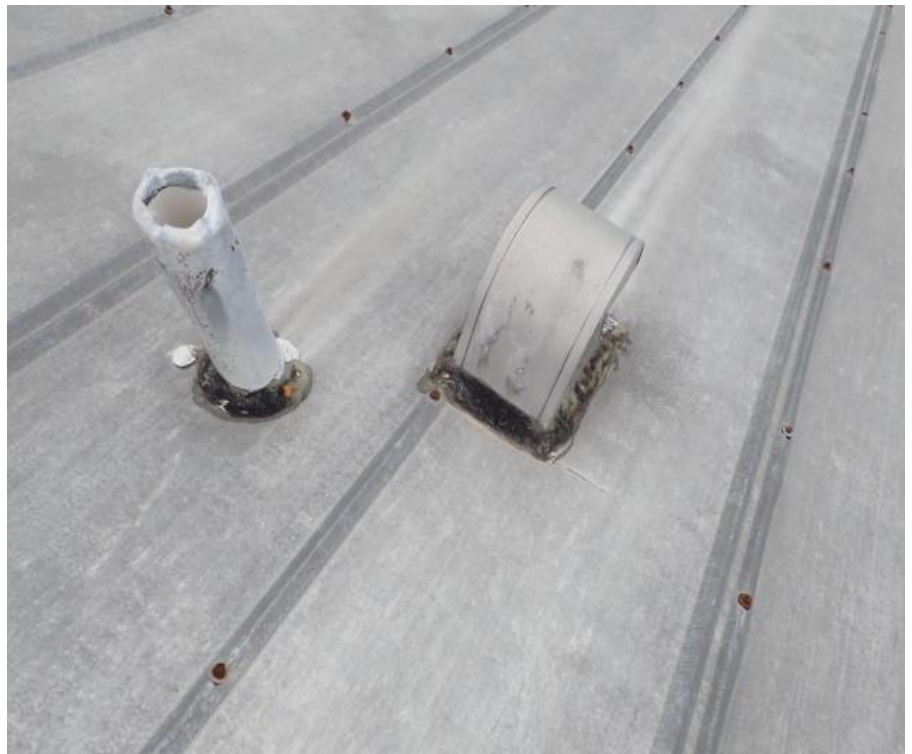
22. Deficiency #4 - Deteriorated previous sealant repairs at penetration flashing

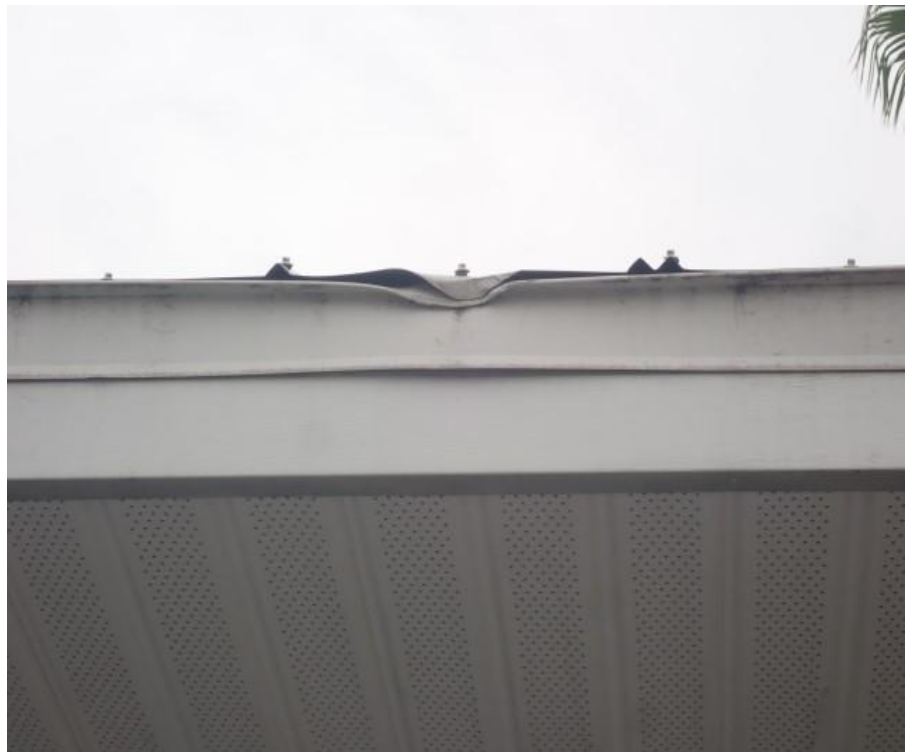
14. Deficiency #1 - Damaged drip edge

Deficiency #2 - Damaged / dented metal panels

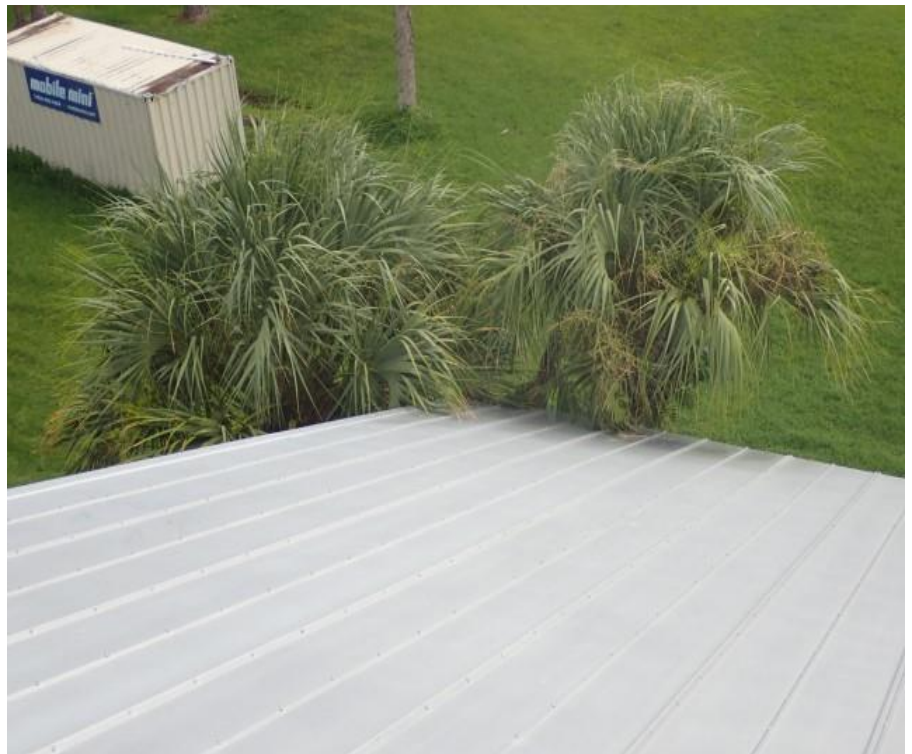
16. Deficiency #3 - Tree limbs /
branches overhanging roof surface

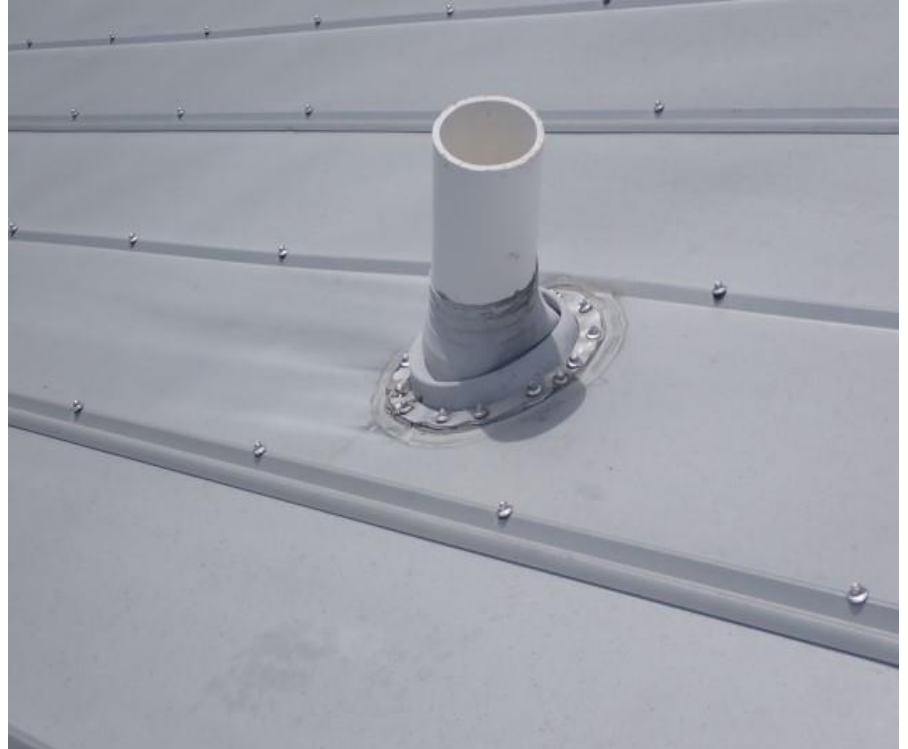
17. Deficiency #4 - Deteriorated sealant application at pipe flashing detail

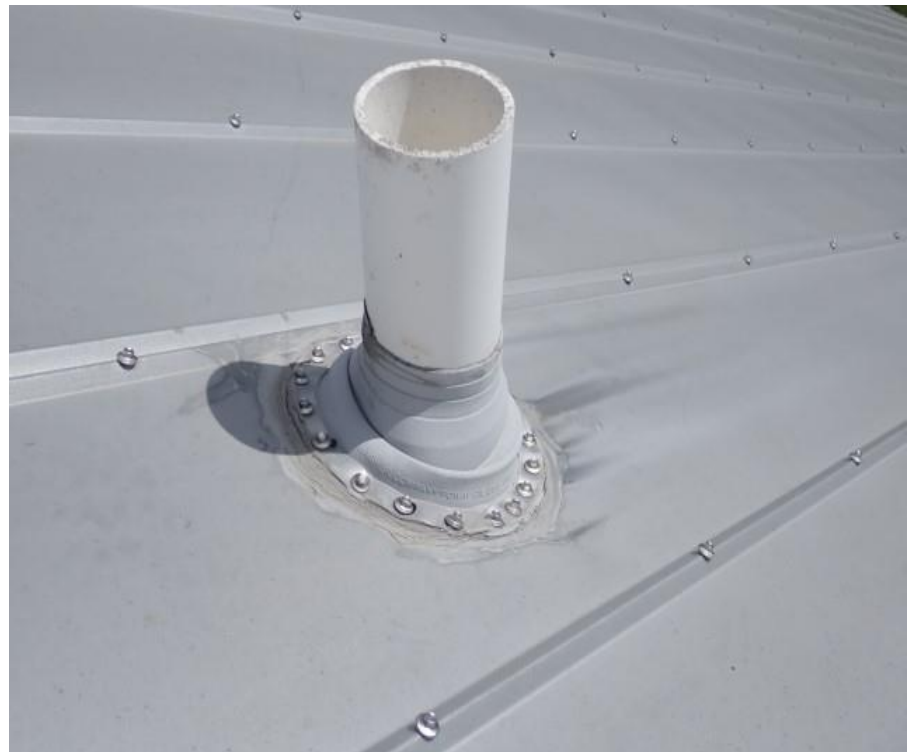
18. Deficiency #4 - Deteriorated sealant application at pipe flashing detail

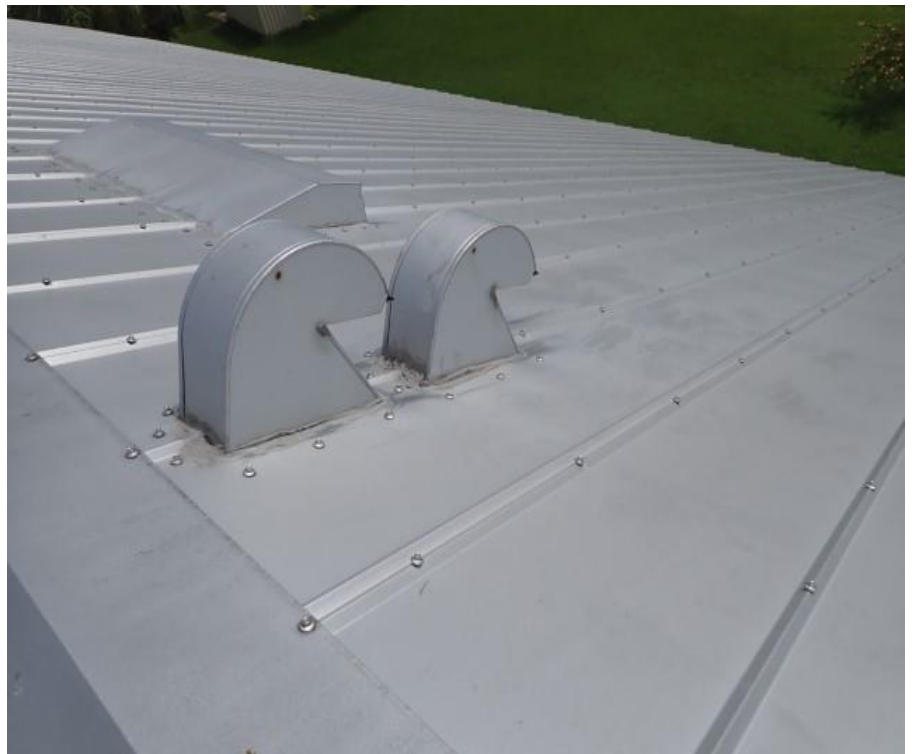
20. Deficiency #5 - Deteriorated previous sealant repairs at penetration flashing

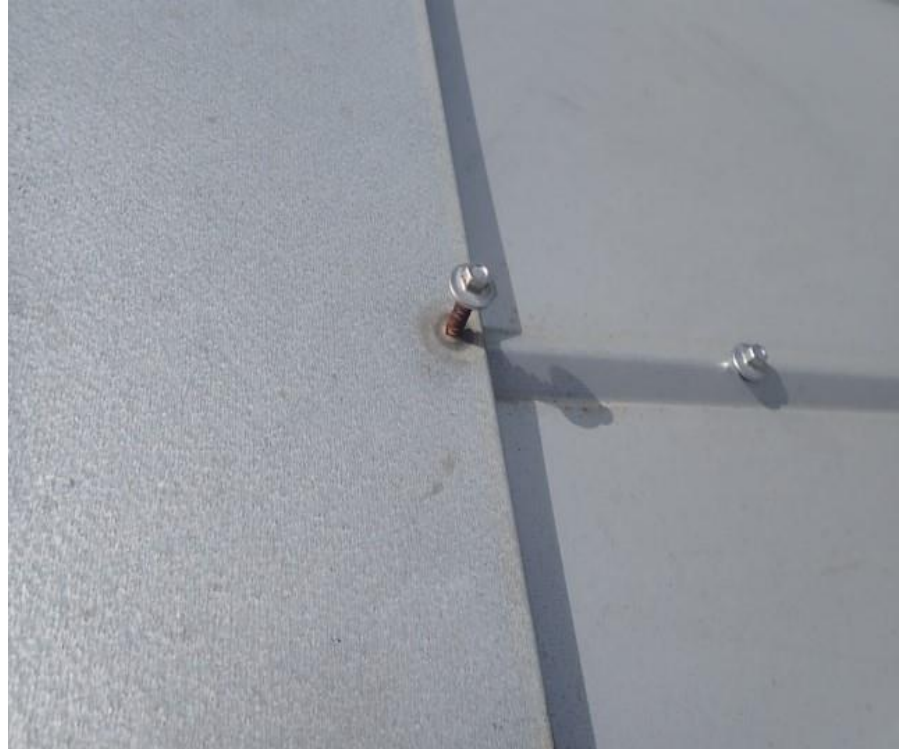
21. Deficiency #6 - Loose fasteners

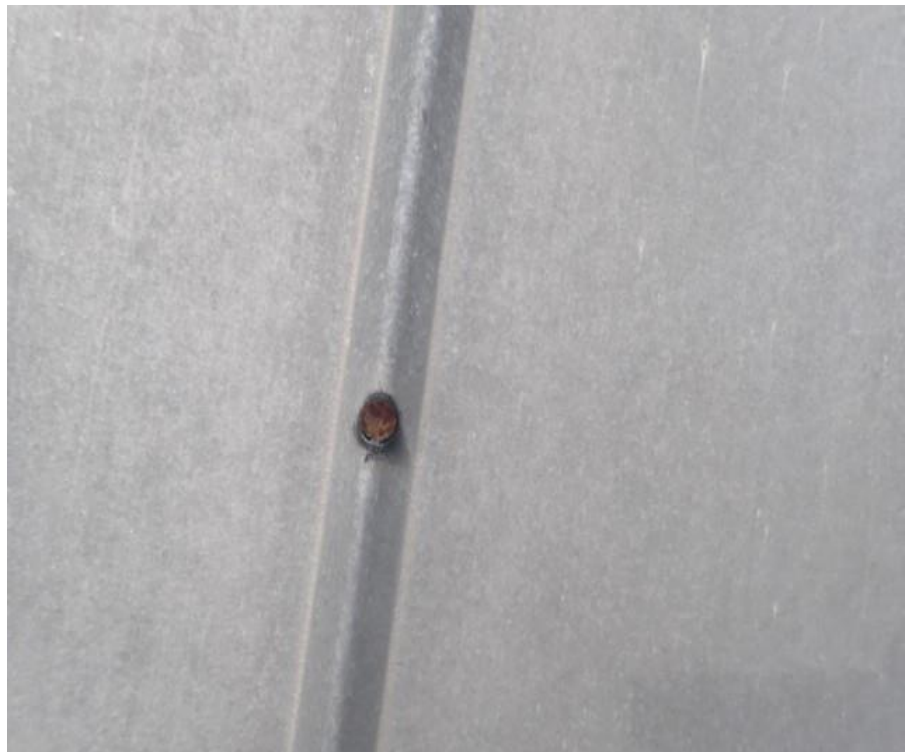
18. Deficiency #1 - Rusted fasteners

Deficiency #2 - Improper fasteners
(nails) used for primary securement
of metal panel assembly

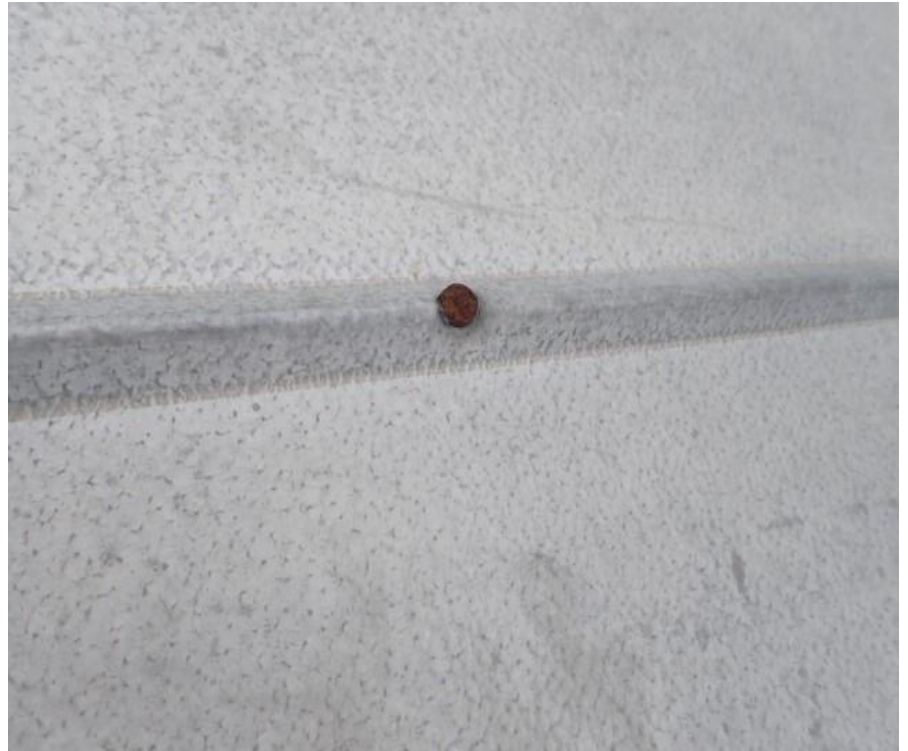
19. Deficiency #1 - Rusted fasteners

Deficiency #2 - Improper fasteners
(nails) used for primary securement
of metal panel assembly

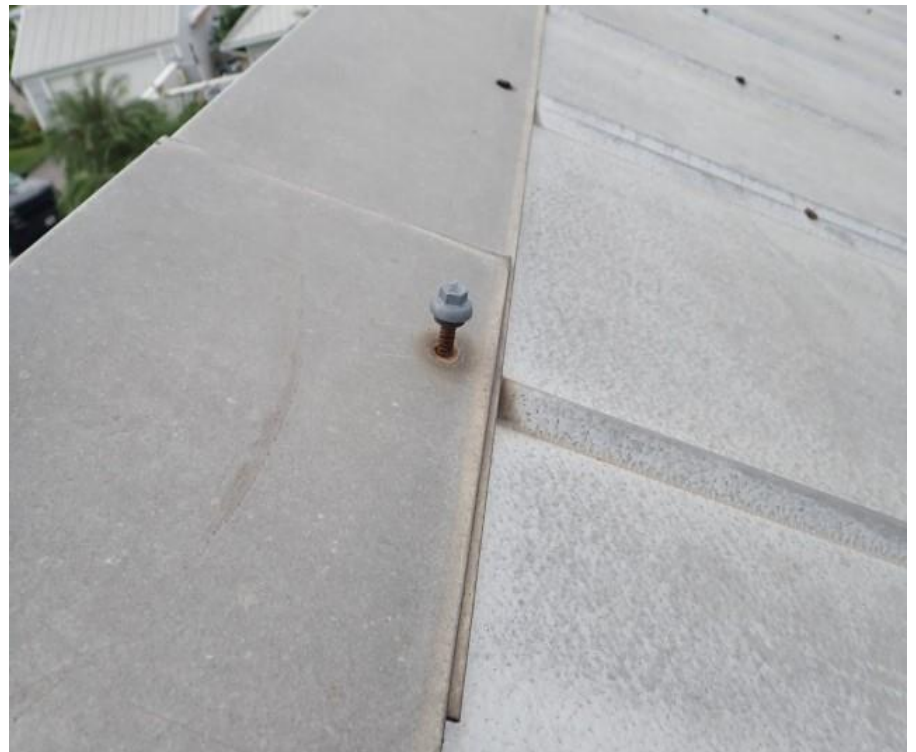
20. Deficiency #3 - Loose fasteners

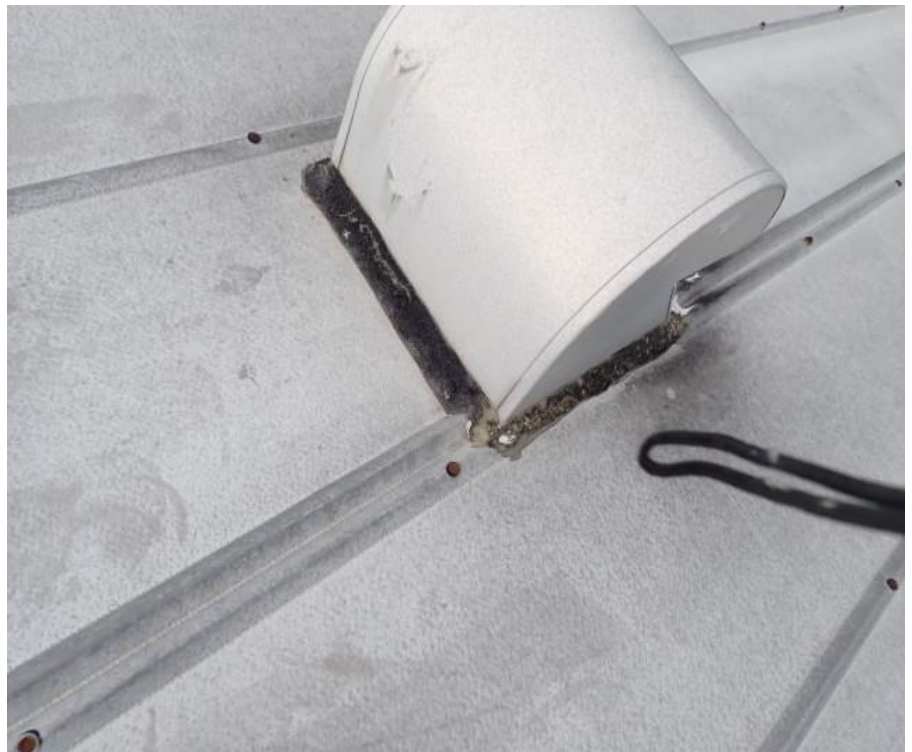
22. Deficiency #4 - Deteriorated previous sealant repairs at penetration flashing

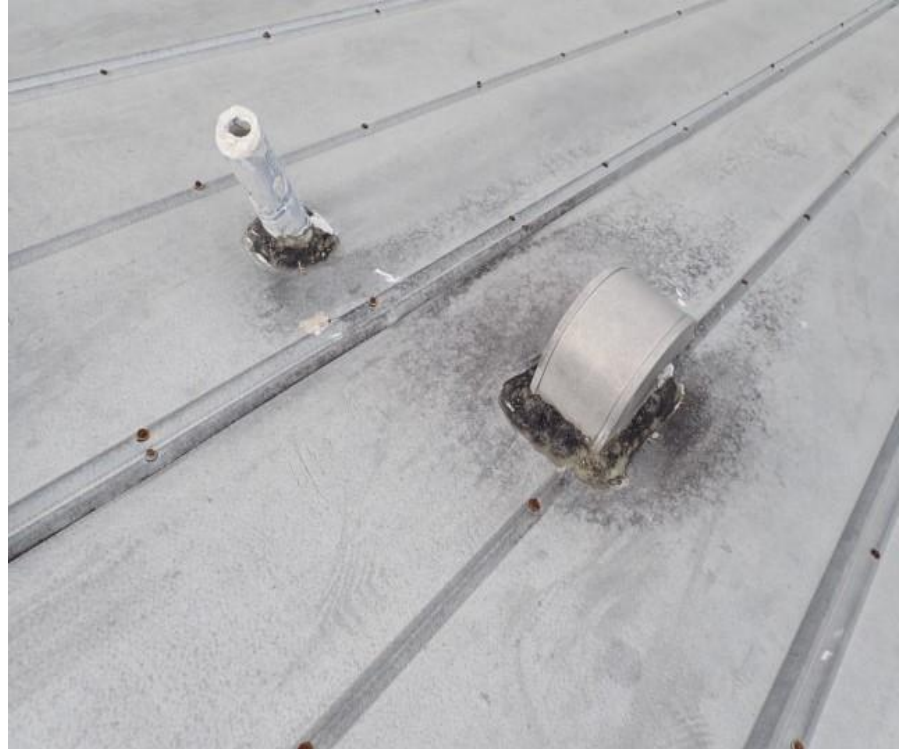
23. Deficiency #4 - Deteriorated
previous sealant repairs at
penetration flashing

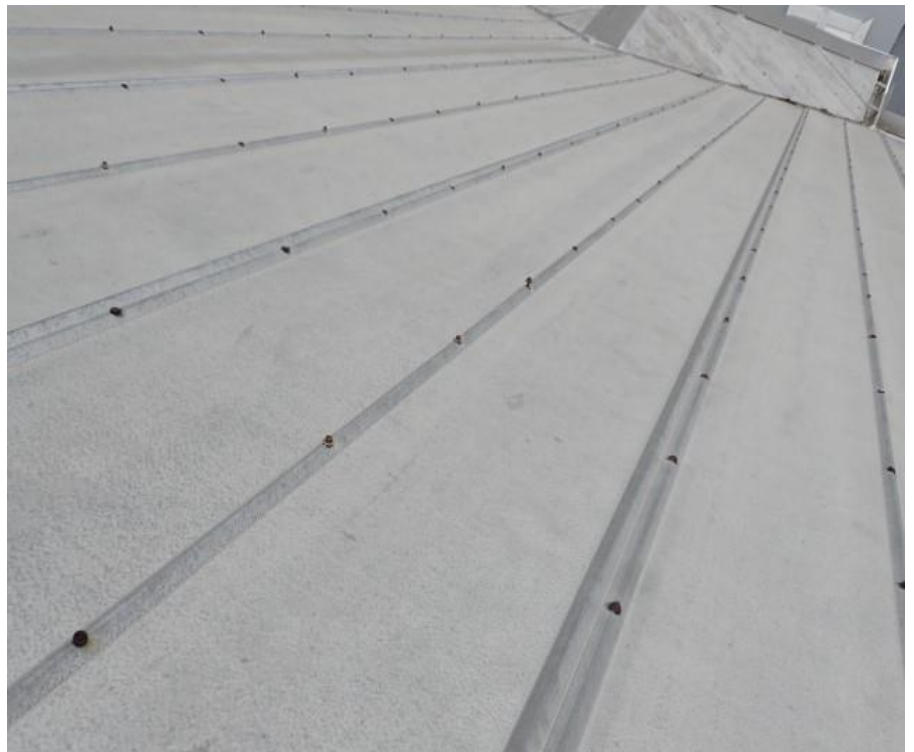
Deficiency #2 - Improper fasteners (nails) used for primary securement of metal panel assembly

Deficiency #3 - Loose fasteners

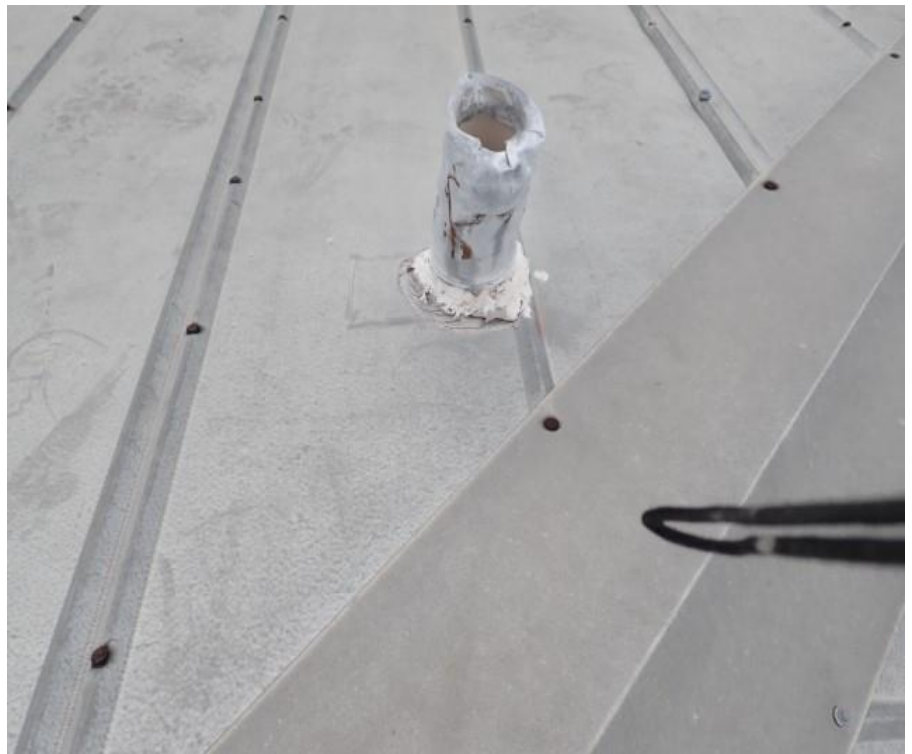
20. Deficiency #4 - Deteriorated previous sealant repairs at penetration flashing

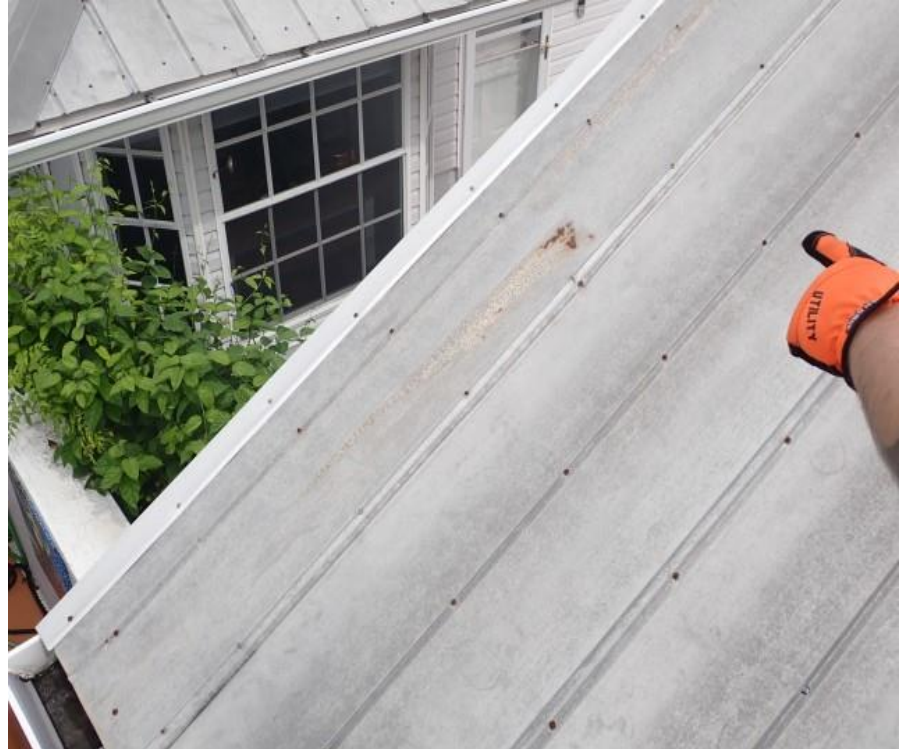
21. Deficiency #5 - Rust development on metal panel

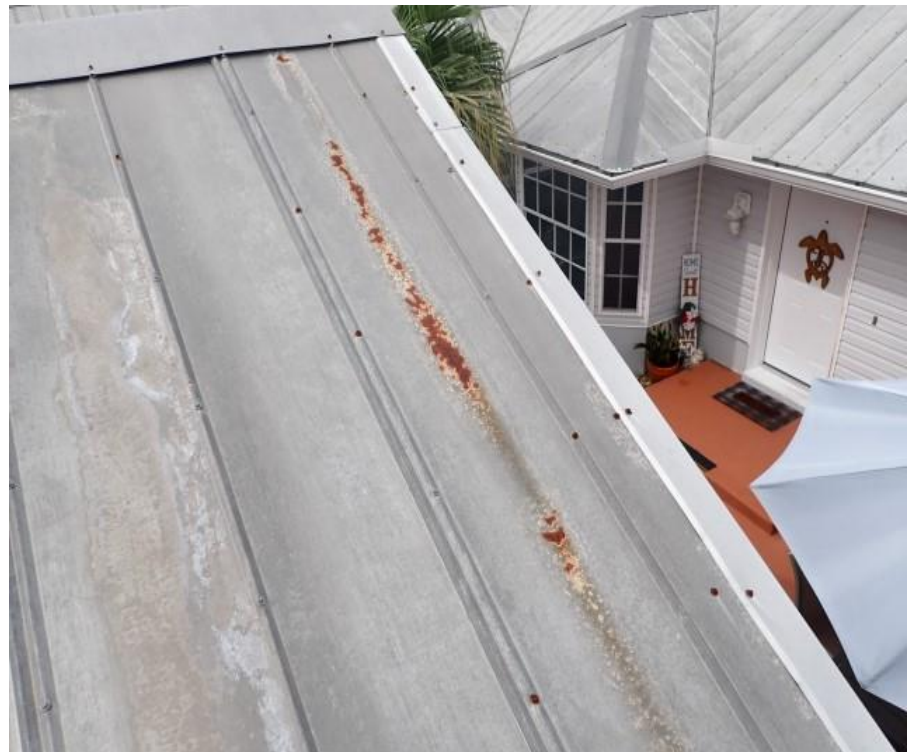
22. Deficiency #5 - Rust development on metal panel

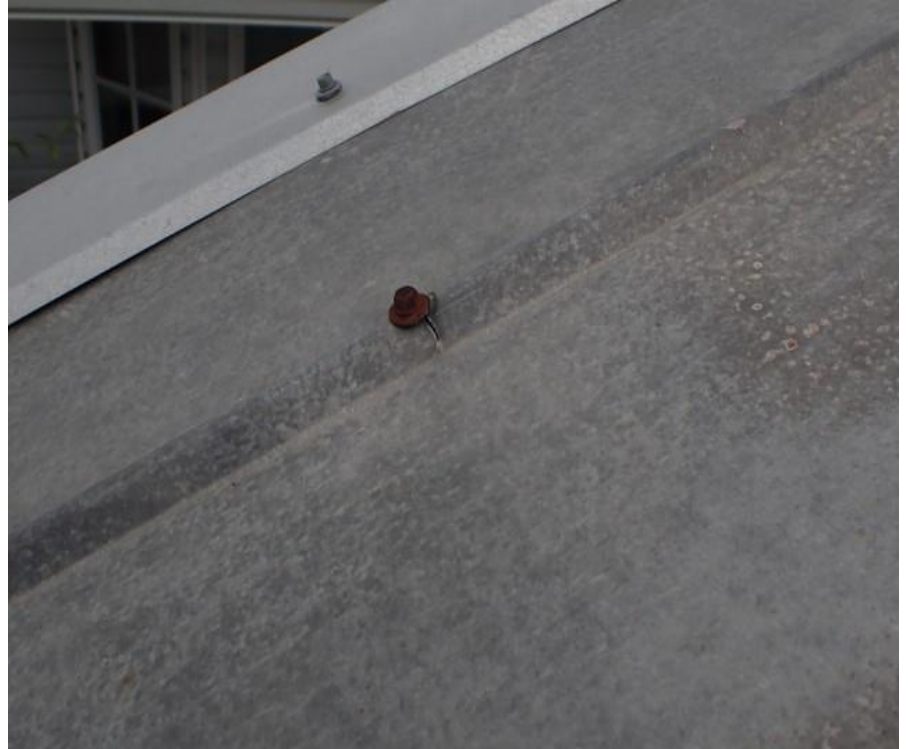
23. Deficiency #6 - Damaged /
dented metal panels

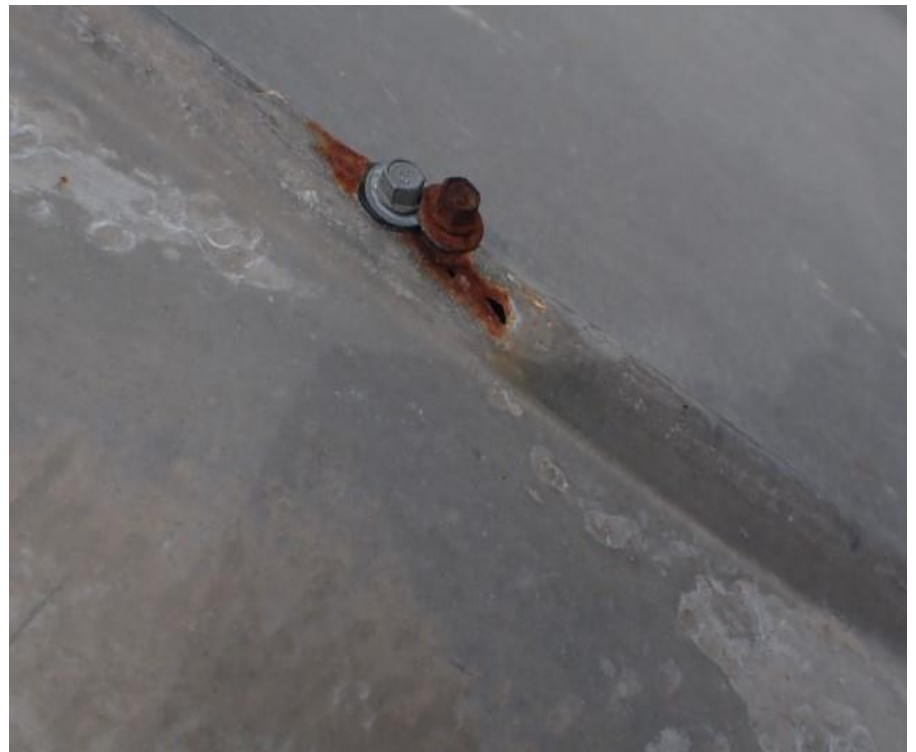
24. Deficiency #6 - Damaged /
dented metal panels

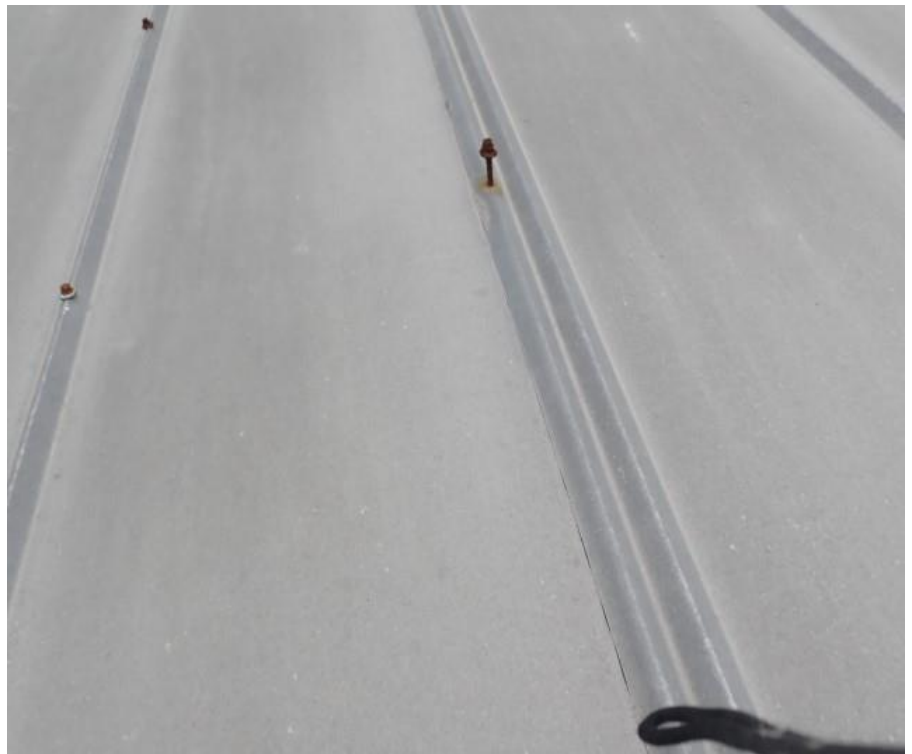
18. Deficiency #1 - Loose fasteners

Deficiency #2 - Rusted fasteners

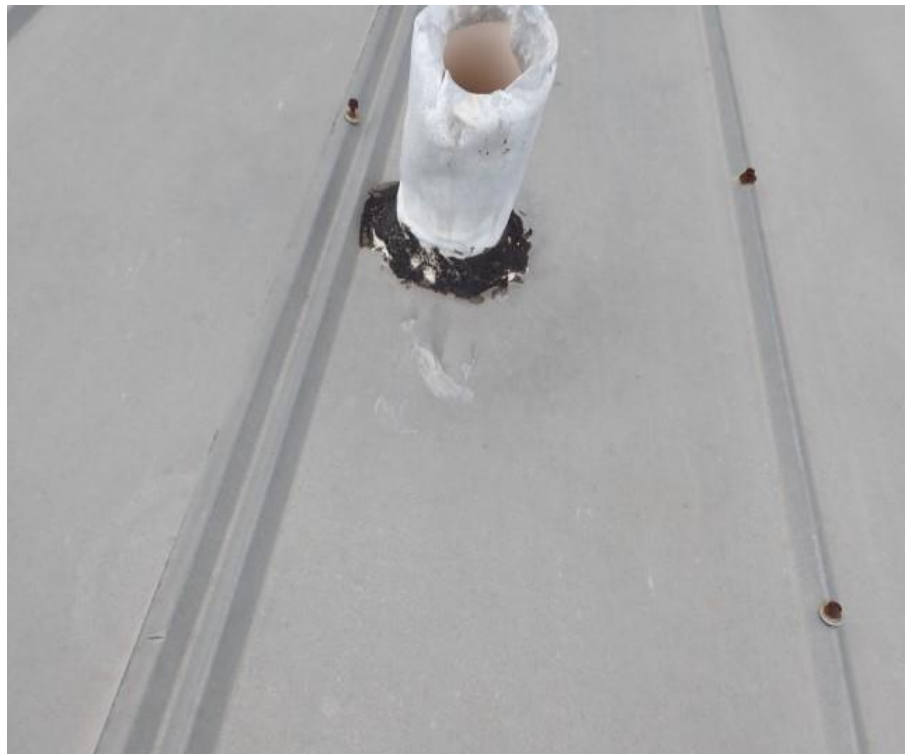
20. Deficiency #3 - Deteriorated previous sealant repairs at penetration flashing
