Village at Indian Creek

**15371 River Vista Drive
North Fort Myers, FL**

10/5/2023

Roof System Condition Evaluation Report

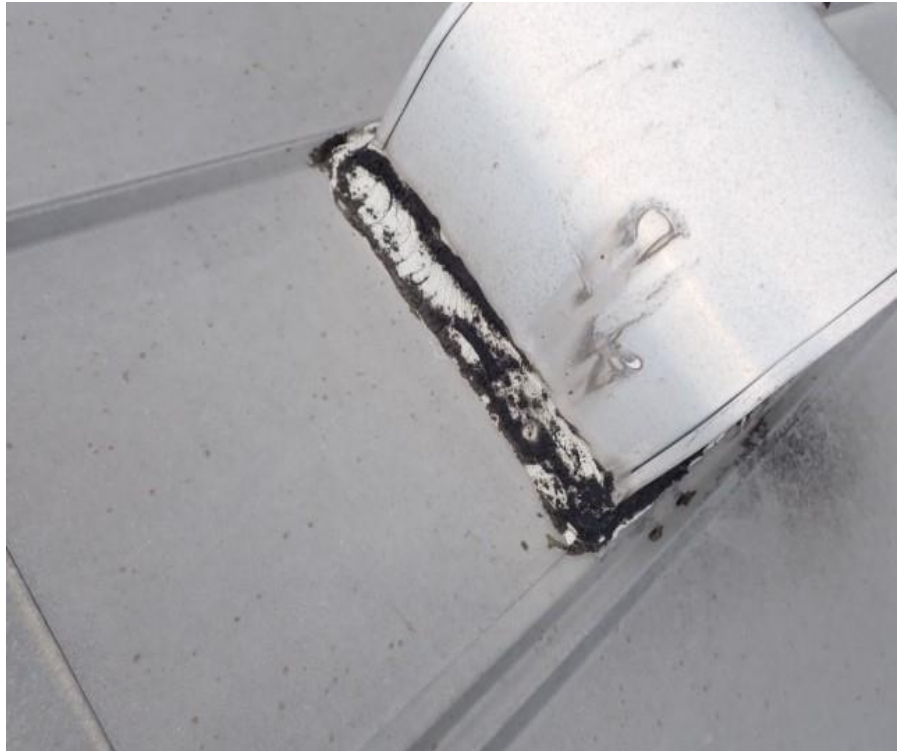
21. Deficiency #3 - Deteriorated previous sealant repairs at penetration flashing

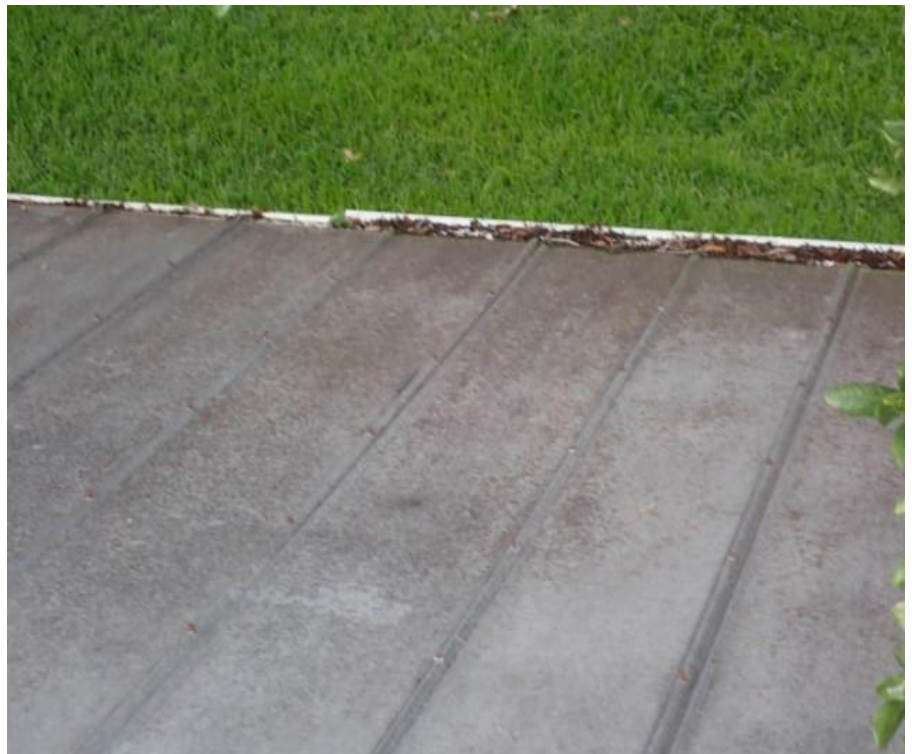
22. Deficiency #4 - Debris in gutter

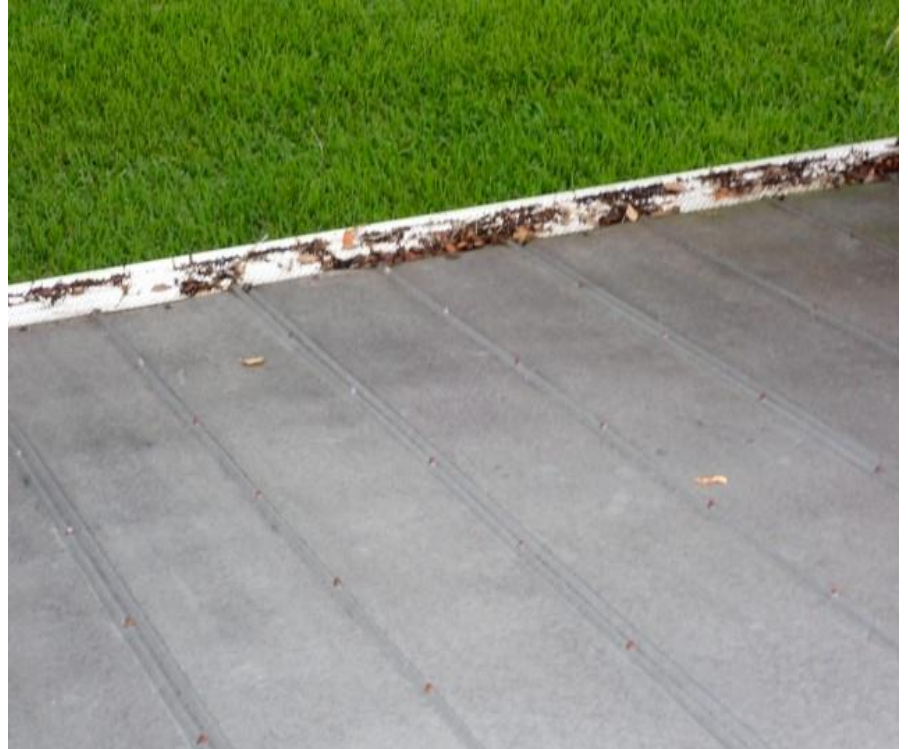
23. Deficiency #4 - Debris in gutter

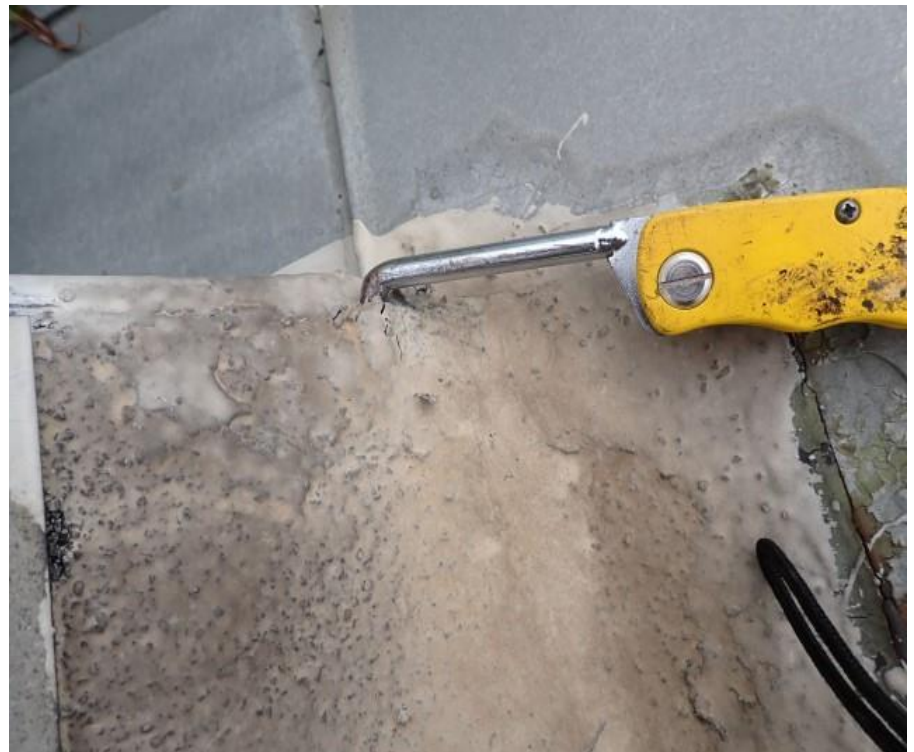
24. Deficiency #5 - Open conditions
at gravel stop

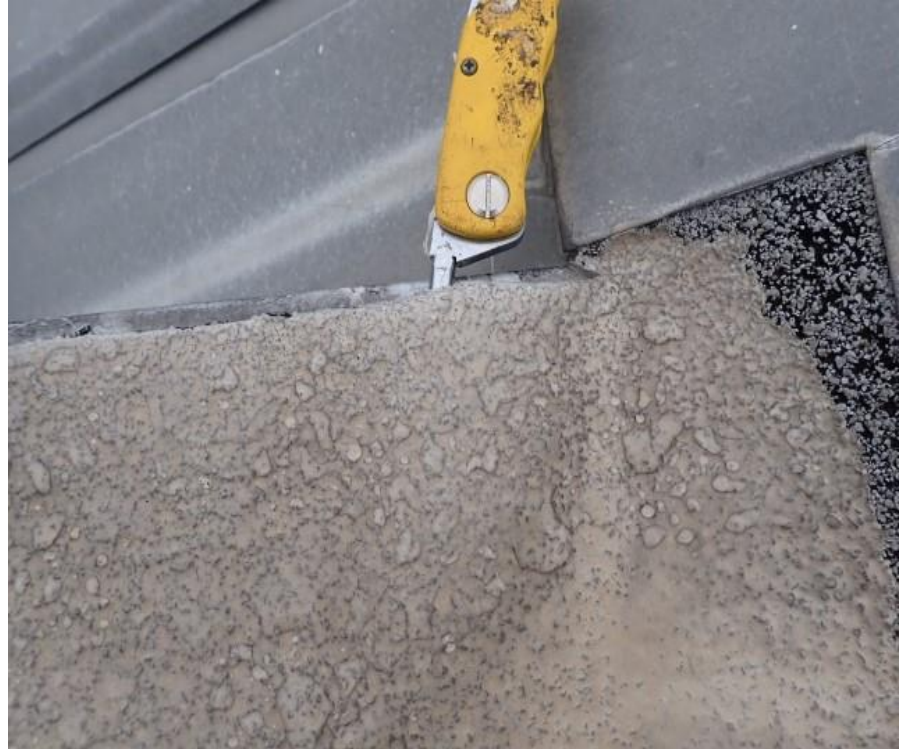
25. Deficiency #5 - Open condition
at valley flashing

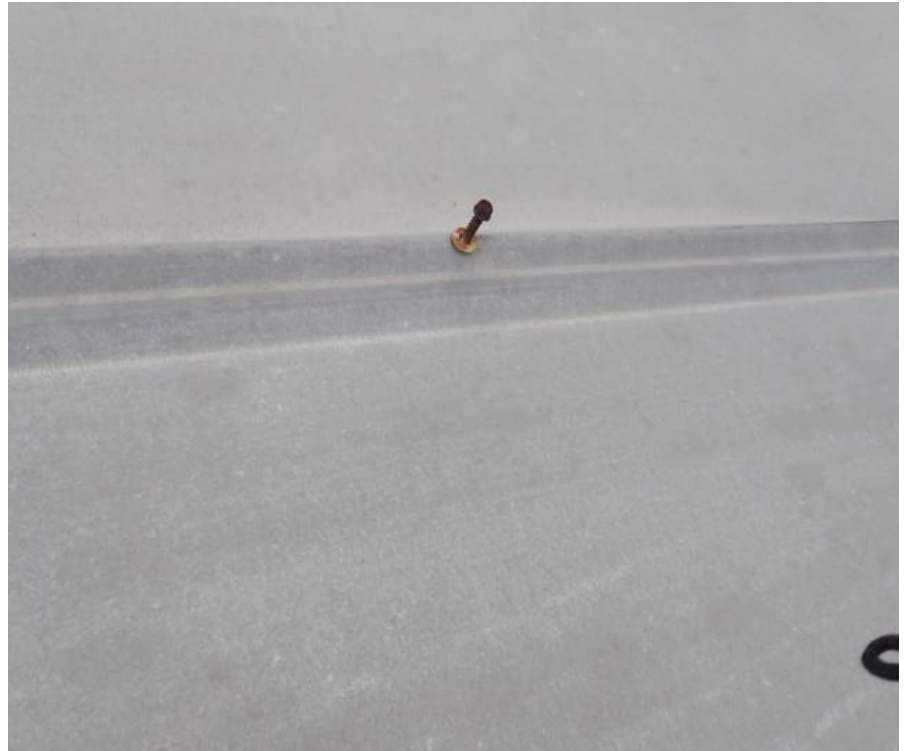
17. Deficiency #1 - Loose fasteners

Deficiency #2 - Rusted fasteners

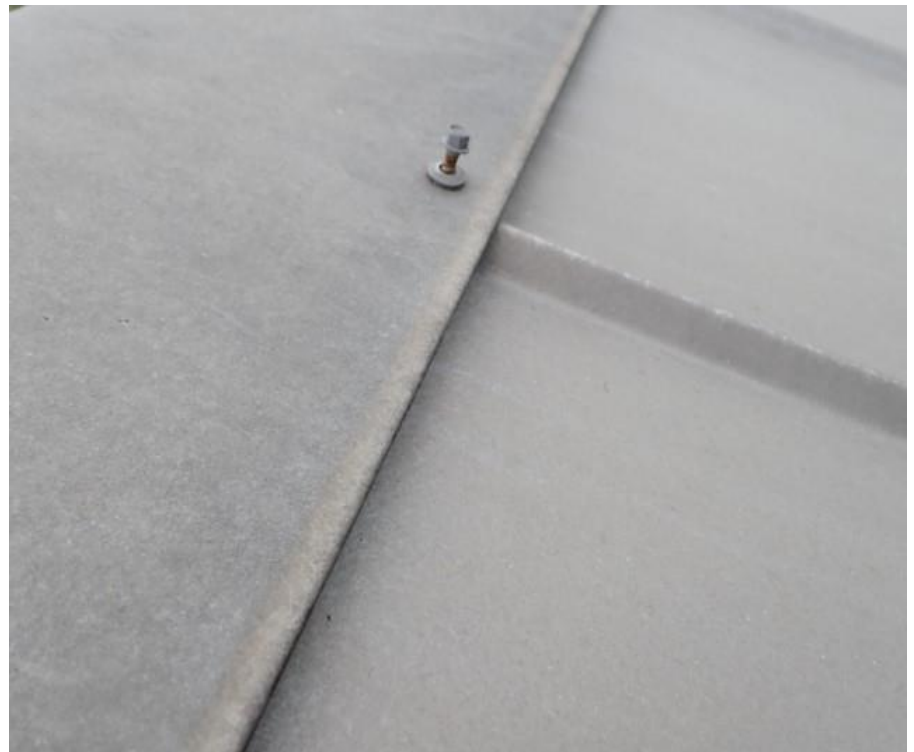
18. Deficiency #1 - Loose fasteners

Deficiency #2 - Rusted fasteners

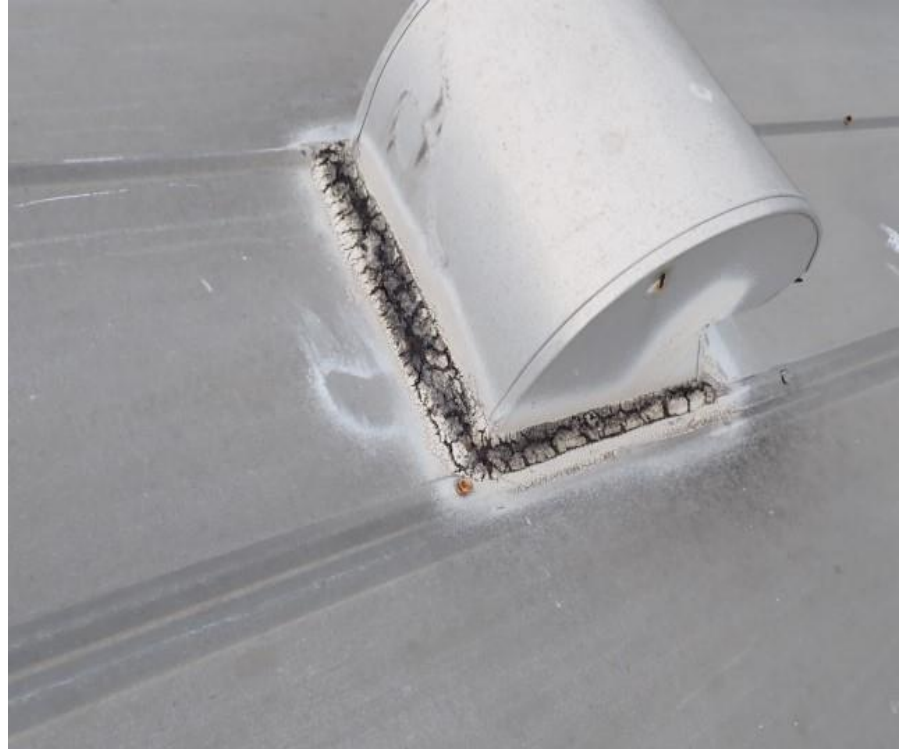
19. Deficiency #3 - Deteriorated previous sealant repairs at penetration flashing

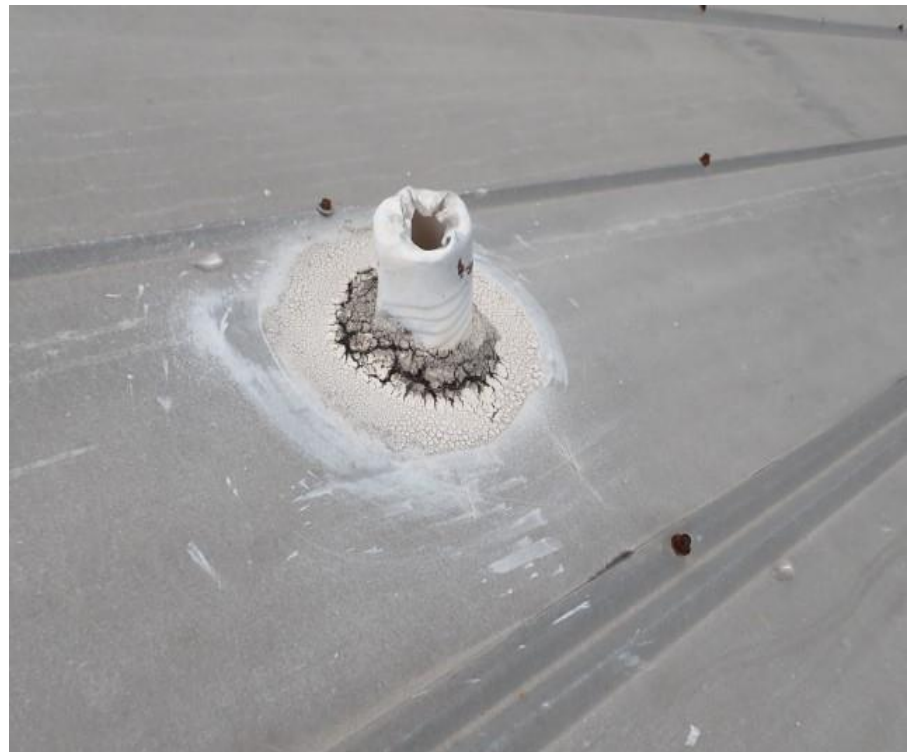
20. Deficiency #3 - Deteriorated previous sealant repairs at penetration flashing

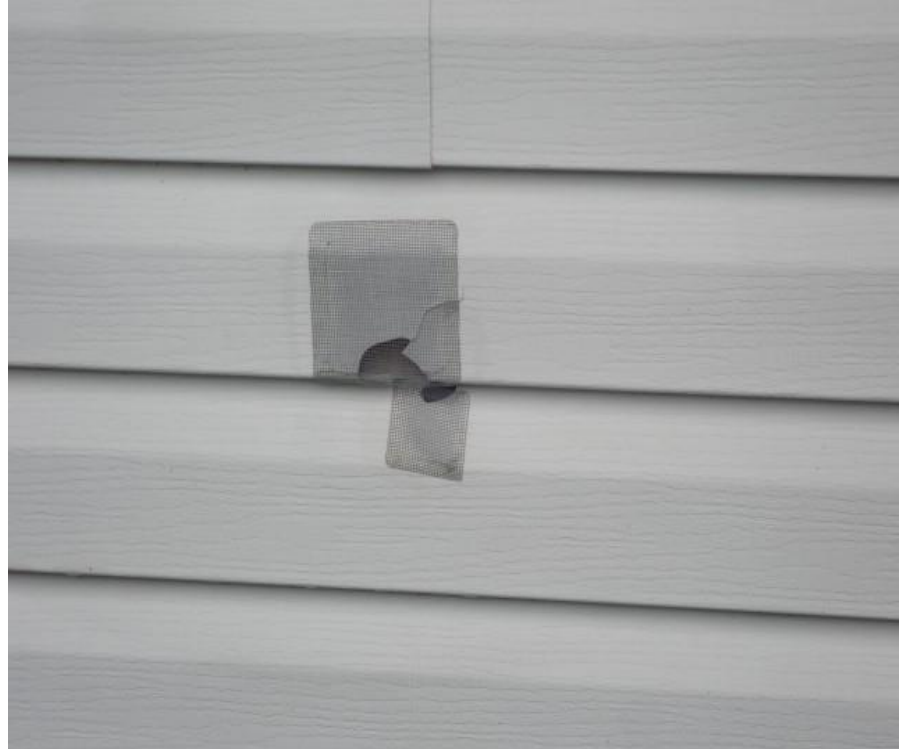
21. Deficiency #4 - Damaged vinyl siding

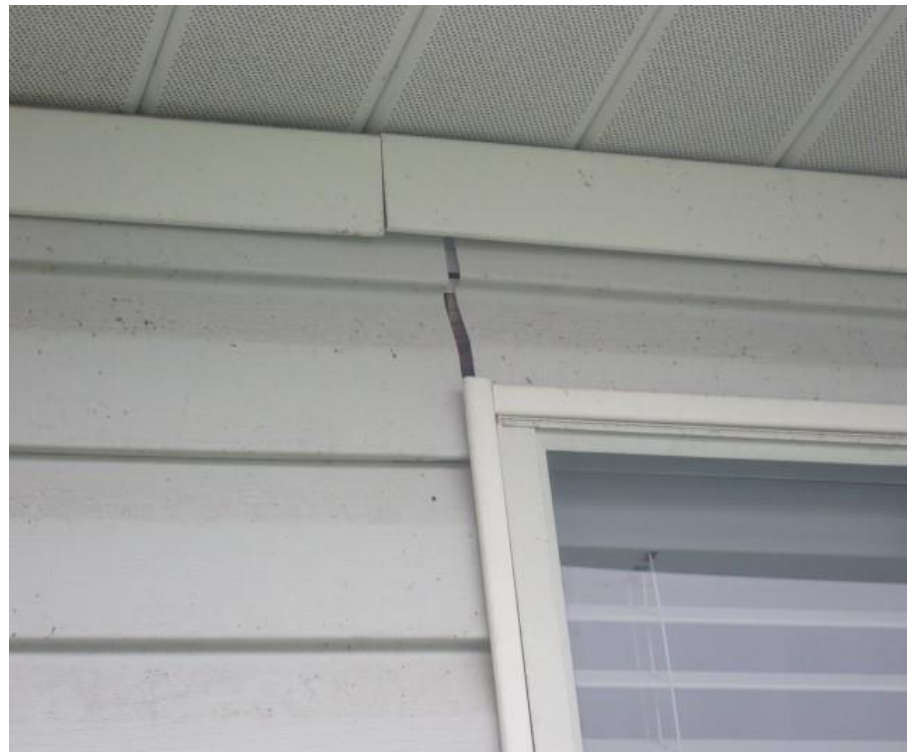
22. Deficiency #4 - Damaged vinyl siding

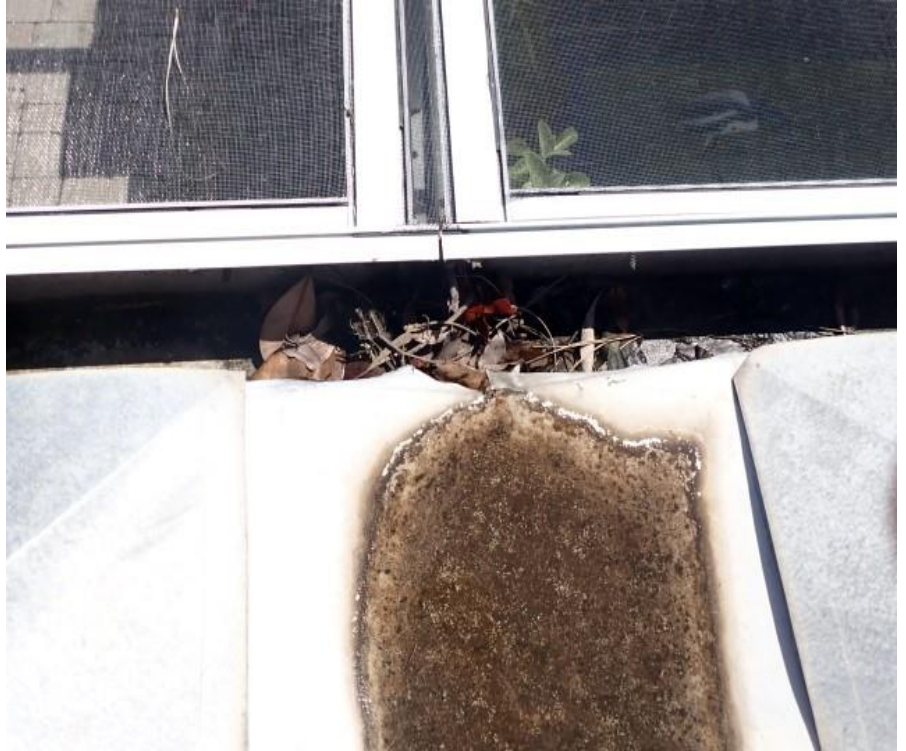
13. Deficiency #1 - Debris in gutter

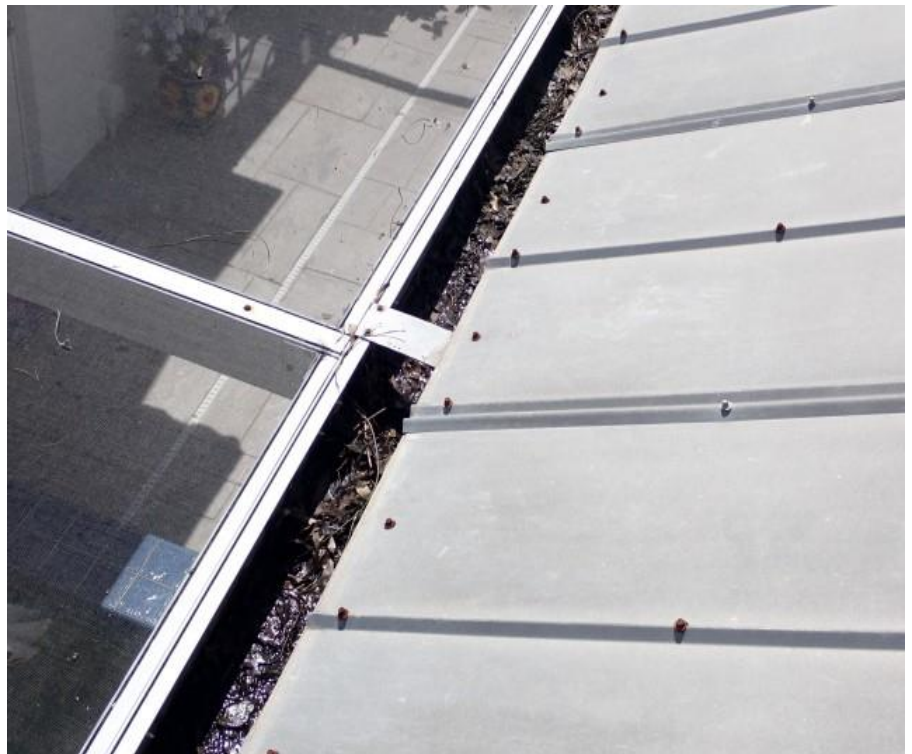
14. Deficiency #1 - Debris in gutter

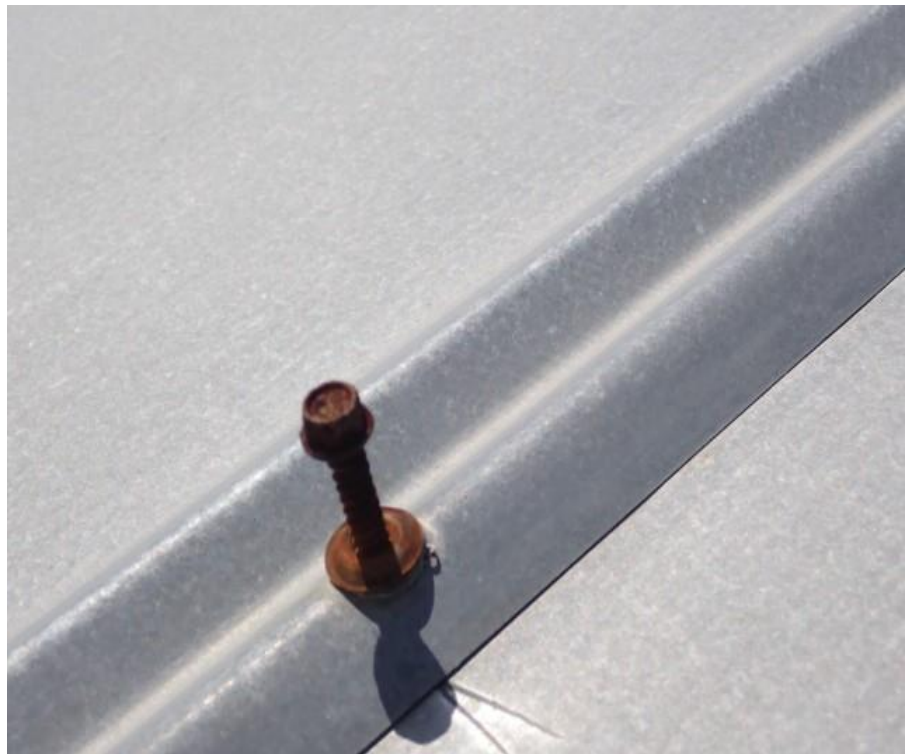
16. Deficiency #2 - Loose fasteners

Deficiency #3 - Rusted fasteners

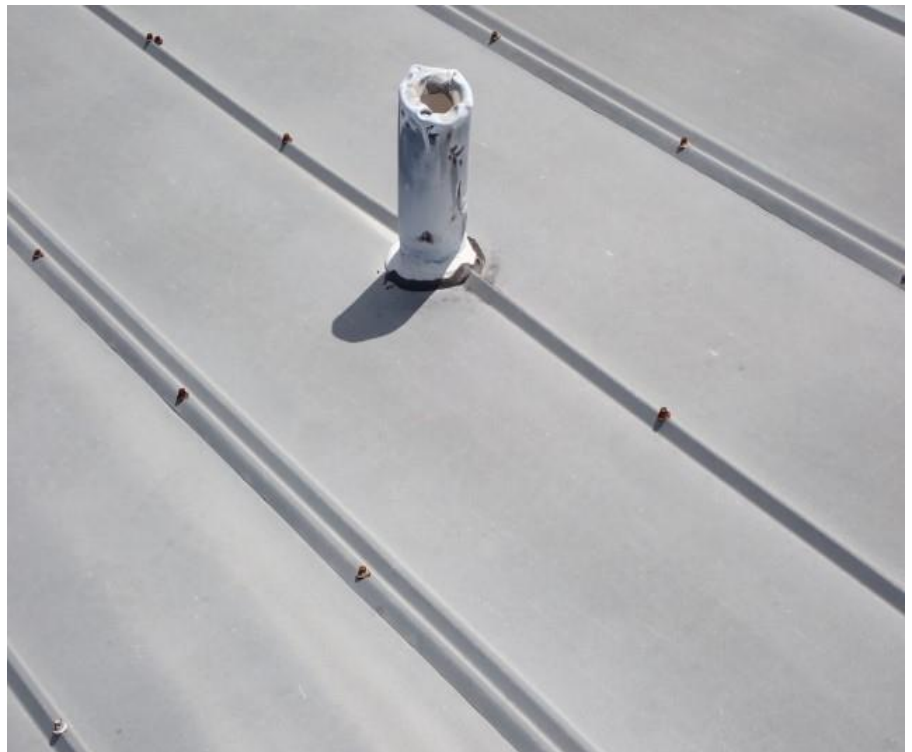
18. Deficiency #4 - Deteriorated
previous sealant repairs at
penetration flashing

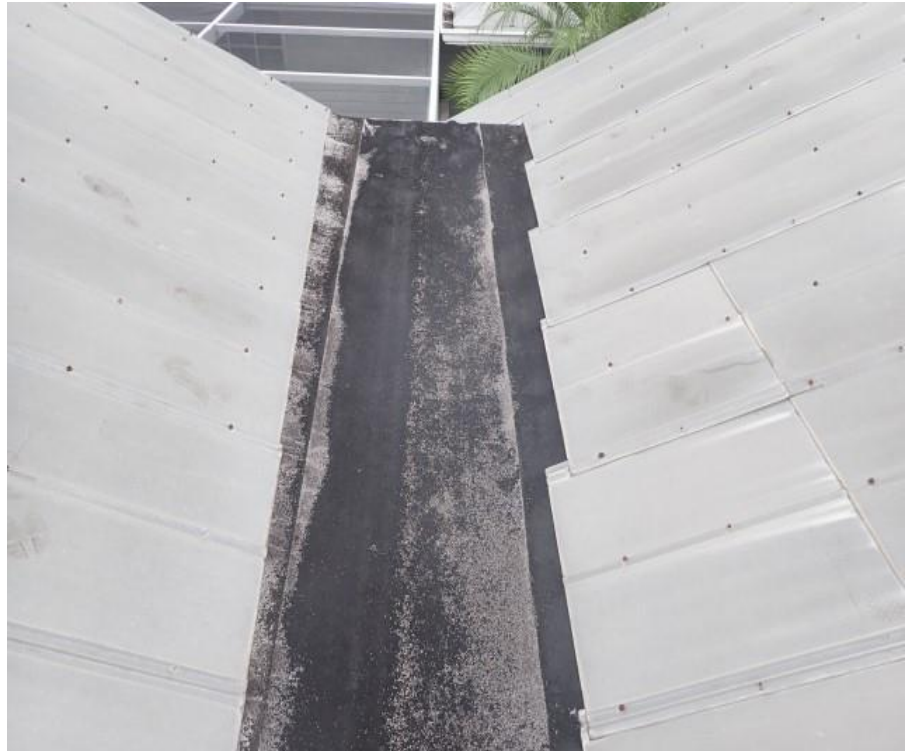
20. Deficiency #6 - Severely deteriorated flashing membrane in roof valley / drainage plane

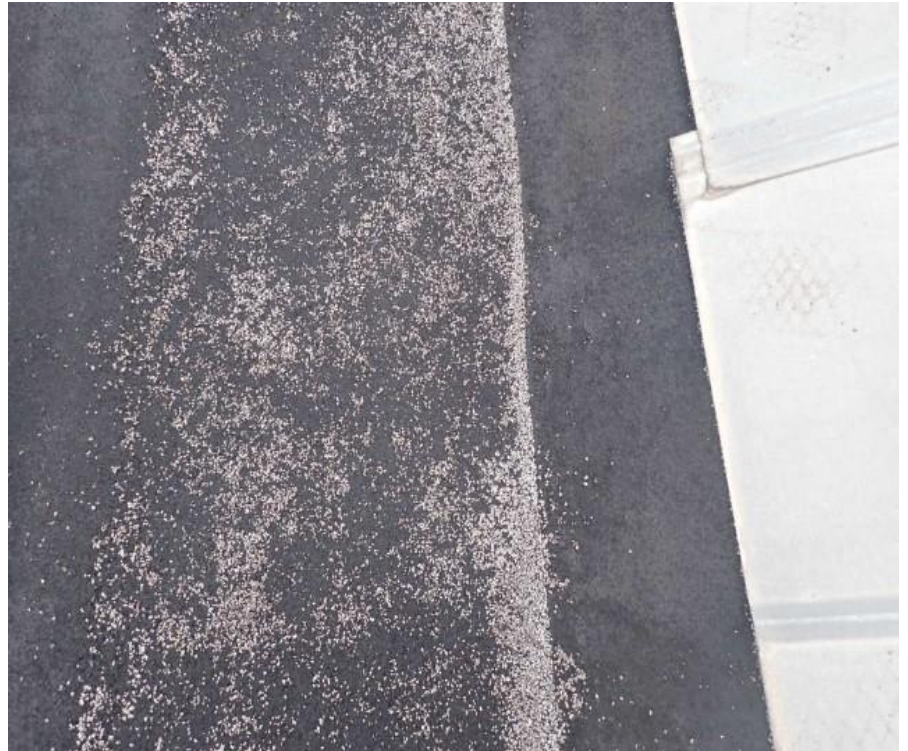
21. Deficiency #6 - Severely deteriorated flashing membrane in roof valley / drainage plane

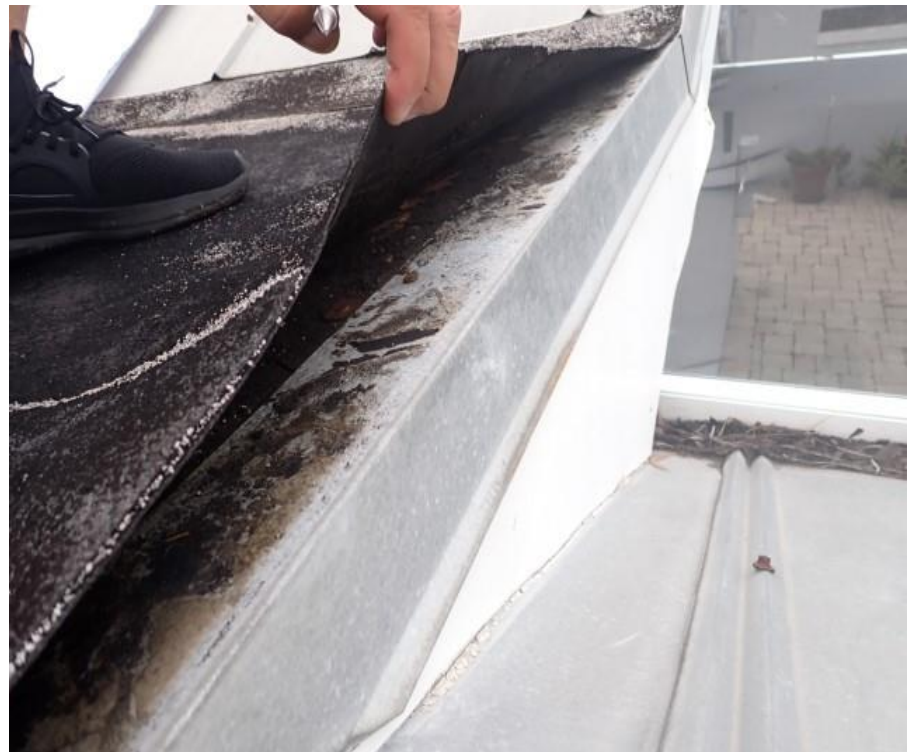
22. Deficiency #7 - Open condition at valley flashing

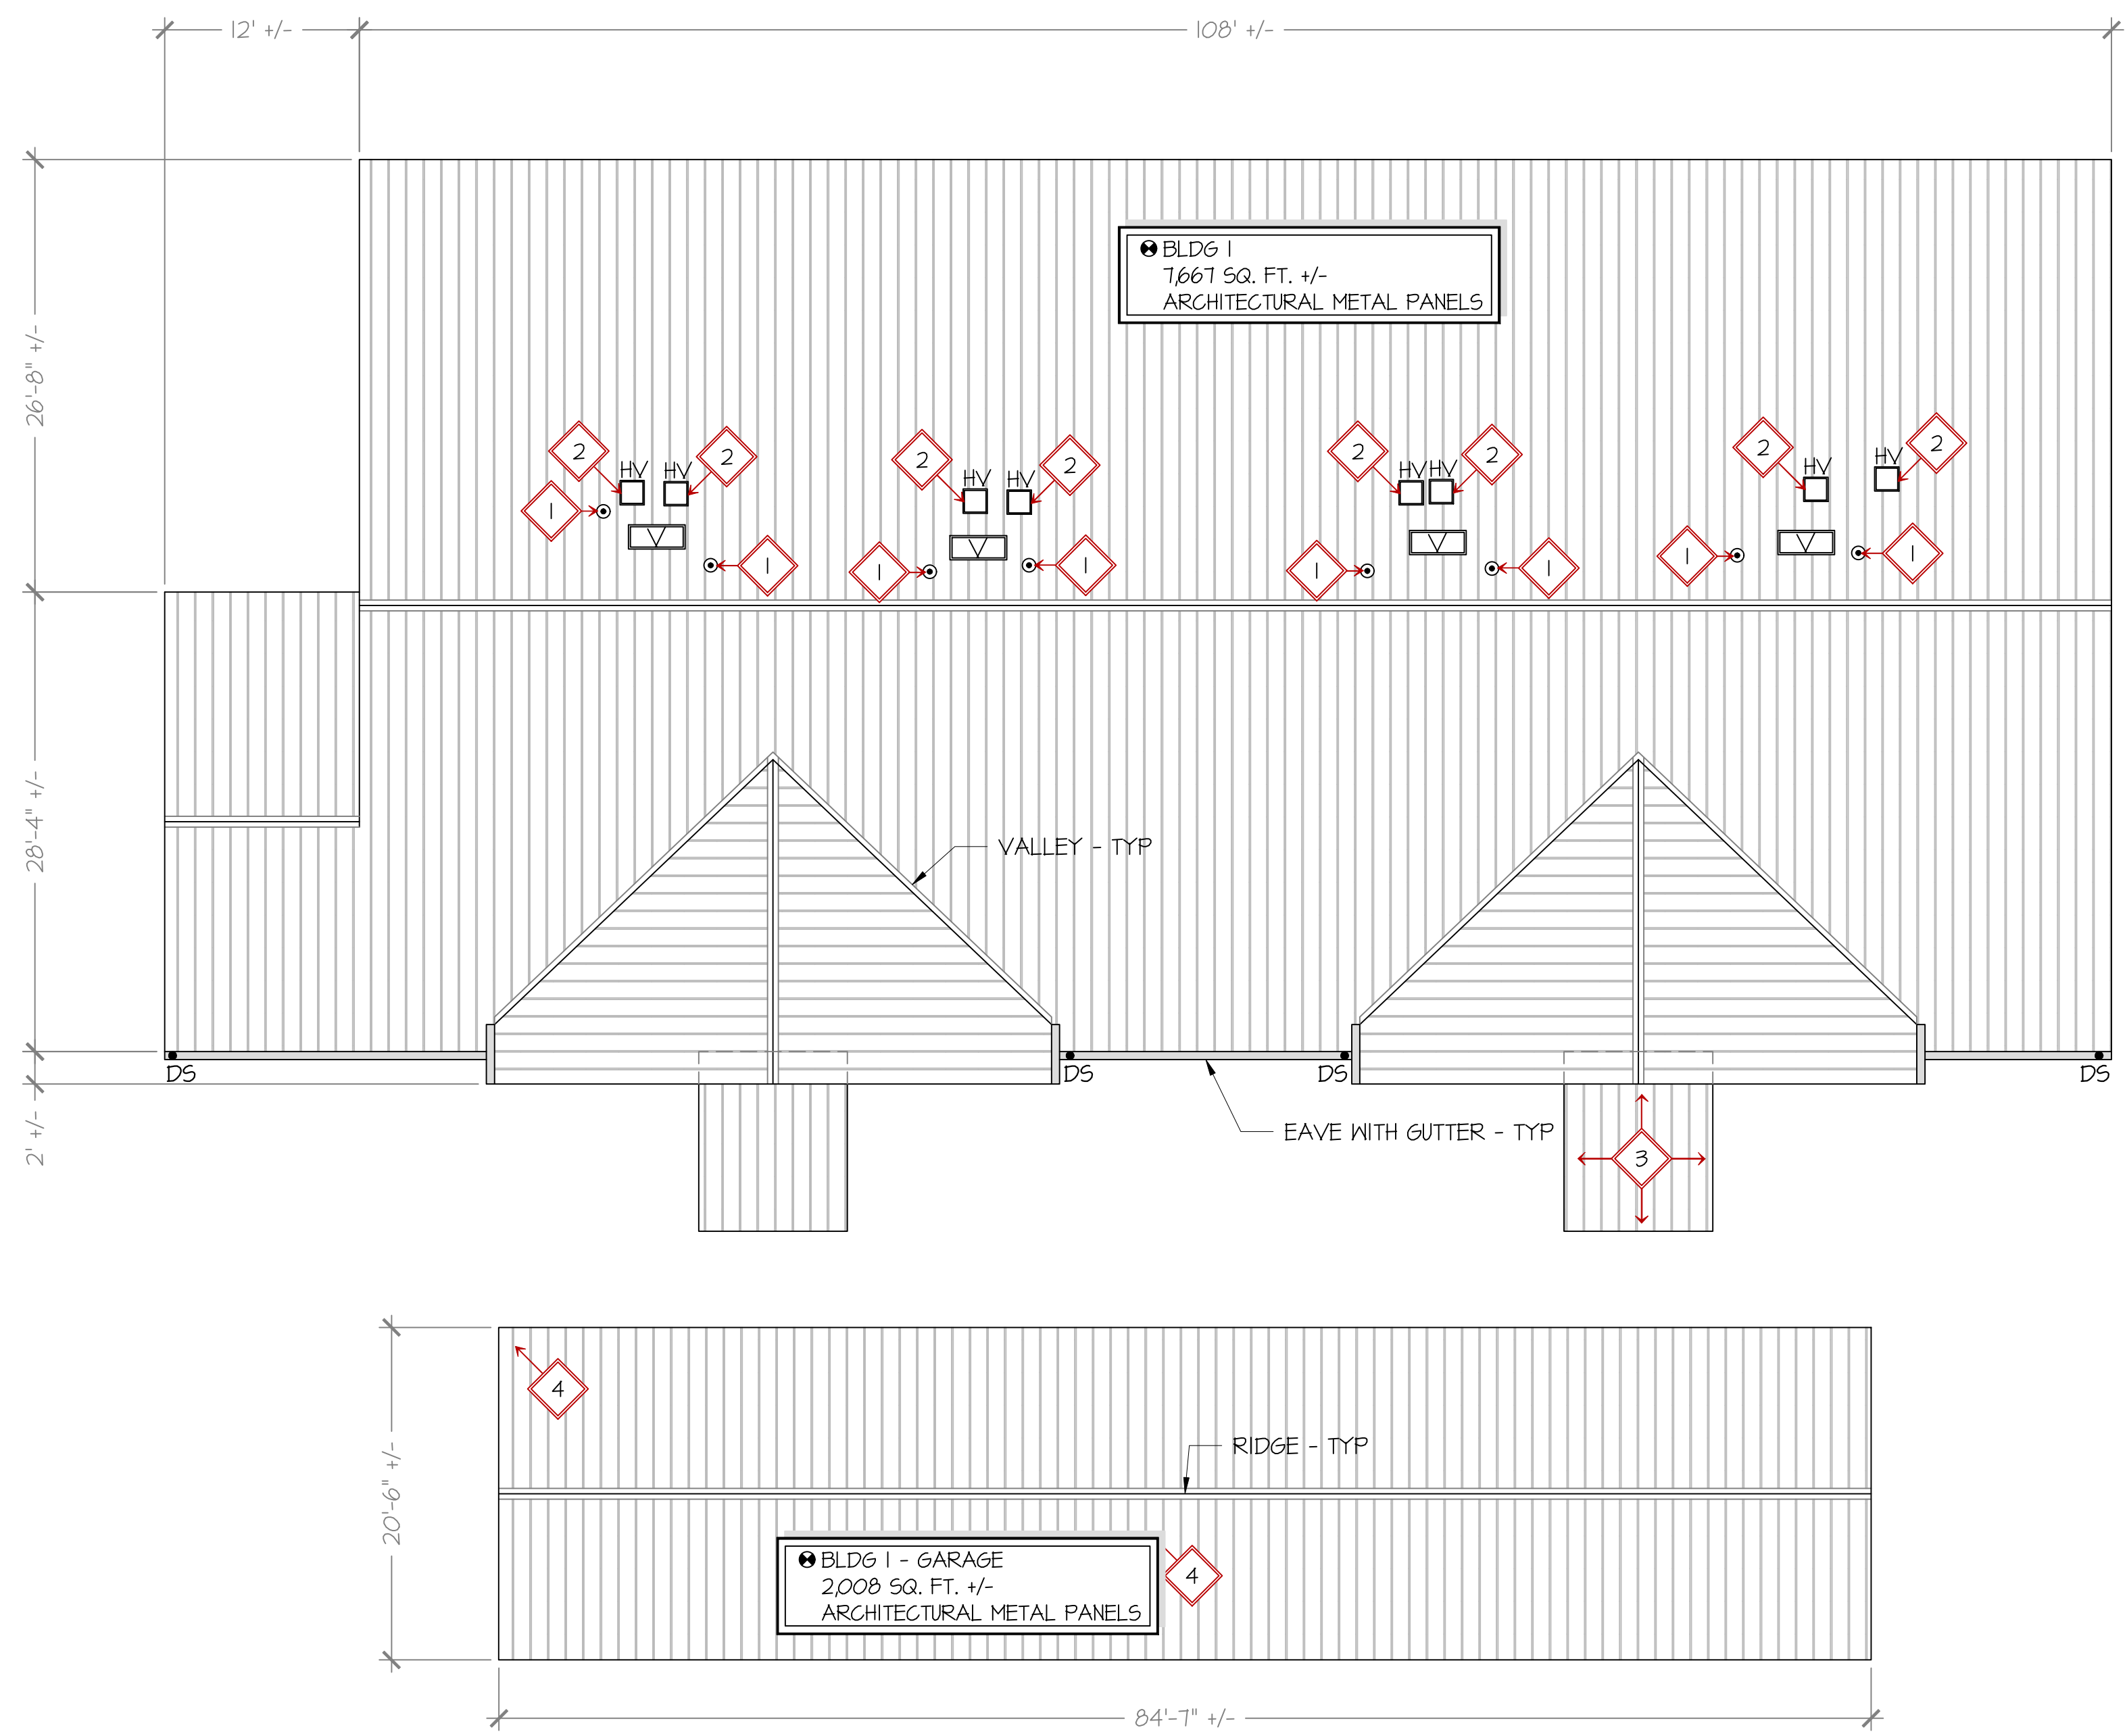
DEFICIENCY LIST - BUILDING 1

- 1 DETERIORATED PIPE FLASHING DETAIL
- 2 DETERIORATED PREVIOUS SEALANT REPAIRS AT PENETRATION FLASHING
- 3 TREE LIMBS / BRANCHES OVERHANGING ROOF SURFACE
- 4 LOOSE, MISSING OR RUSTED FASTENERS OR DETERIORATED NEOPRENE WASHERS

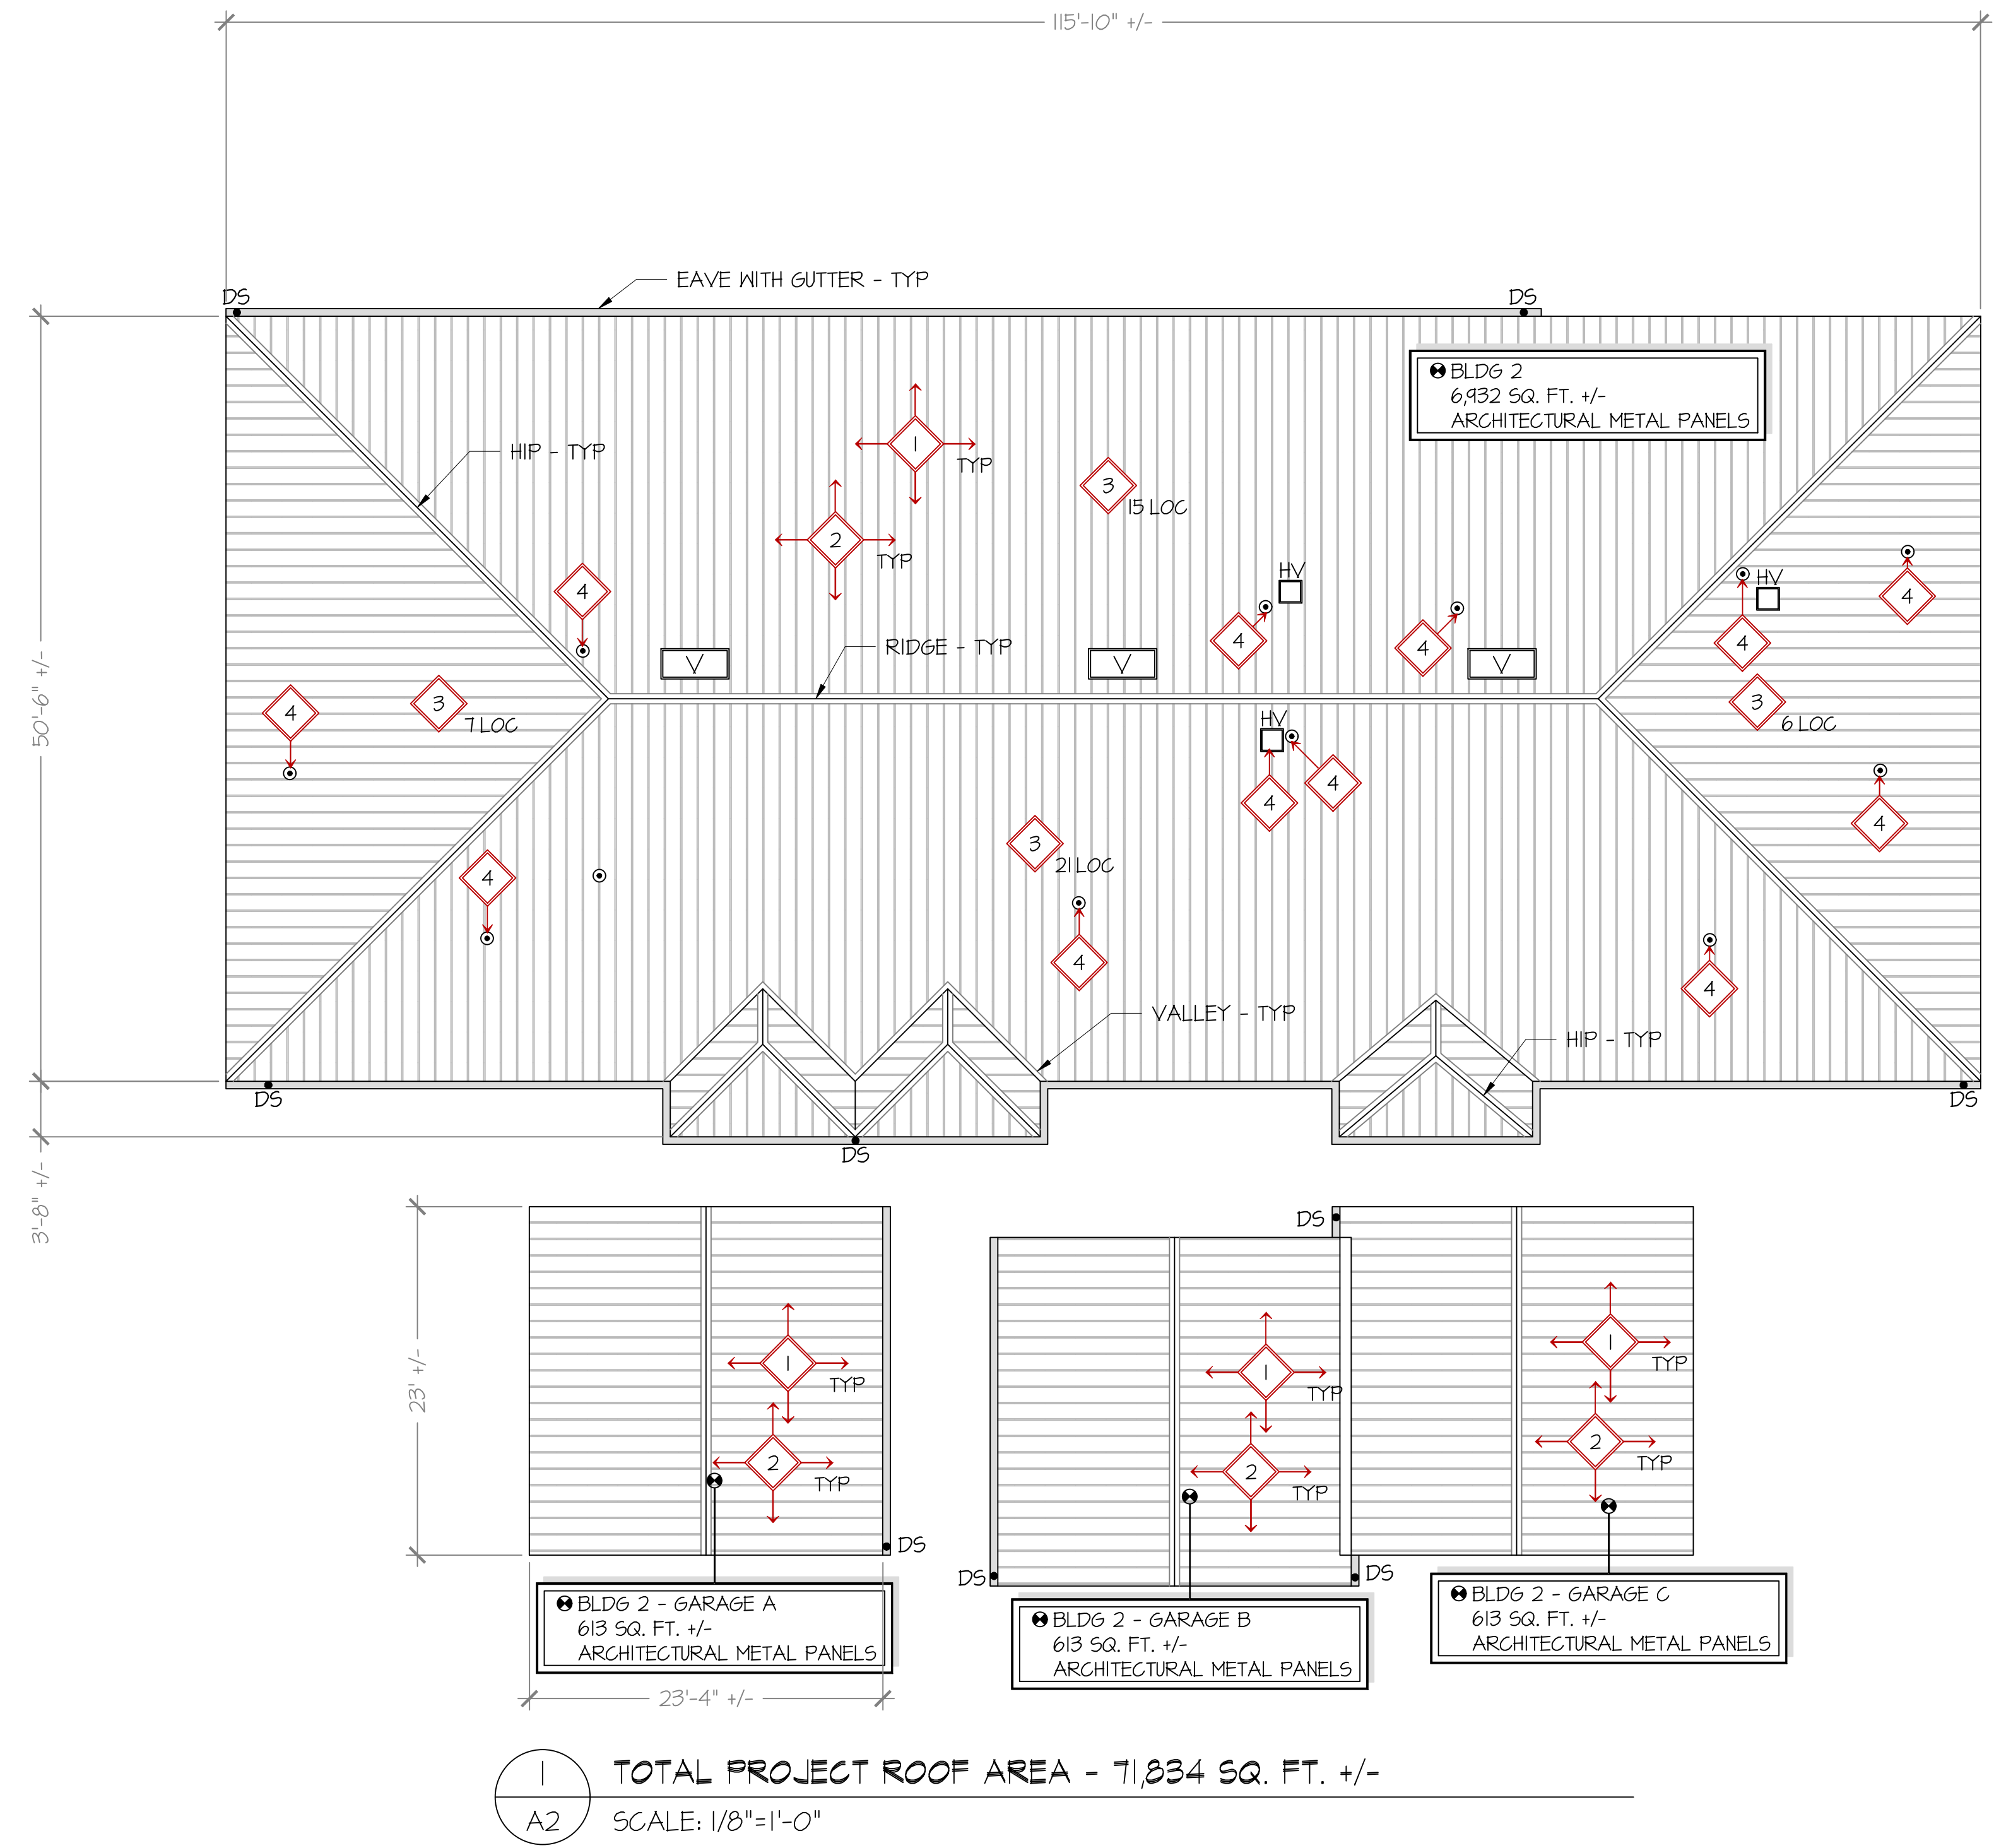
DEFICIENCY LIST - BUILDING 2

- 1 RUSTED FASTENERS
- 2 IMPROPER FASTENERS (NAILS) USED FOR PRIMARY SECUREMENT OF METAL PANEL ASSEMBLY
- 3 LOOSE FASTENERS
- 4 DETERIORATED PREVIOUS SEALANT REPAIRS AT PENETRATION FLASHING
