Village at Indian Creek

**15371 River Vista Drive
North Fort Myers, FL**

10/5/2023

Roof System Condition Evaluation Report

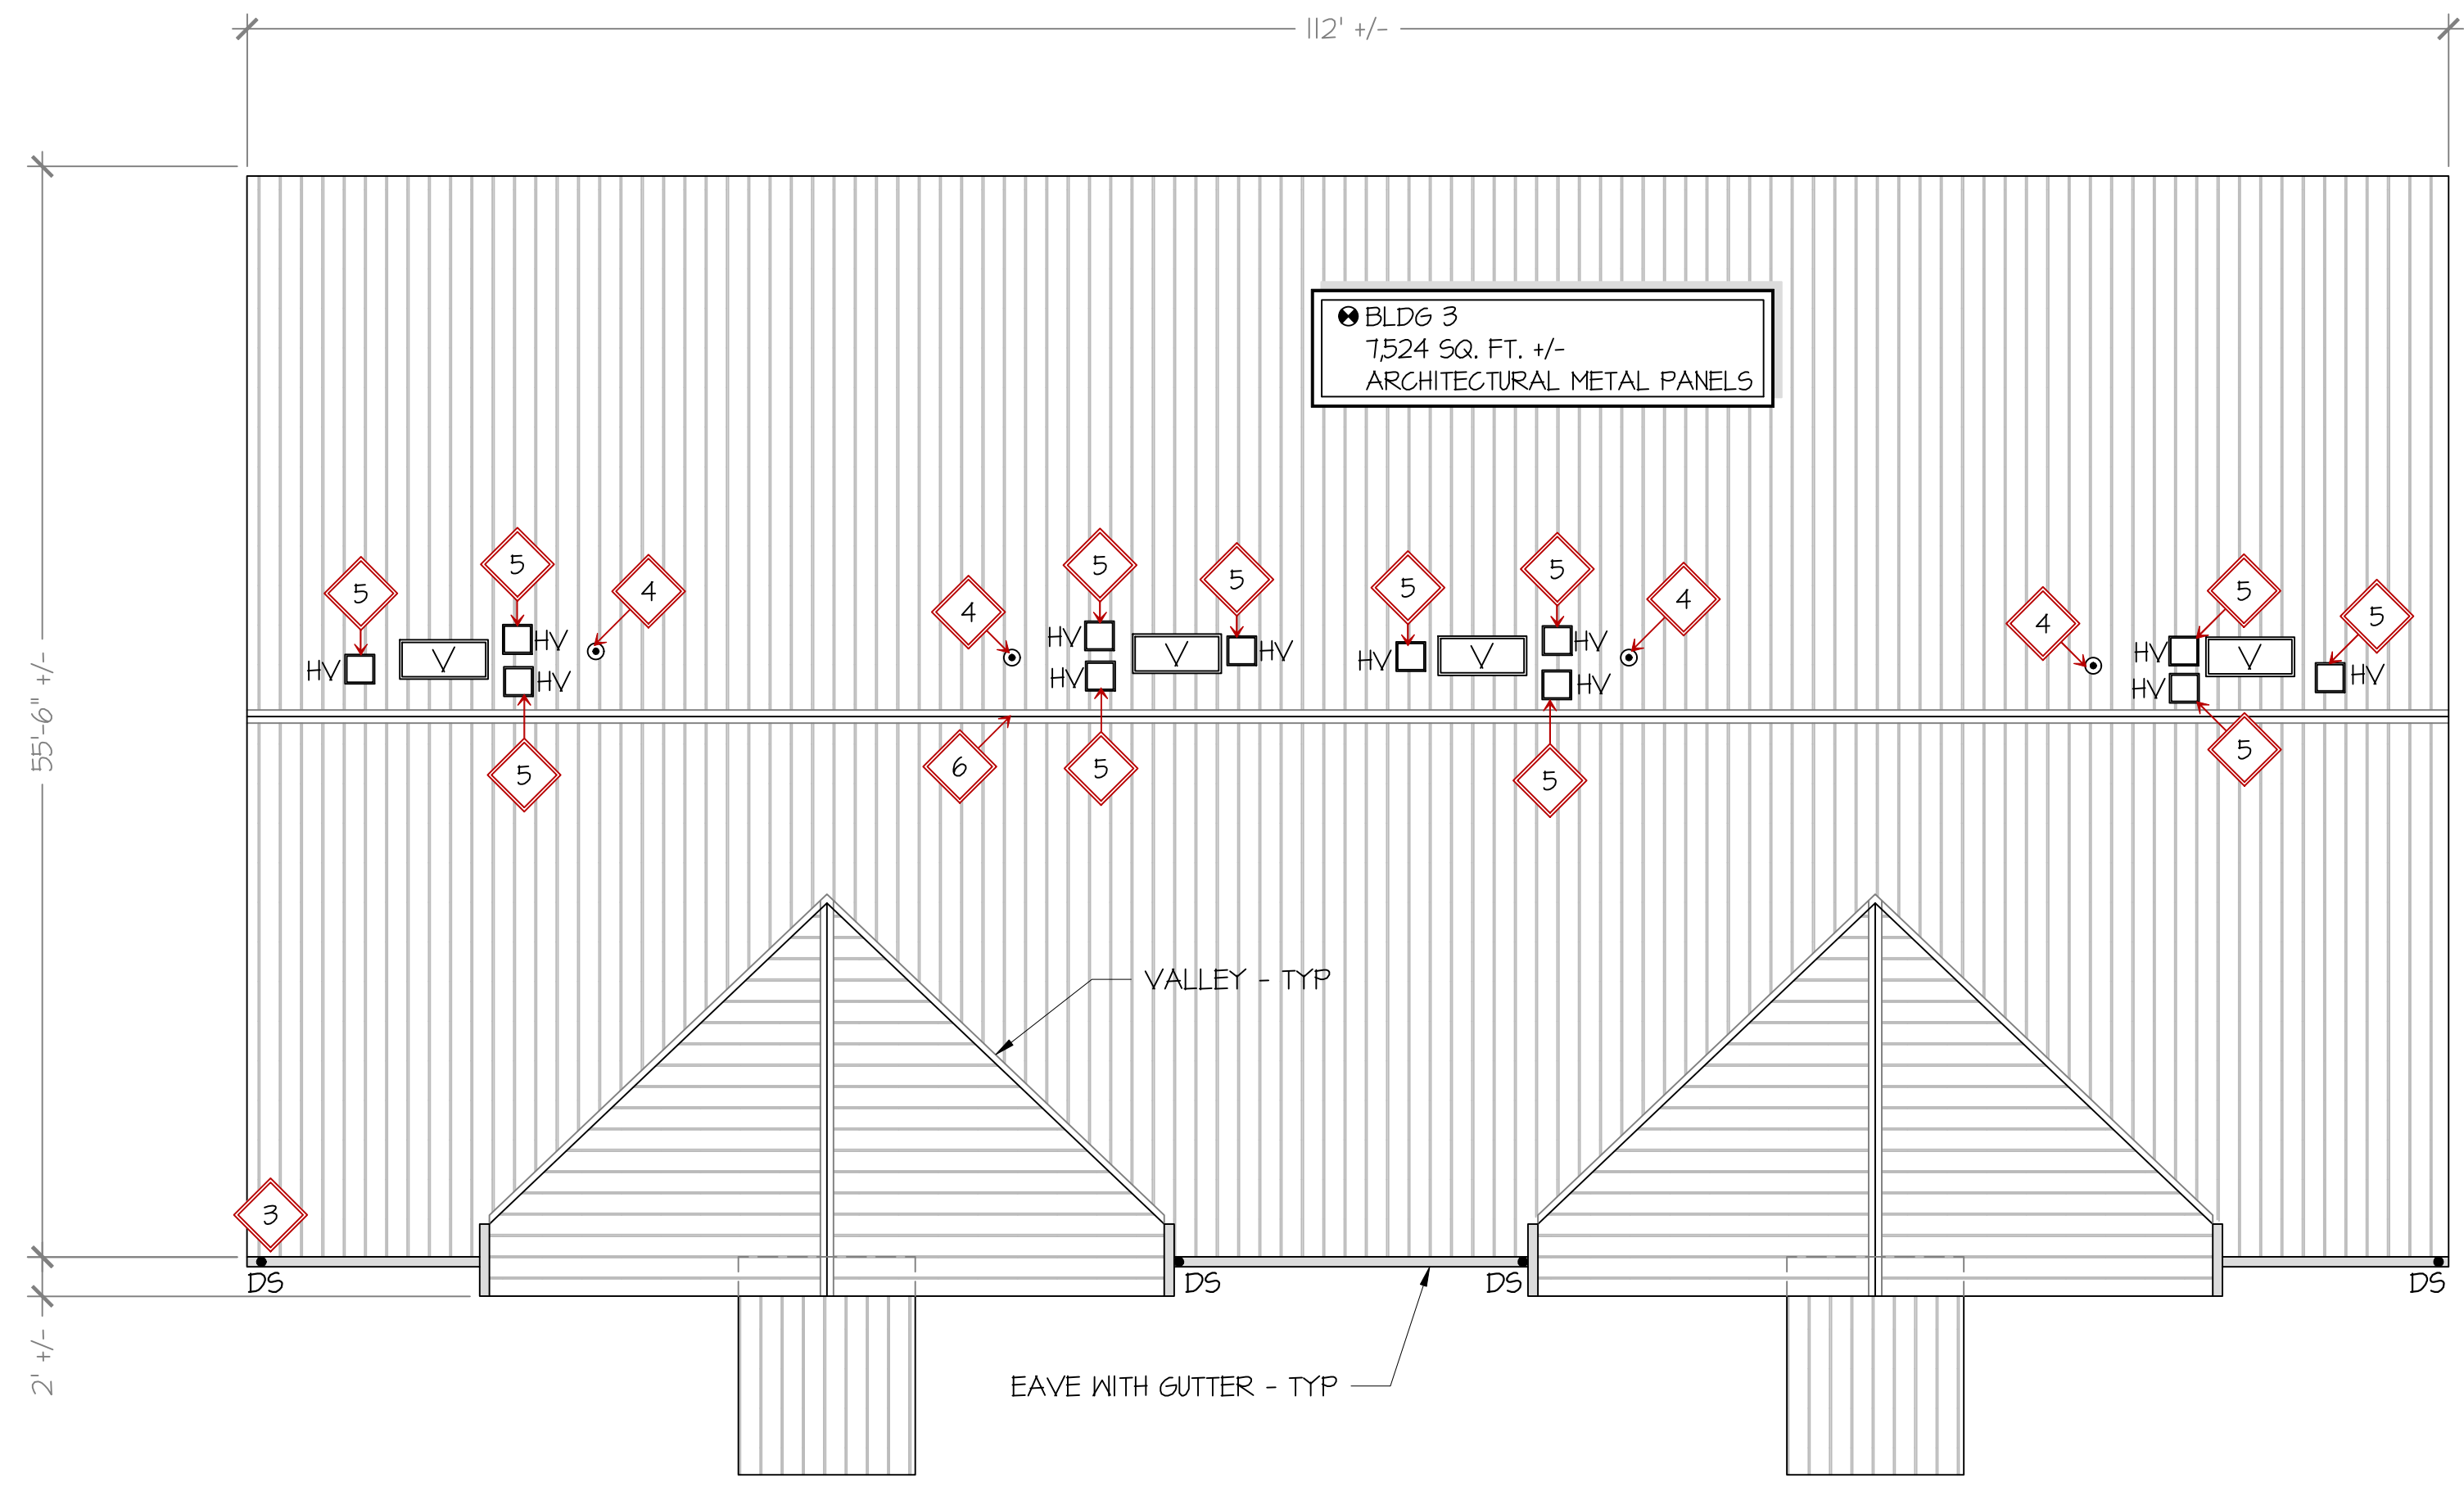
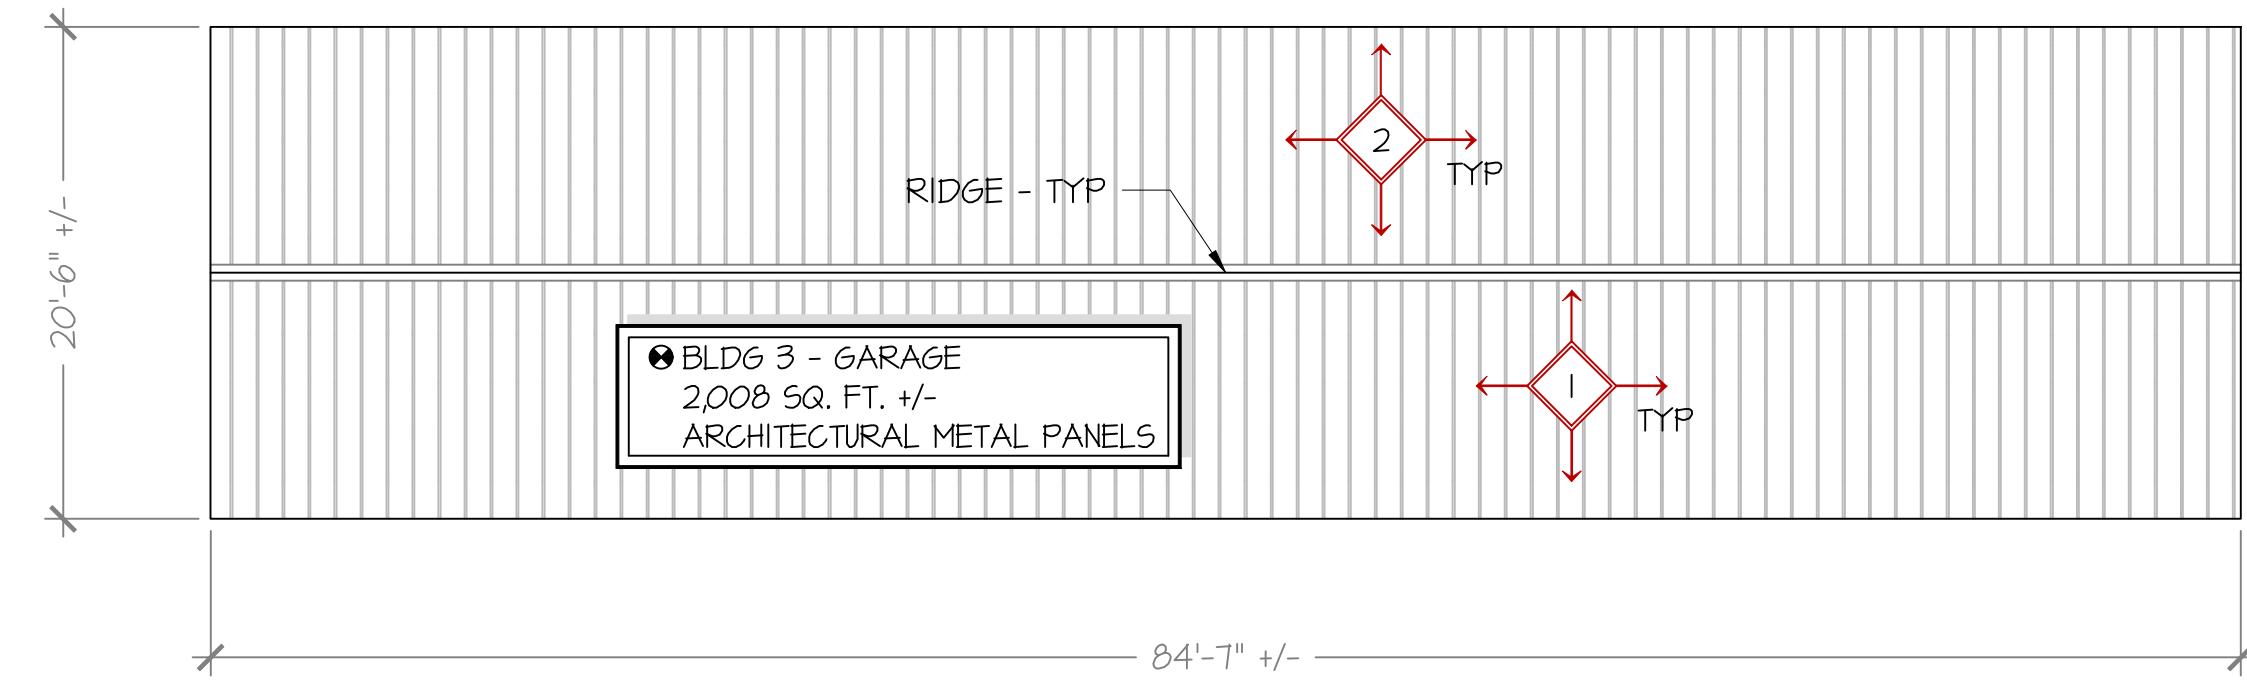
DEFICIENCY LIST - BUILDING 3

- ◆ 1 DAMAGED DRIP EDGE
- ◆ 2 DAMAGED / DENTED METAL PANELS
- ◆ 3 TREE LIMBS / BRANCHES OVERHANGING ROOF SURFACE
- ◆ 4 DETERIORATED SEALANT APPLICATION AT PIPE FLASHING DETAIL
- ◆ 5 DETERIORATED PREVIOUS SEALANT REPAIRS AT PENETRATION FLASHING
- ◆ 6 LOOSE FASTENERS

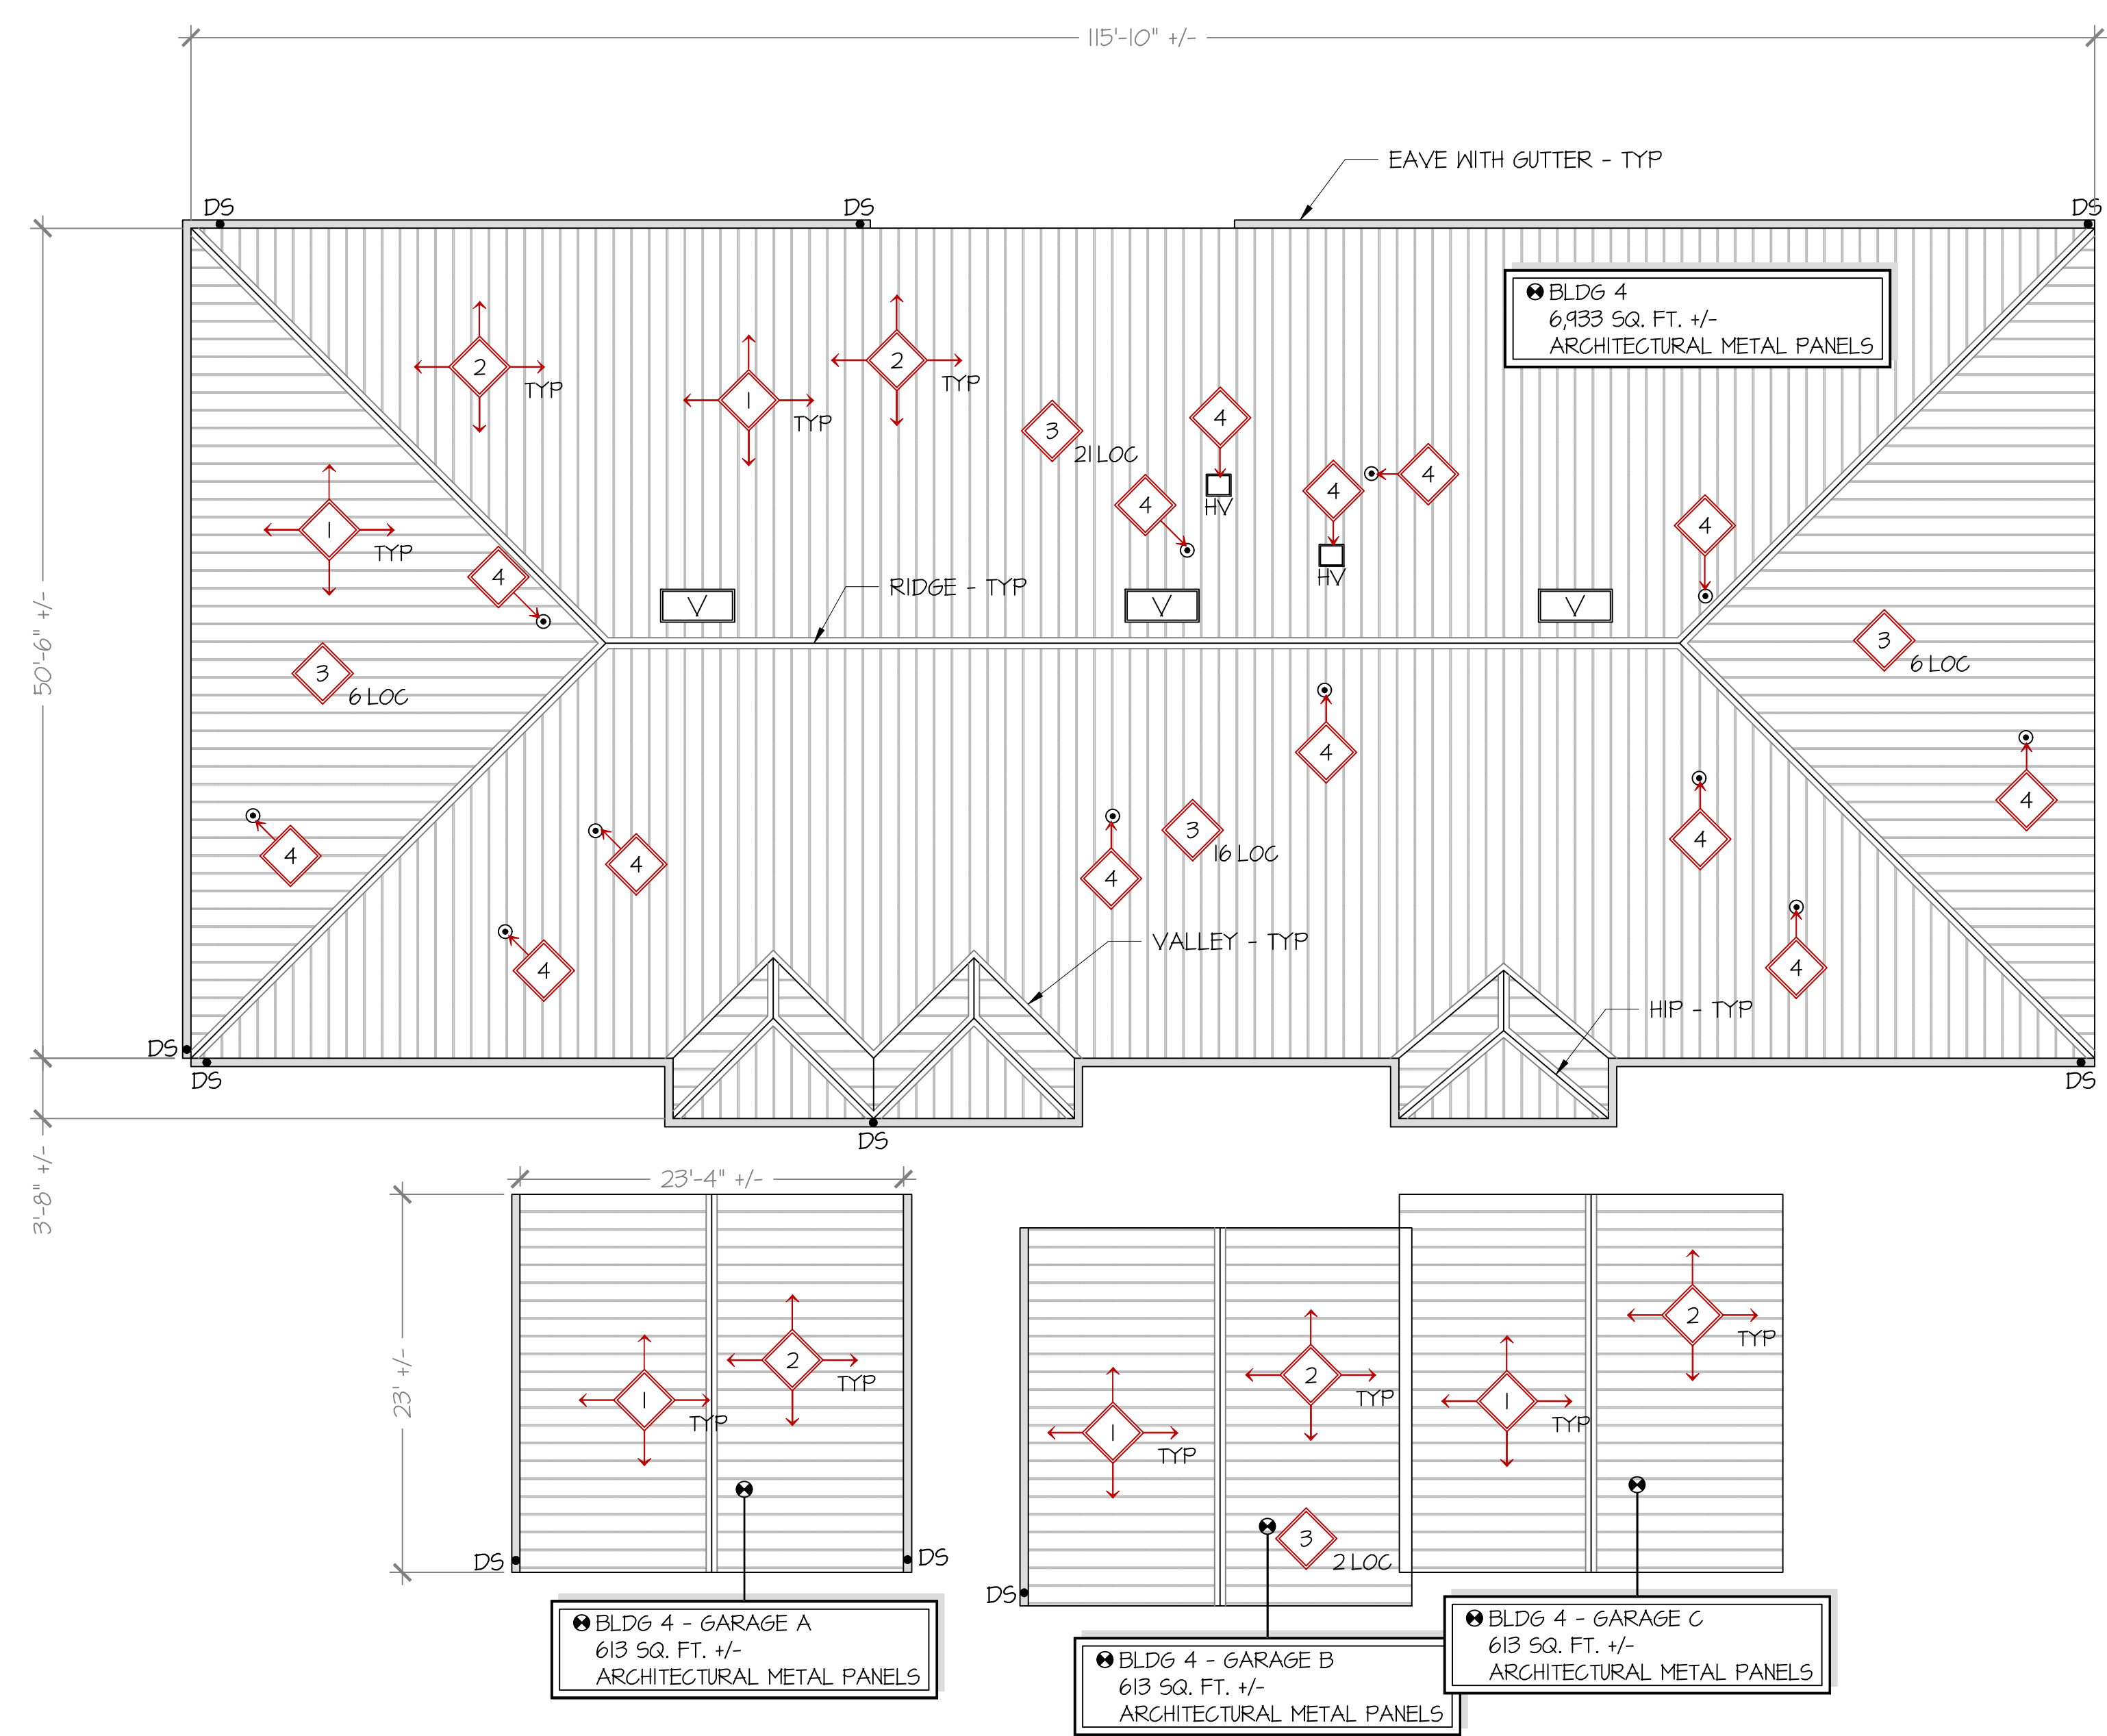
DEFICIENCY LIST - BUILDING 4

- 1 RUSTED FASTENERS
- 2 IMPROPER FASTENERS (NAILS) USED FOR PRIMARY SECUREMENT OF METAL PANEL ASSEMBLY
- 3 LOOSE FASTENERS
- 4 DETERIORATED PREVIOUS SEALANT REPAIRS AT PENETRATION FLASHING

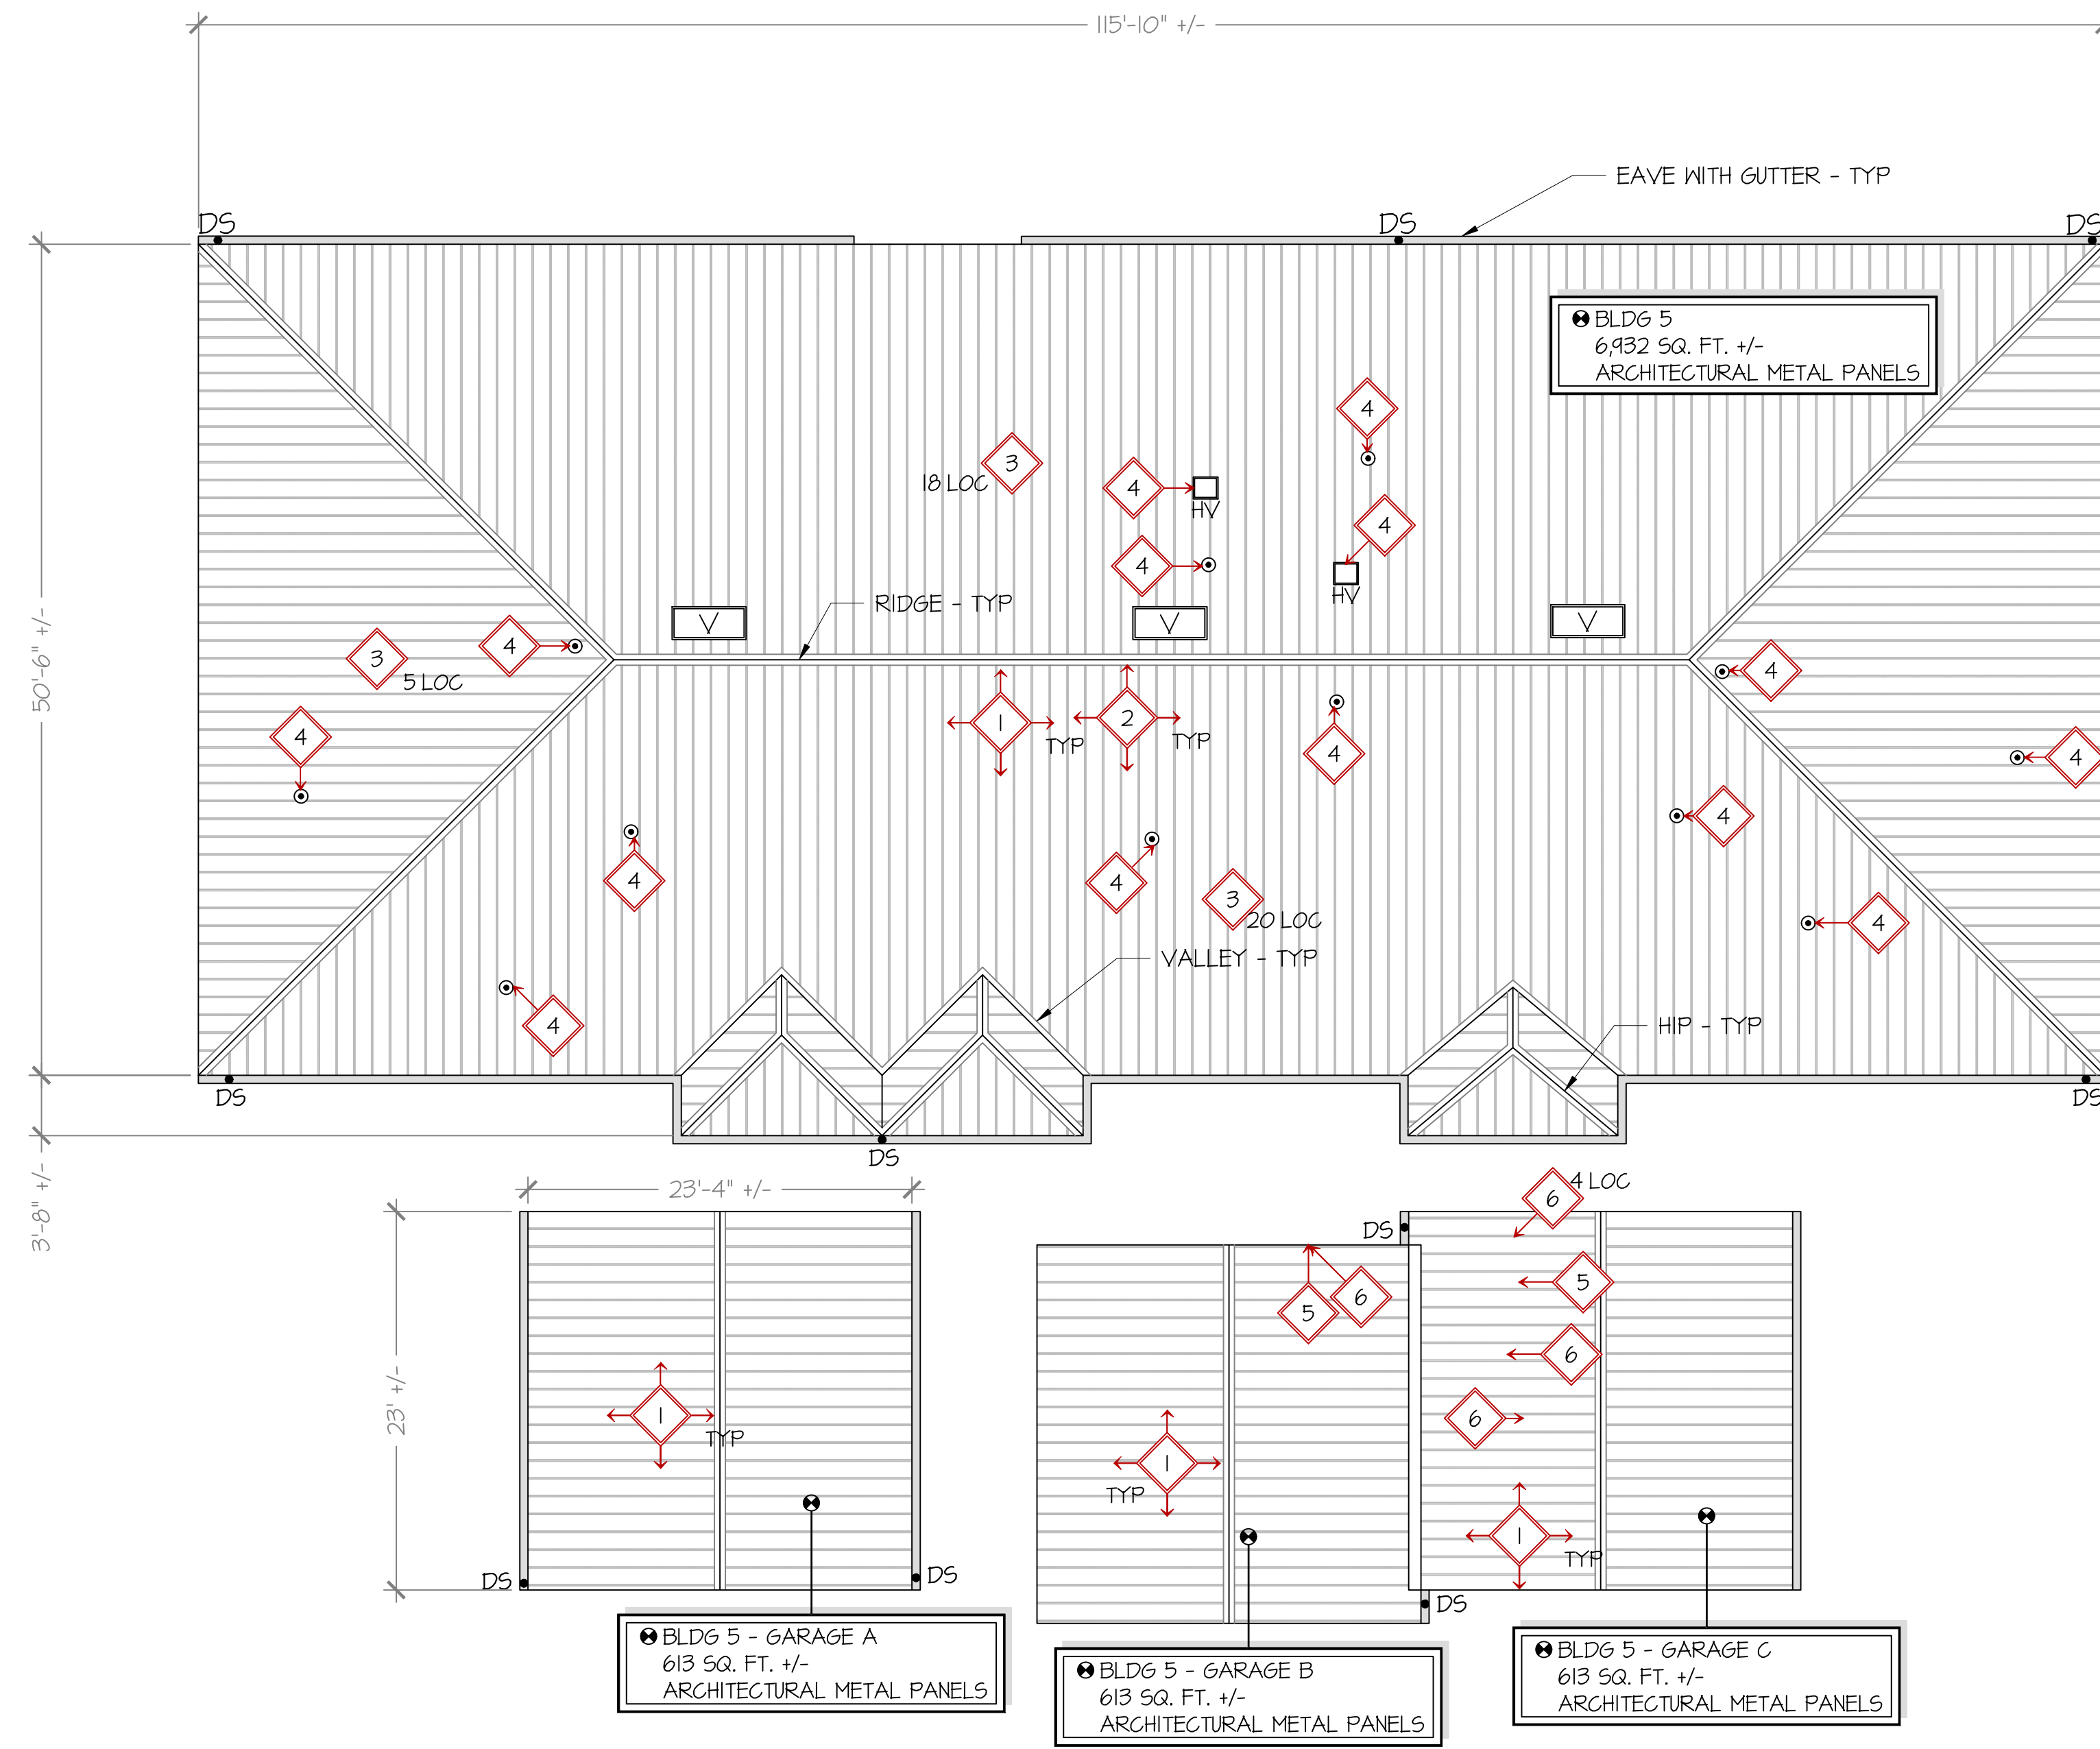
DEFICIENCY LIST - BUILDING 5

- 1 RUSTED FASTENERS
- 2 IMPROPER FASTENERS (NAILS) USED FOR PRIMARY SECUREMENT OF METAL PANEL ASSEMBLY
- 3 LOOSE FASTENERS
- 4 DETERIORATED PREVIOUS SEALANT REPAIRS AT PENETRATION FLASHING
- 5 RUST DEVELOPMENT ON METAL PANEL
- 6 DAMAGED / DENTED METAL PANELS

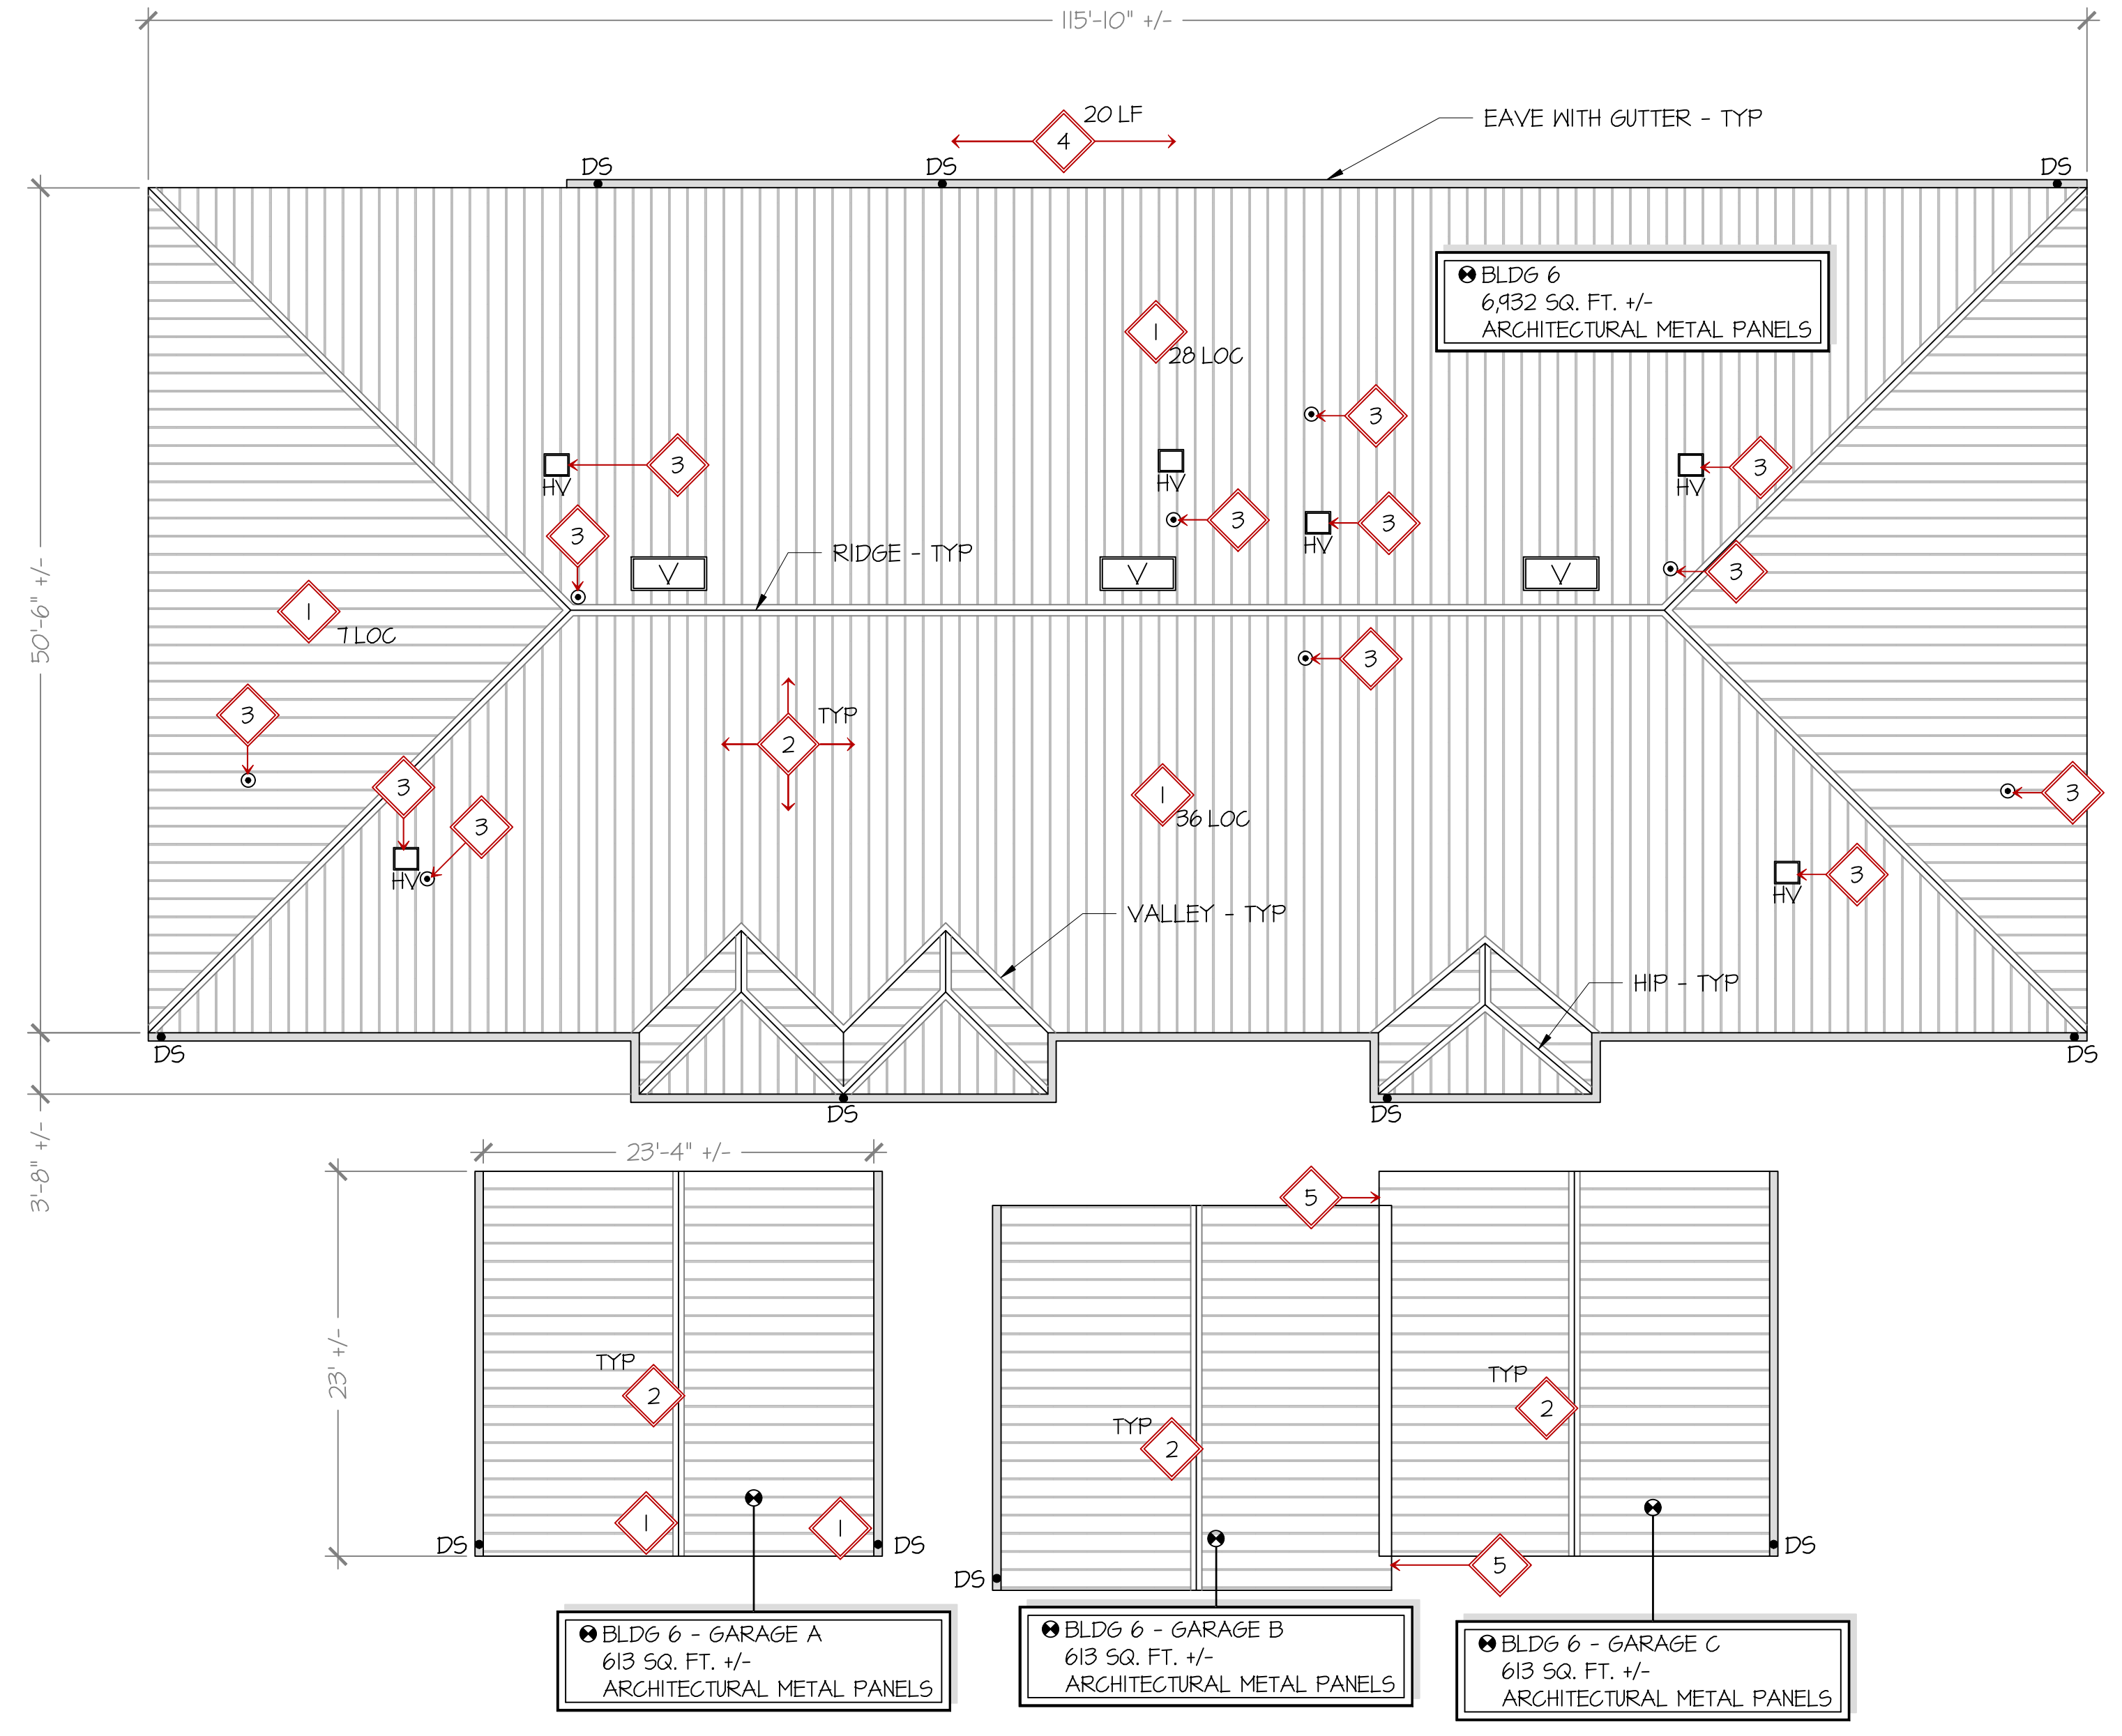
DEFICIENCY LIST - BUILDING 6

- ◆ 1 LOOSE FASTENERS
- ◆ 2 RUSTED FASTENERS
- ◆ 3 DETERIORATED PREVIOUS SEALANT REPAIRS AT PENETRATION FLASHING
- ◆ 4 DEBRIS IN GUTTER
- ◆ 5 OPEN CONDITION AT VALLEY FLASHING

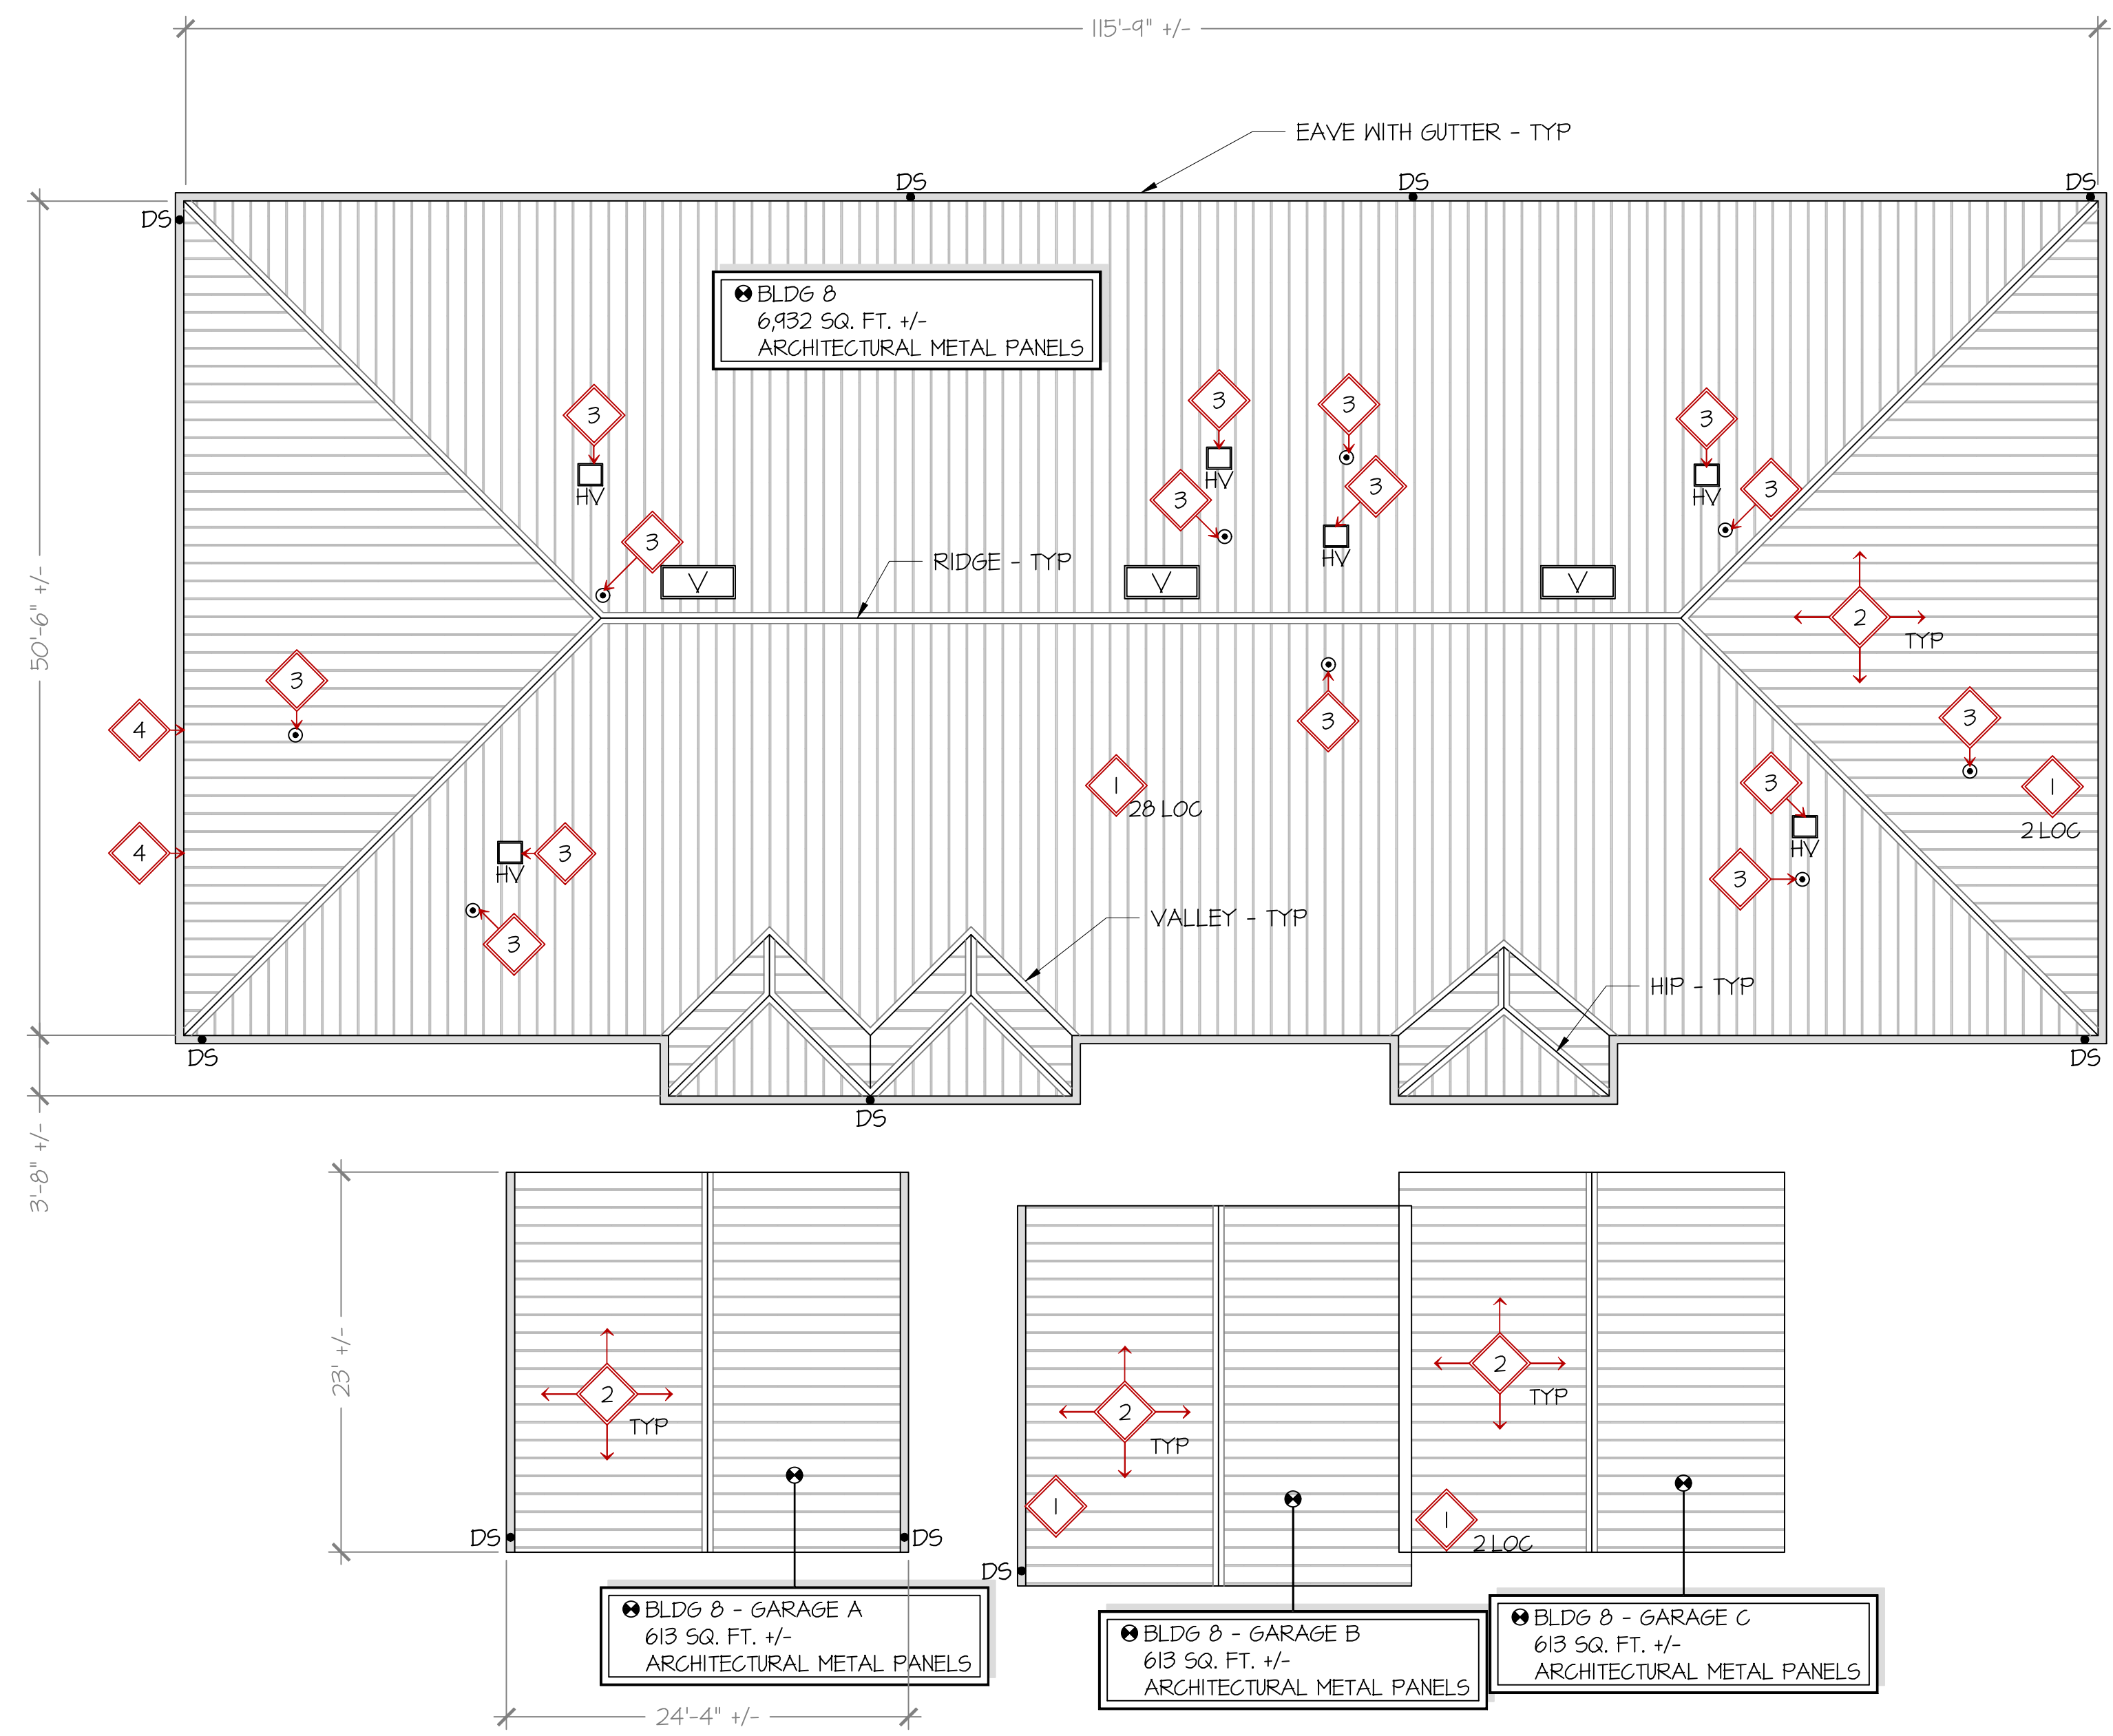
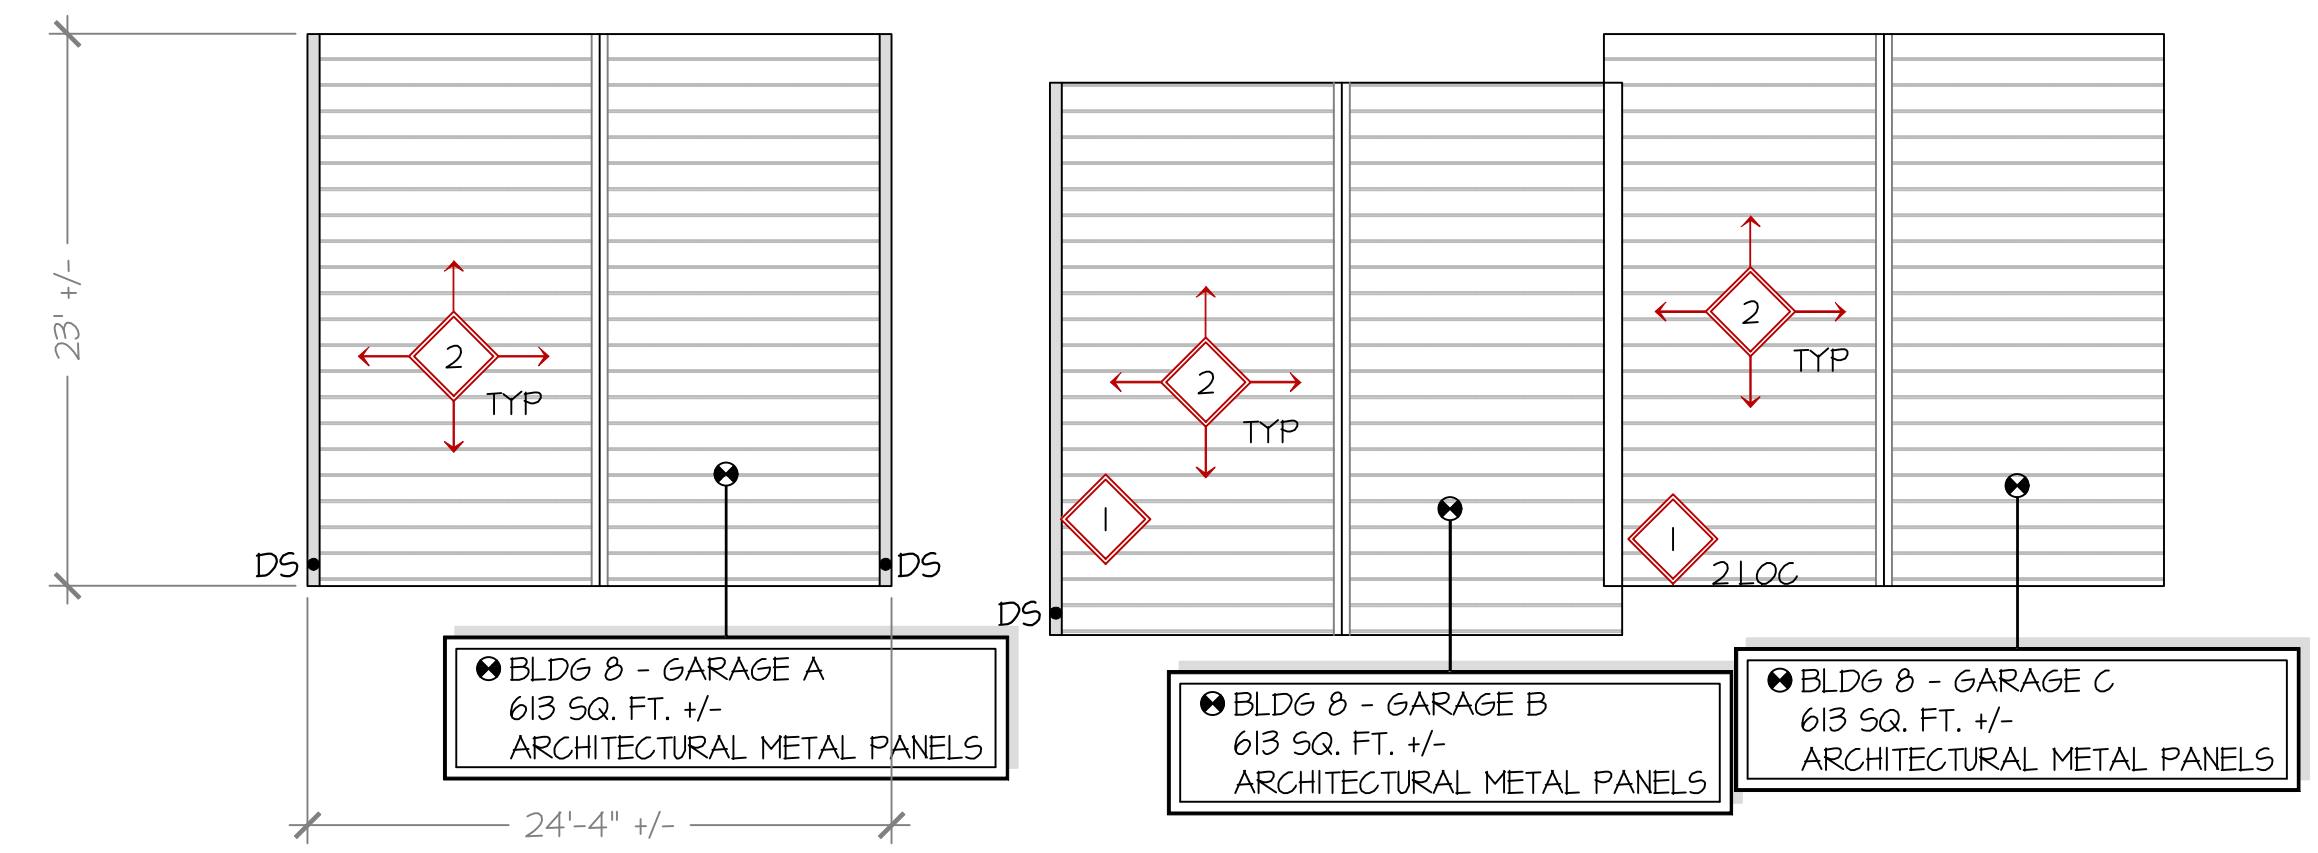
- 1 LOOSE FASTENERS
- 2 RUSTED FASTENERS
- 3 DETERIORATED PREVIOUS SEALANT REPAIRS AT PENETRATION FLASHING
- 4 DAMAGED VINYL SIDING
