Village at Indian Creek

**15371 River Vista Drive
North Fort Myers, FL**

10/5/2023

Roof System Condition Evaluation Report

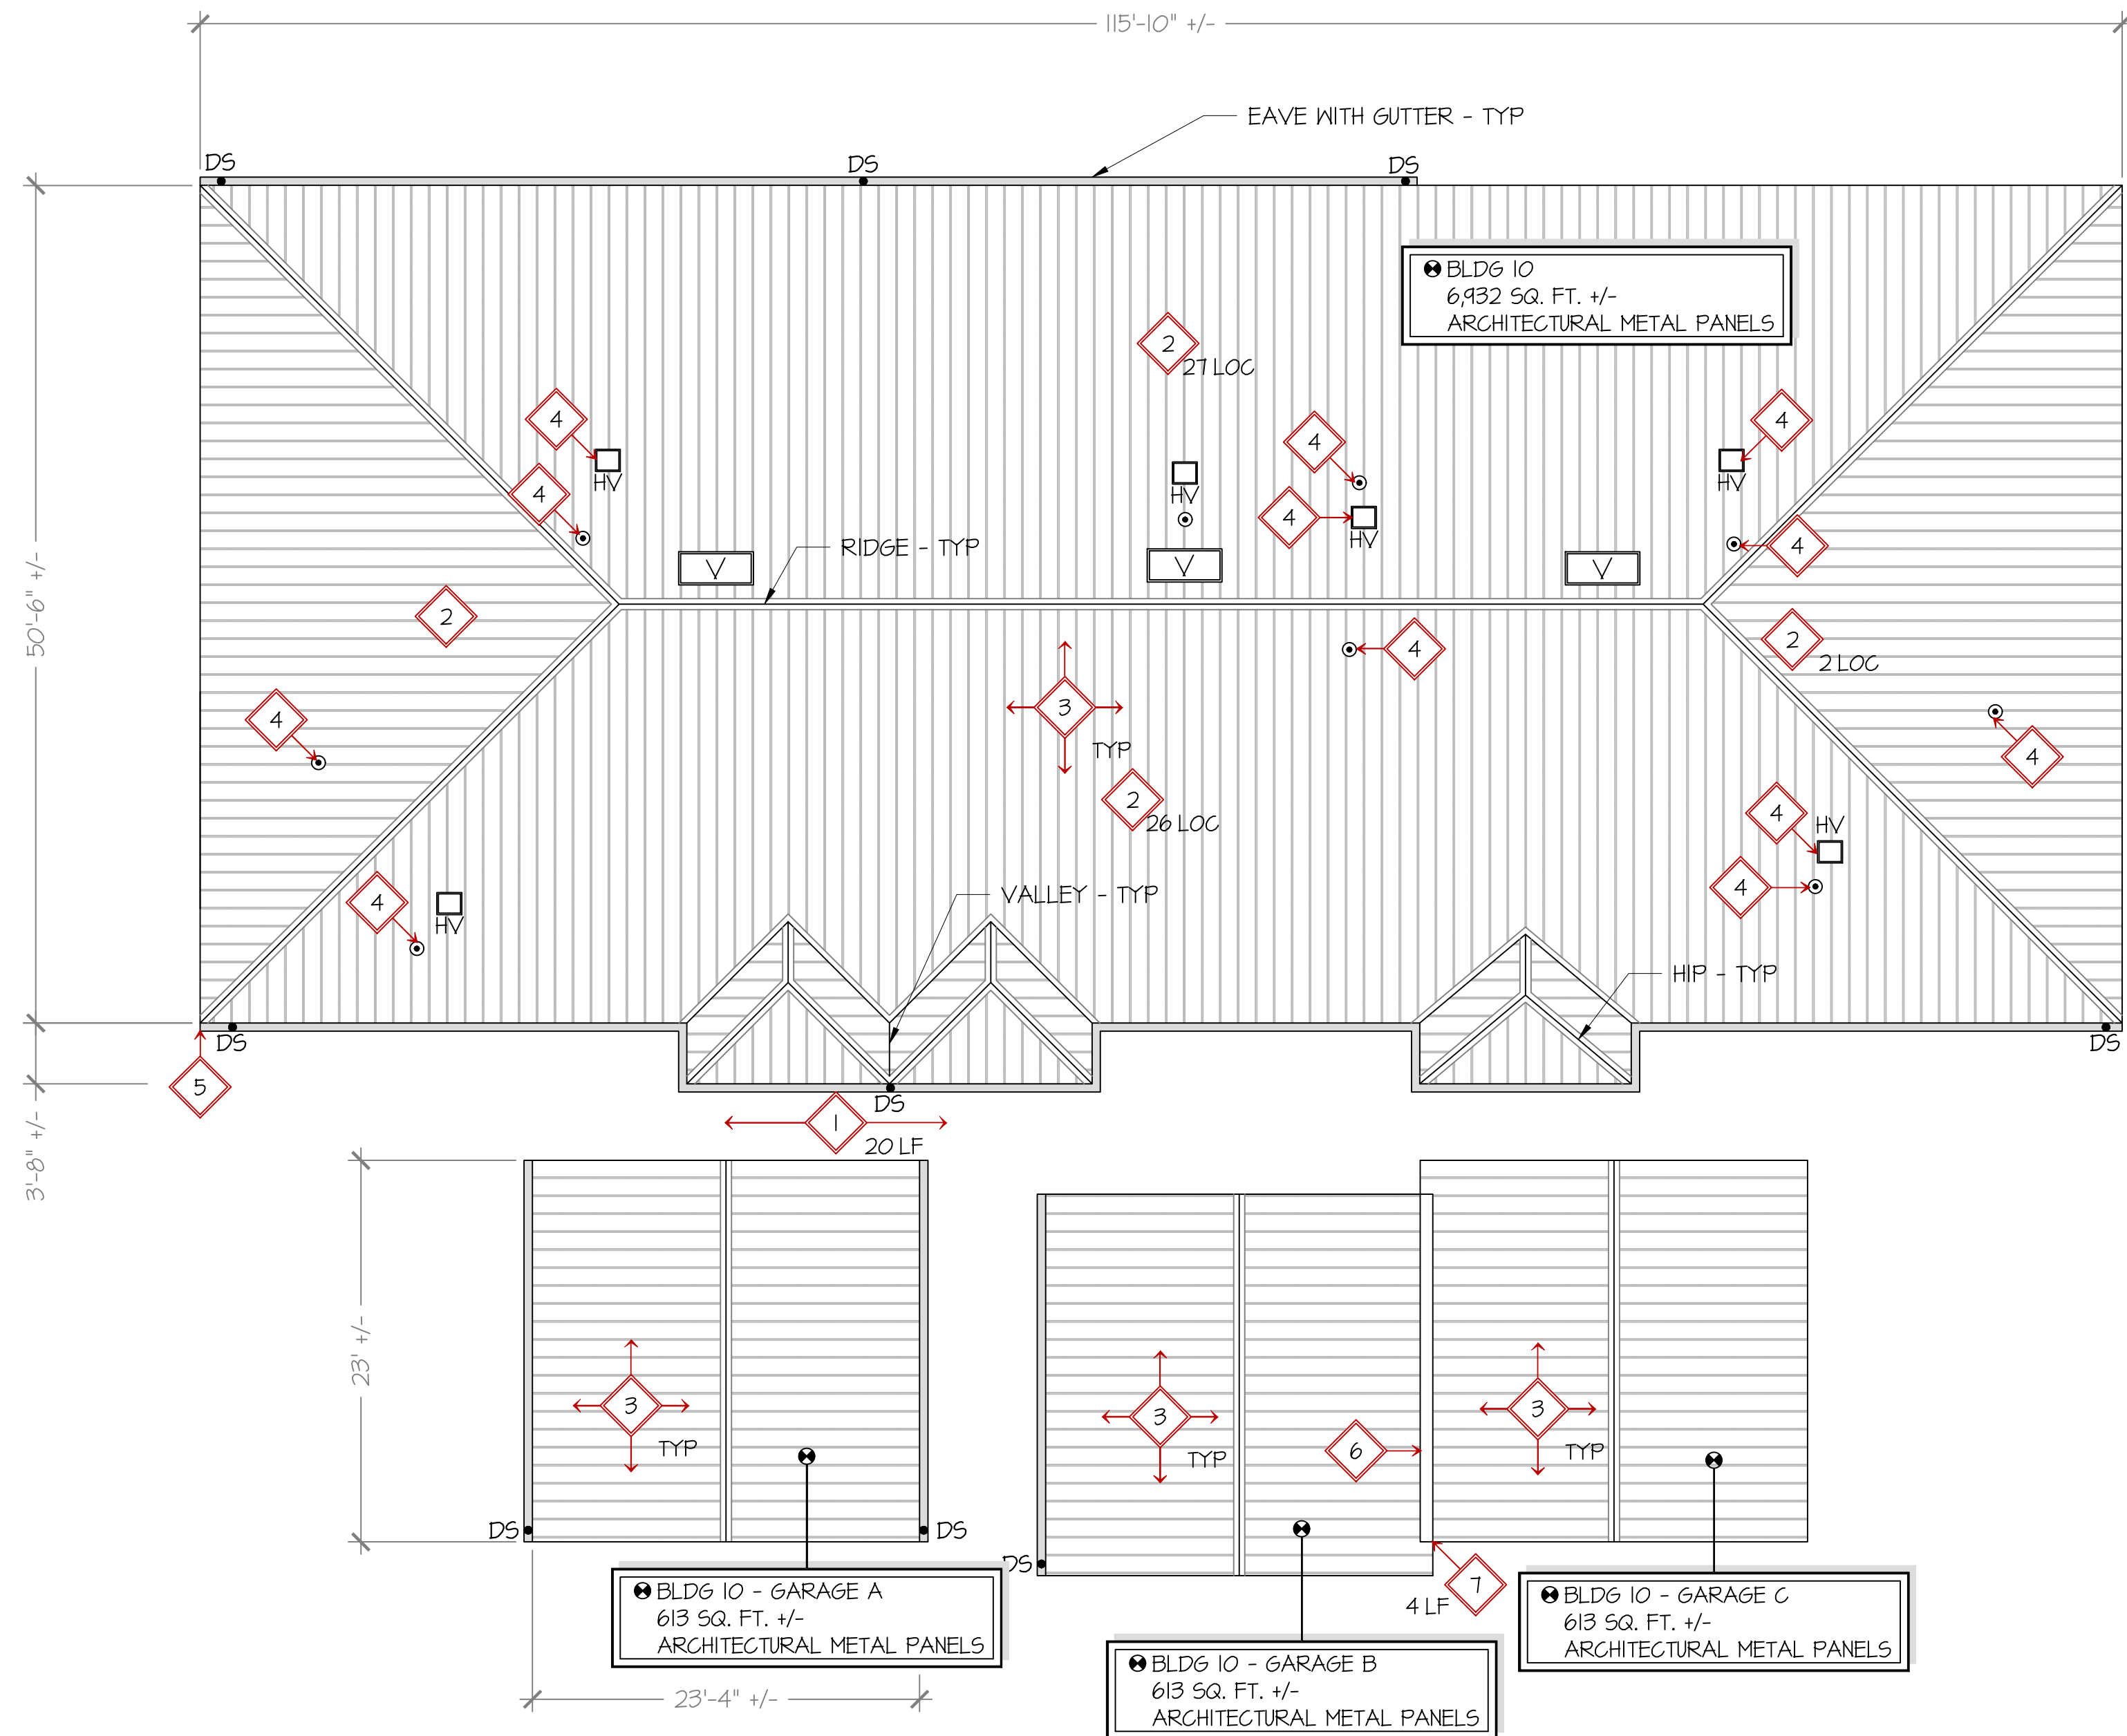
DEFICIENCY LIST - BUILDING 10

- ◆ 1 DEBRIS IN GUTTER
- ◆ 2 LOOSE FASTENERS
- ◆ 3 RUSTED FASTENERS
- ◆ 4 DETERIORATED PREVIOUS SEALANT REPAIRS AT PENETRATION FLASHING
- ◆ 5 MISSING END CAP ON GUTTER
- ◆ 6 SEVERELY DETERIORATED FLASHING MEMBRANE IN ROOF VALLEY / DRAINAGE PLANE
- ◆ 7 OPEN CONDITION AT VALLEY FLASHING
