Uniform Mitigation Verification Inspection Form

Inspection Date: 04/05/2024			
Owner Information			
Owner Name: Sawmill Villas Condo Assn.		Contact Person: Sawmill Villas Co...	
Address: 5709 Foxlake Drive		Home Phone:	
City: North Fort Myers	Zip: 33917	Work Phone:	
County: Lee		Cell Phone:	
Insurance Company:		Policy #:	
Year of Home: 1996	# of Stories: 2	Email:

Inspectors Initials TF Property Address 5709 Foxlake Drive, North Fort Myers, FL 33917

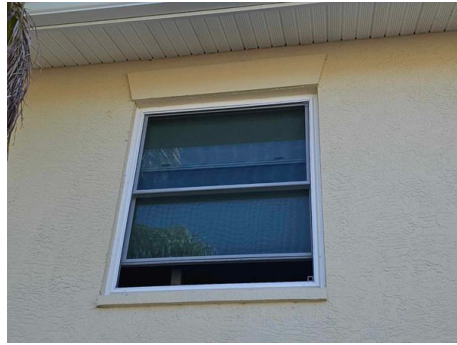
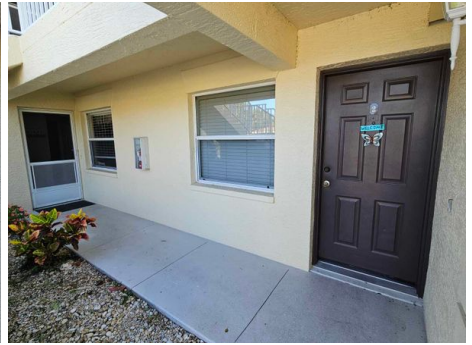
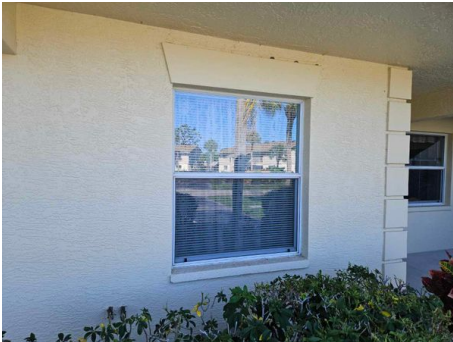
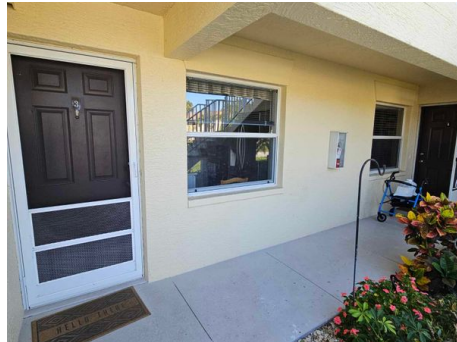
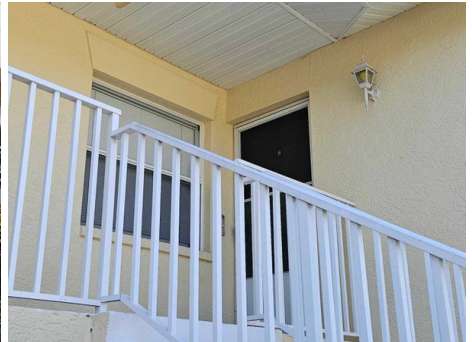
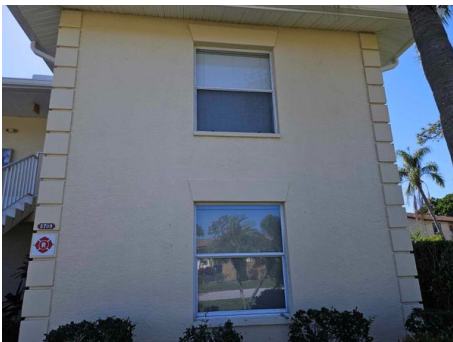
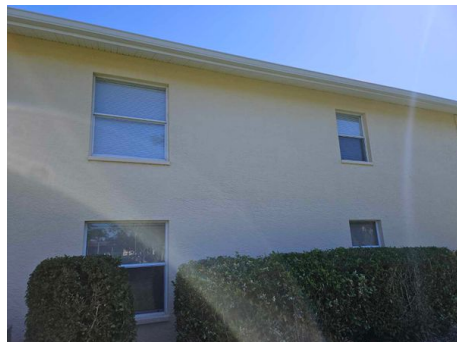
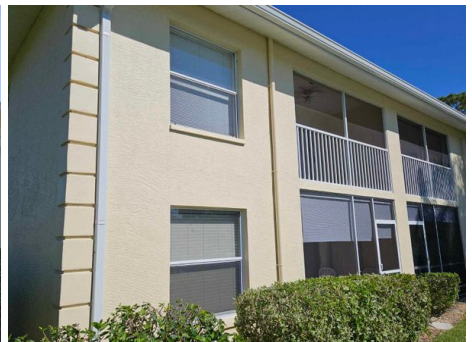
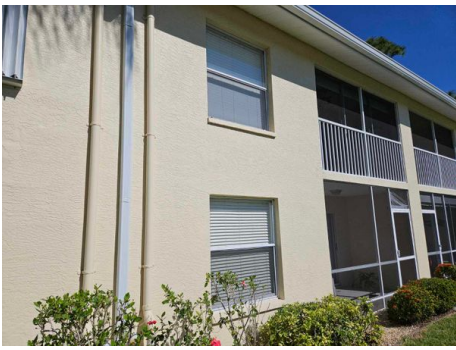
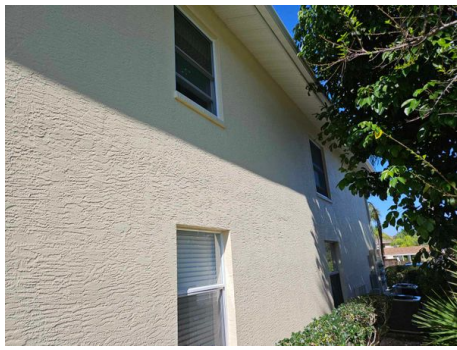
N	Opening Protection products that appear to be A or B but are not verified						
	Other protective coverings that cannot be identified as A, B, or C						
X	No Windborne Debris Protection	X				X

No Protection Throughout

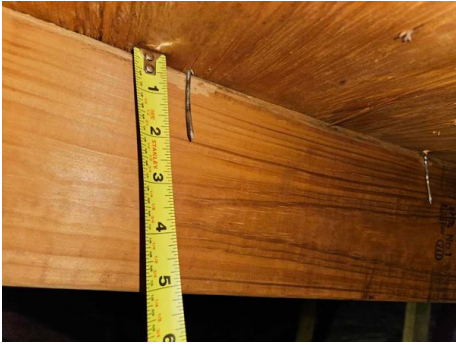
- B. Plywood/OSB roof sheathing with a minimum thickness of 7/16" inch attached to the roof truss/rafter (spaced a maximum of 24" inches o.c.) by 8d common nails spaced a maximum of 12" inches in the field. -OR- Any system of screws, nails, adhesives, other deck fastening system or truss/rafter spacing that is shown to have an equivalent or greater resistance 8d nails spaced a maximum of 12 inches in the field or has a mean uplift resistance of at least 103 psf.

8D Nail

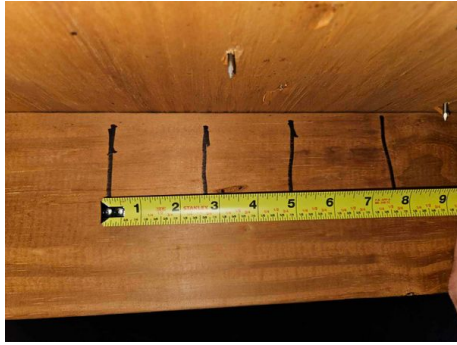
Nail Spacing

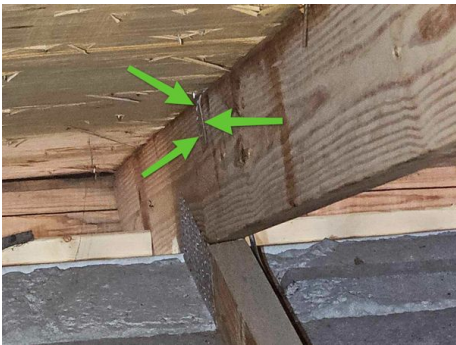
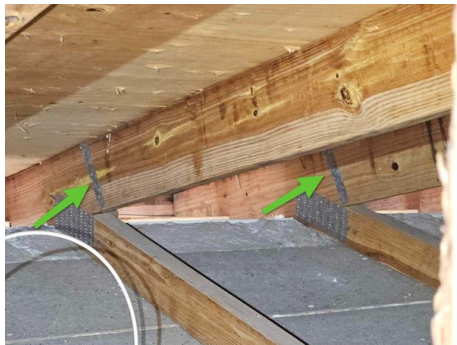
- C. Single Wraps
 - Metal connectors consisting of a single strap that wraps over the top of the truss/rafter and is secured with a minimum of 2 nails on the front side and a minimum of 1 nail on the opposing side.

Single Wraps

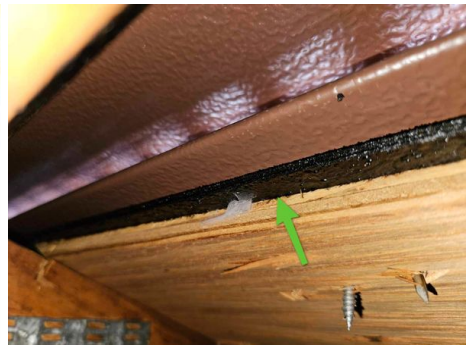
- A. SWR (also called Sealed Roof Deck) Self-adhering polymer modified-bitumen roofing underlayment applied directly to the sheathing or foam adhesive SWR barrier (not foamed-on insulation) applied as a supplemental means to protect the dwelling from water intrusion in the event of roof covering loss.
- B. No SWR.
- C. Unknown or undetermined.

SWR
