Village at Indian Creek

**15371 River Vista Drive
North Fort Myers, FL**

10/5/2023

Roof System Condition Evaluation Report

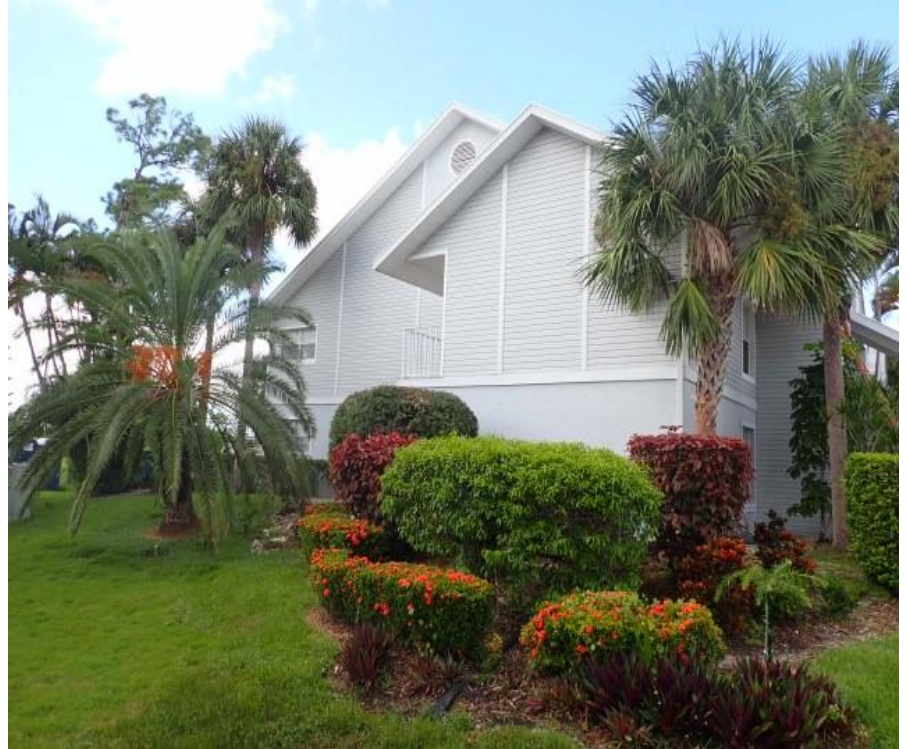
3. Building exterior side elevation overview

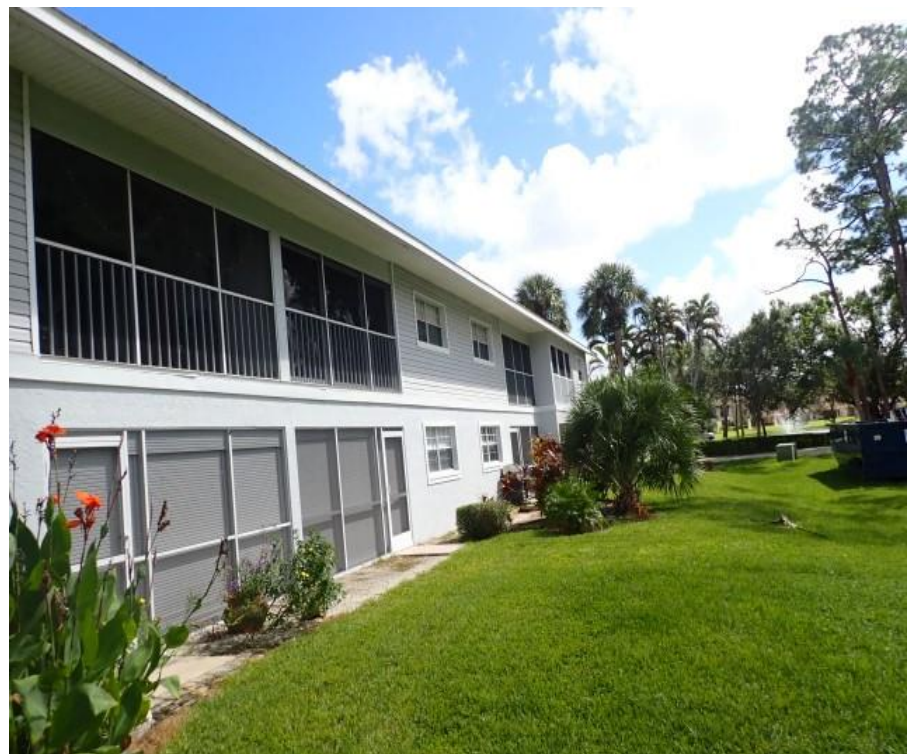
4. Building exterior rear elevation overview

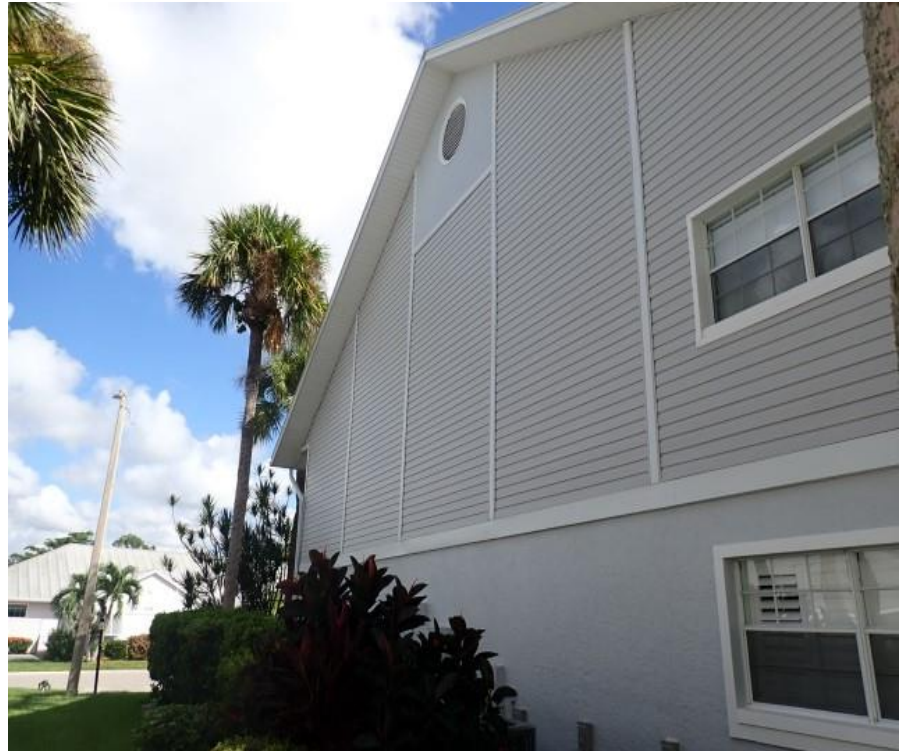
5. Building exterior side elevation overview

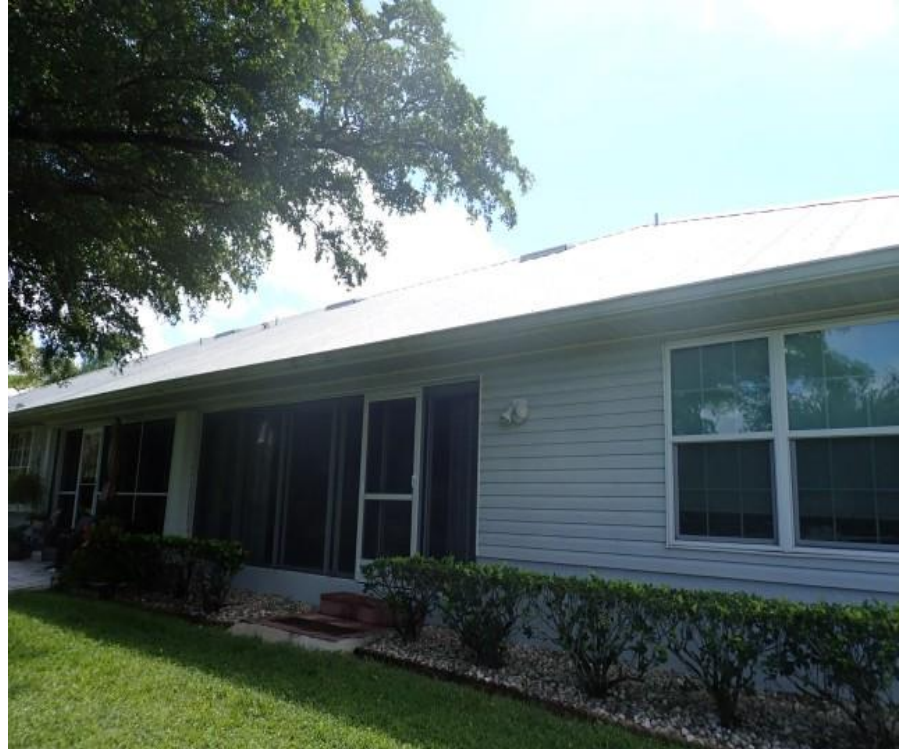
3. Building exterior rear elevation overview

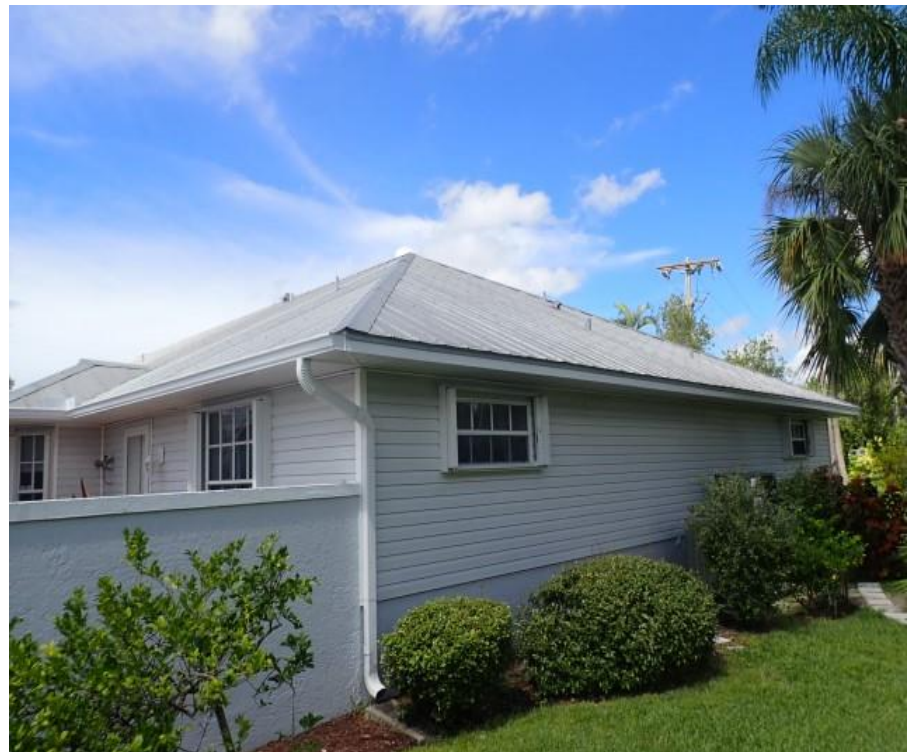
4. Building exterior side elevation overview

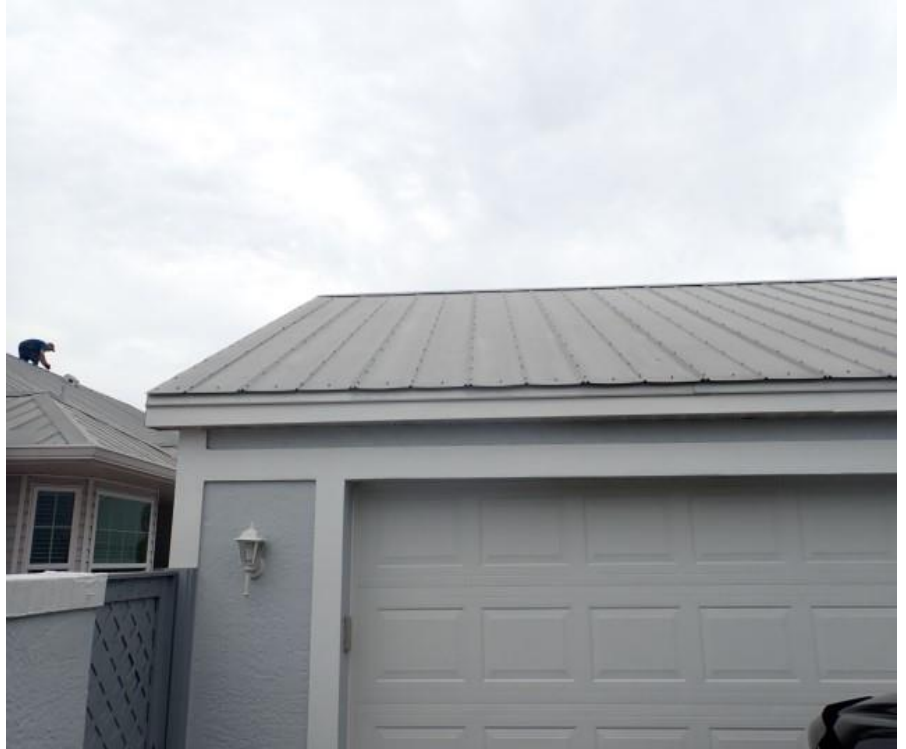
5. Bldg 2 - Garage A roof system overview

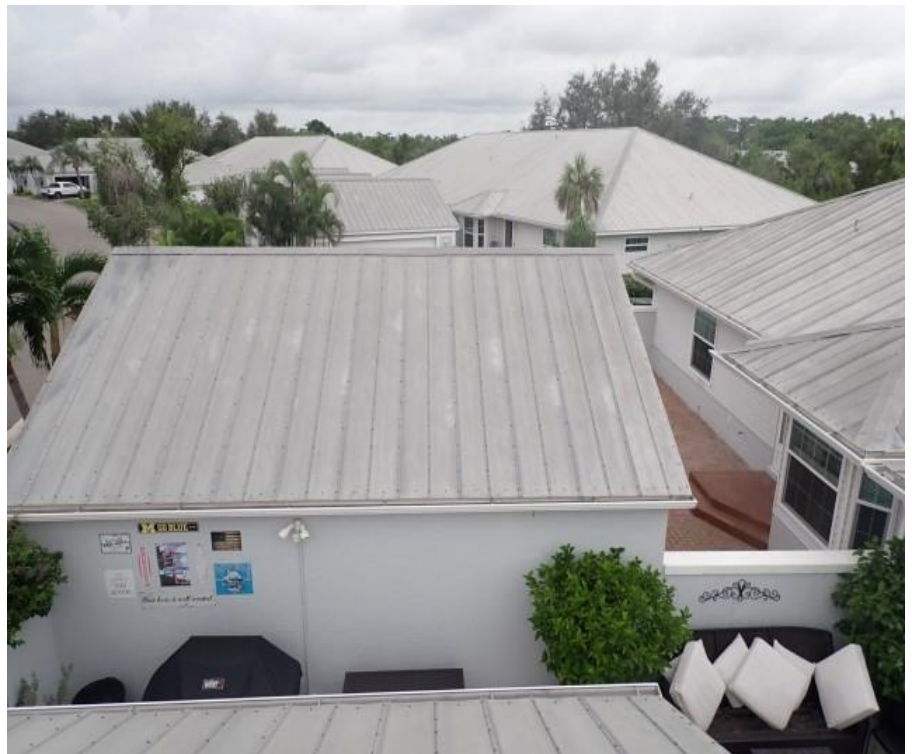
6. Bldg 2 - Garage A roof system overview

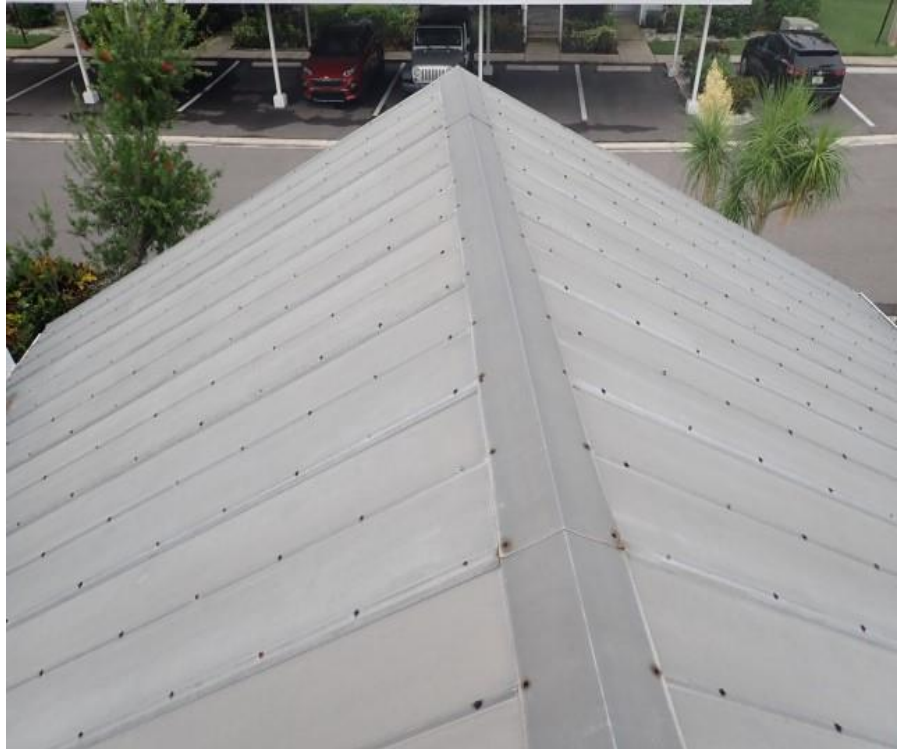
7. Bldg 2 - Garage B roof system overview

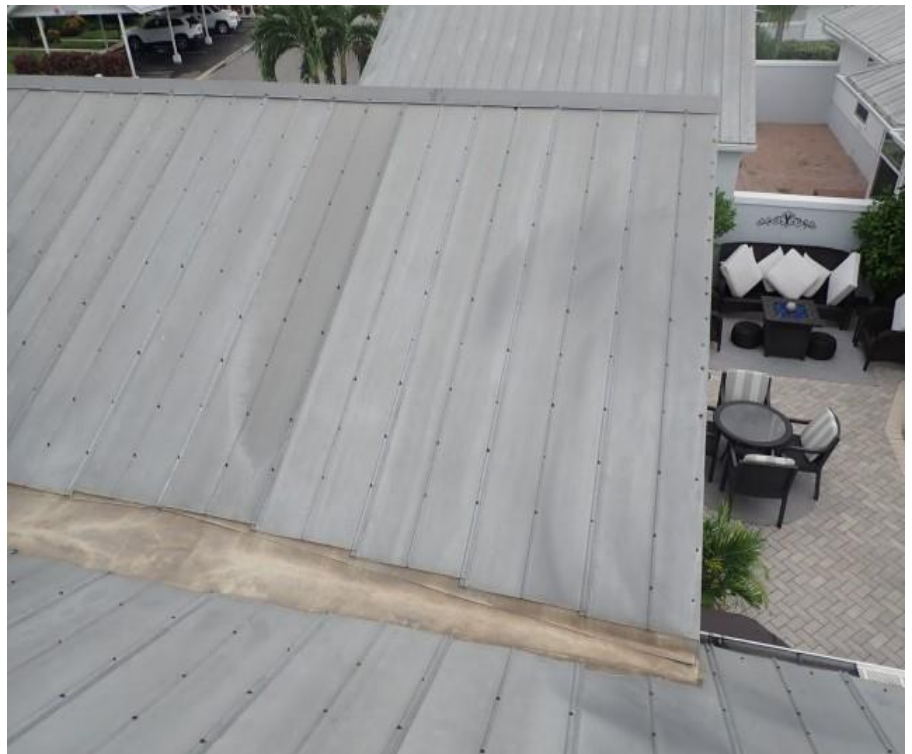
8. Bldg 2 - Garage B roof system overview

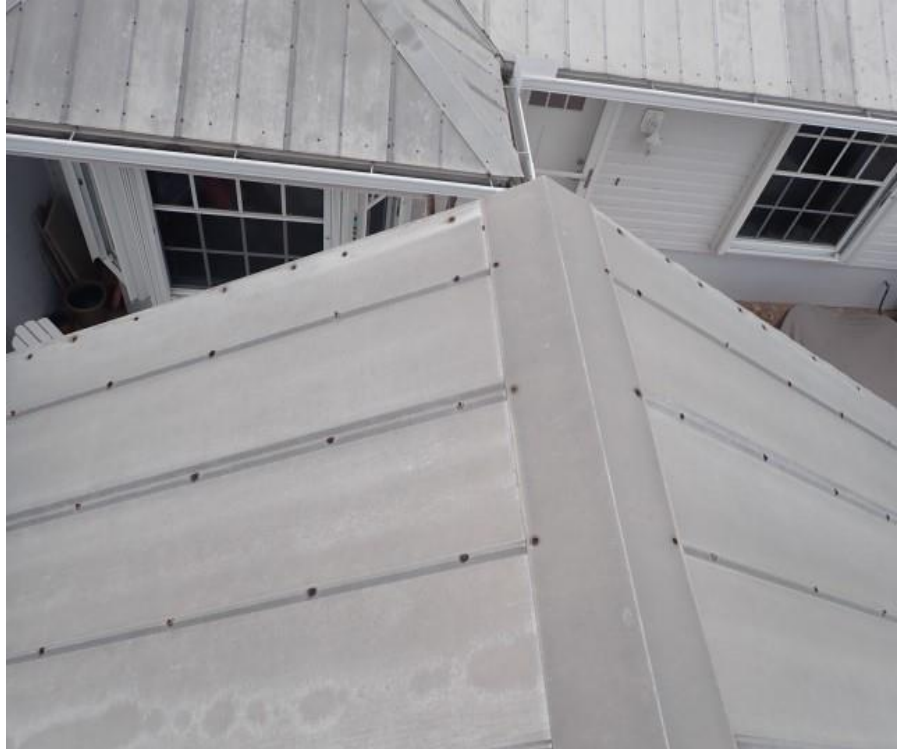
9. Bldg 2 - Garage B roof system overview

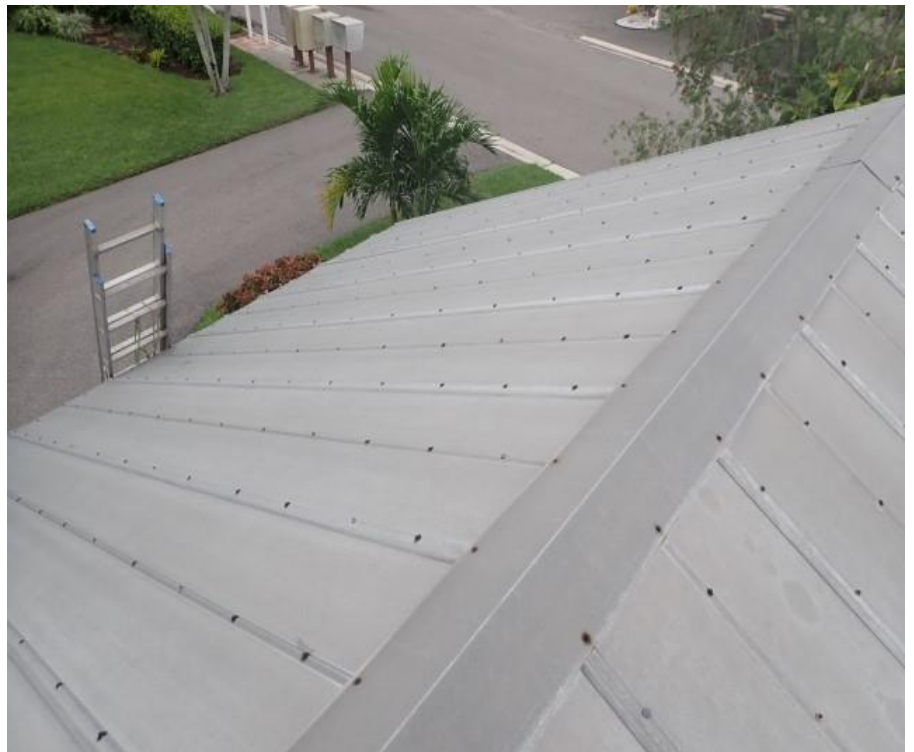
10. Bldg 2 - Garage C roof system overview

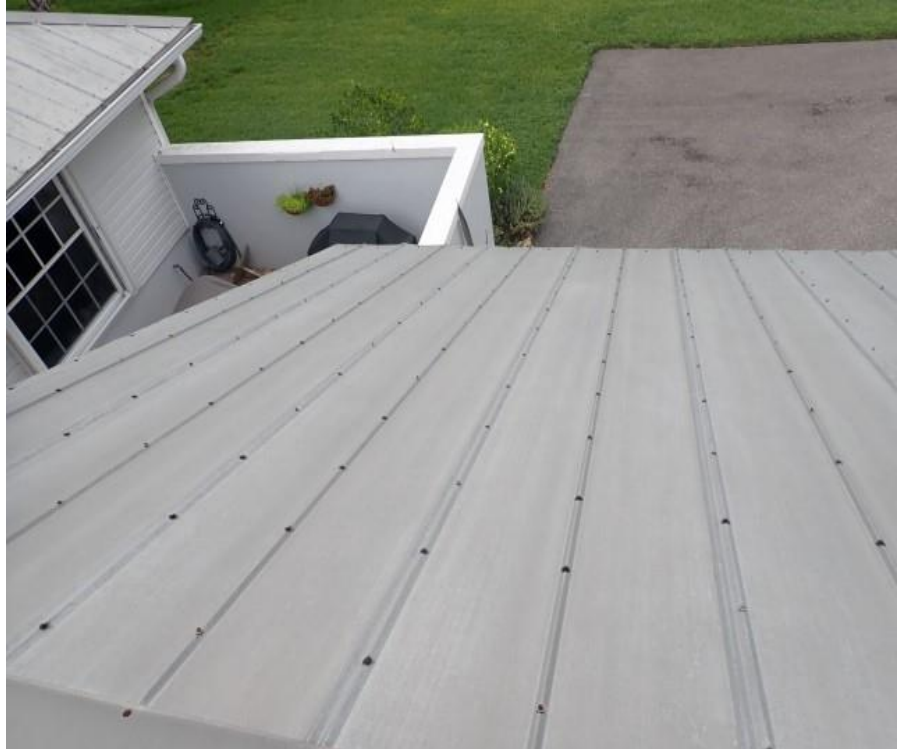
11. Bldg 2 - Garage C roof system overview

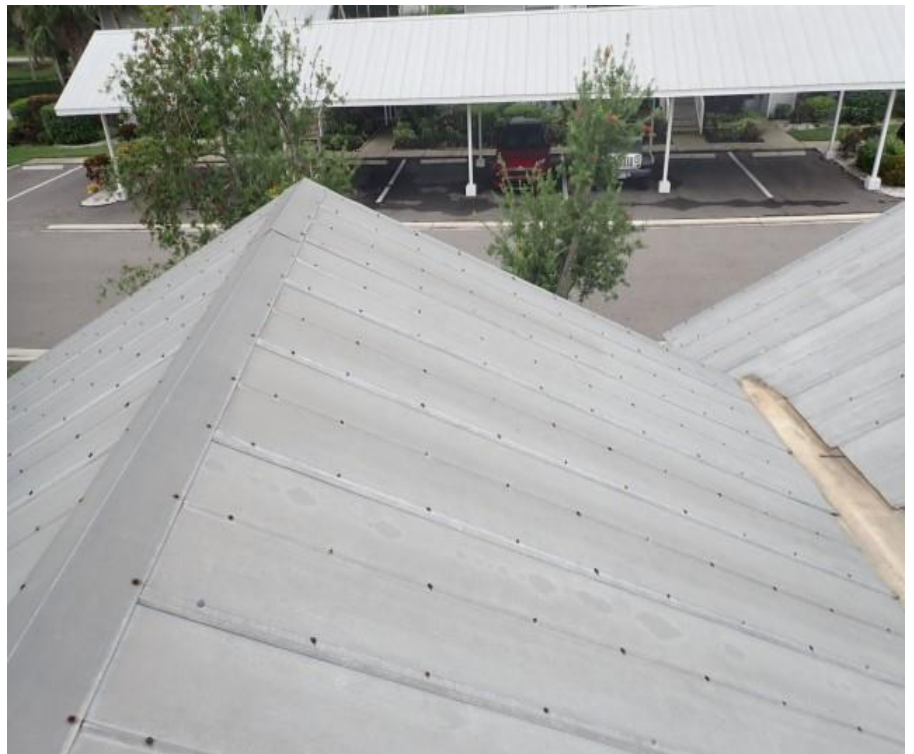
12. Bldg 2 - Garage C roof system overview

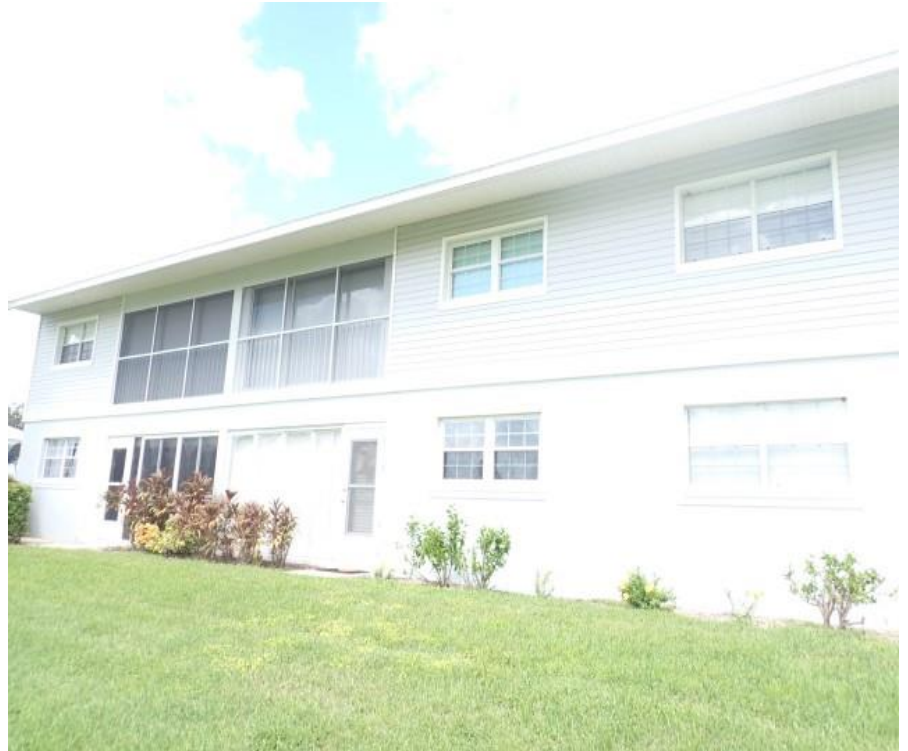
3. Building exterior rear elevation overview

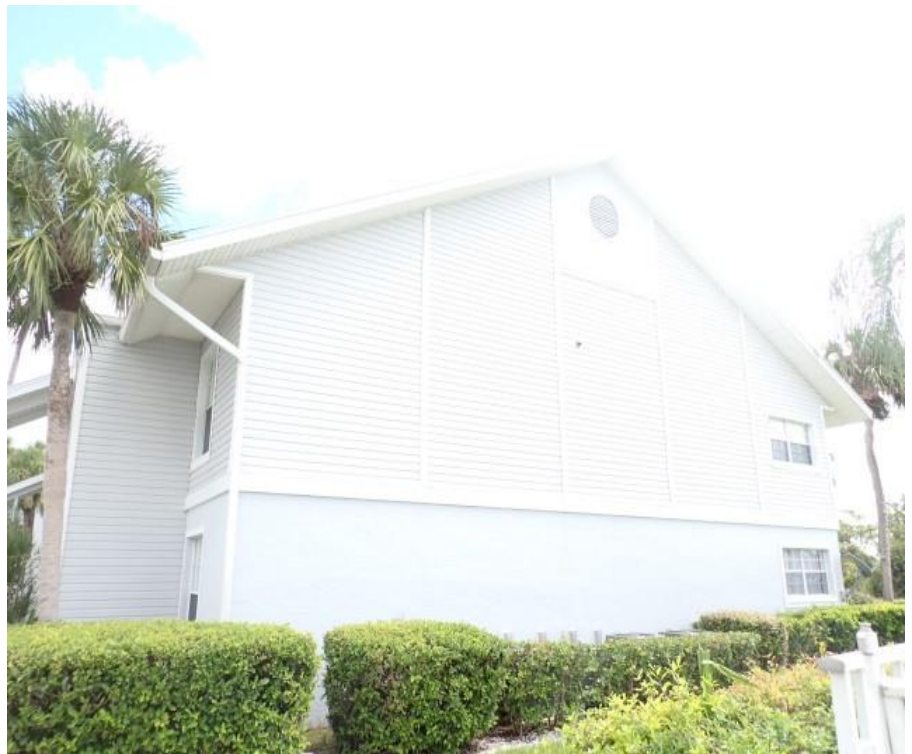
4. Building exterior side elevation overview

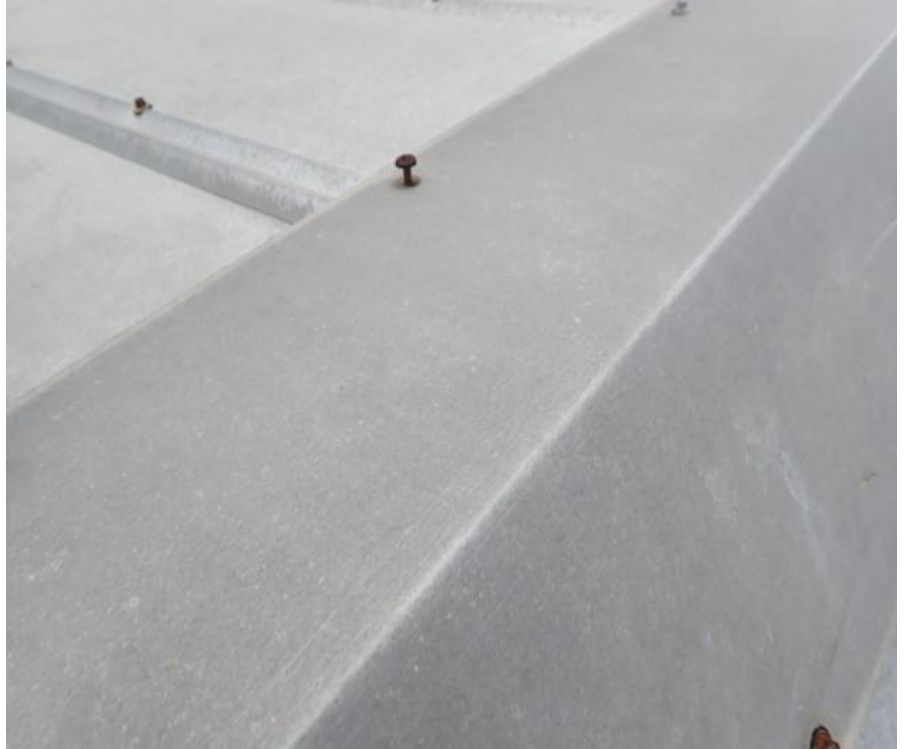
21. Deficiency #3 - Loose fasteners

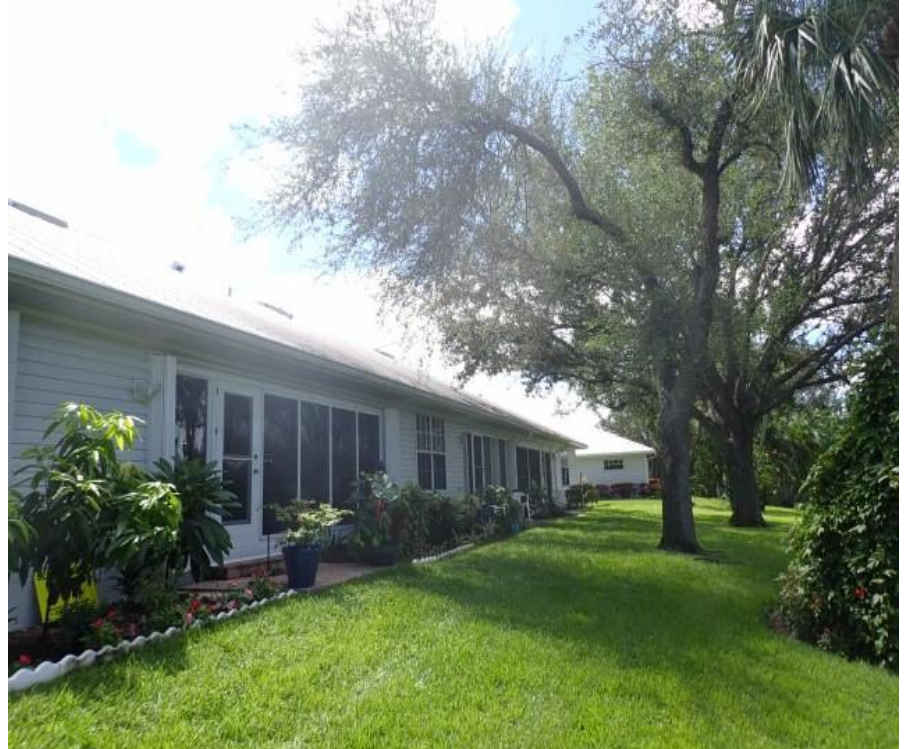
3. Building exterior rear elevation overview

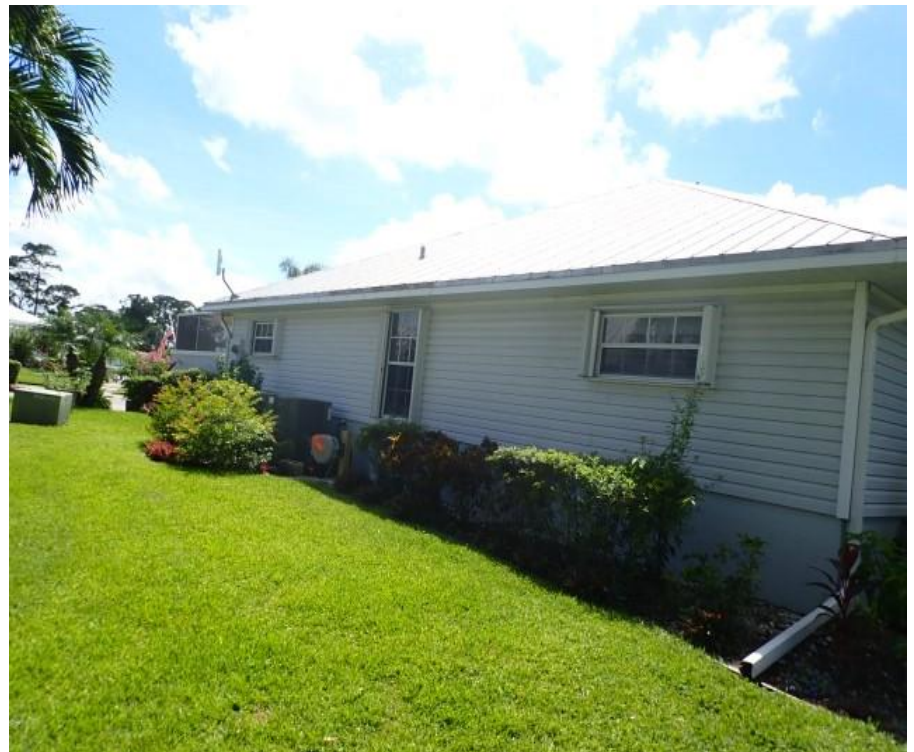
4. Building exterior side elevation overview

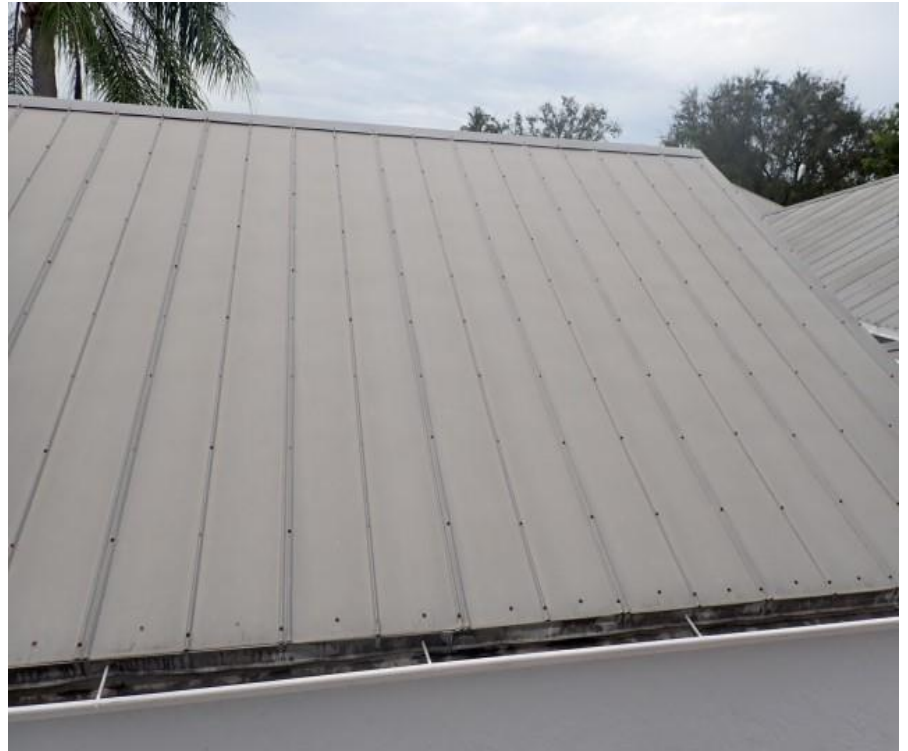
5. Bldg 6 - Garage A roof system overview

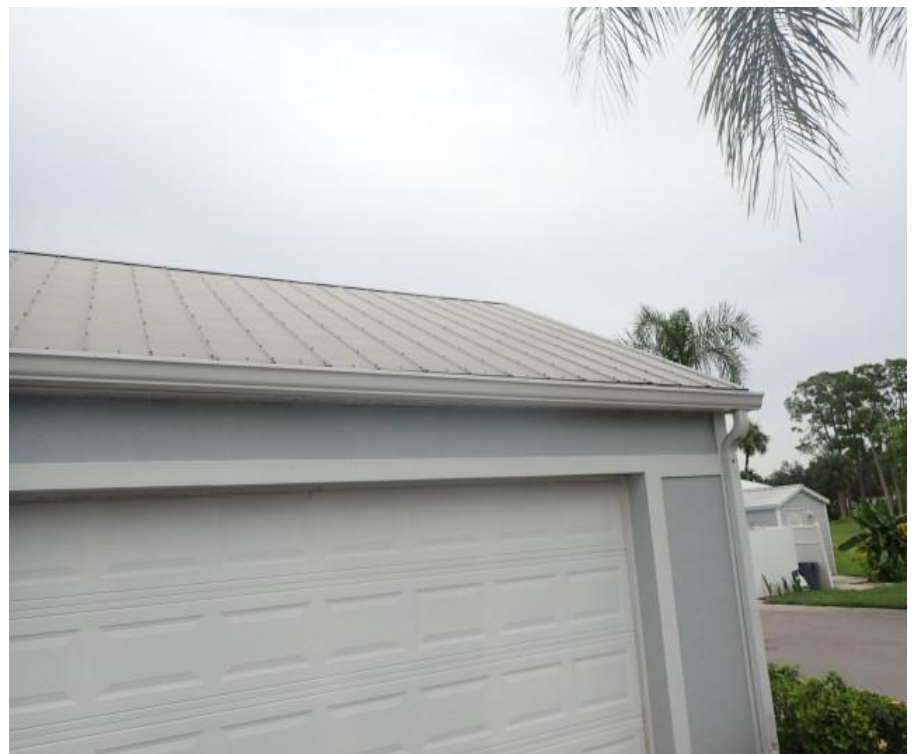
6. Bldg 6 - Garage A roof system overview

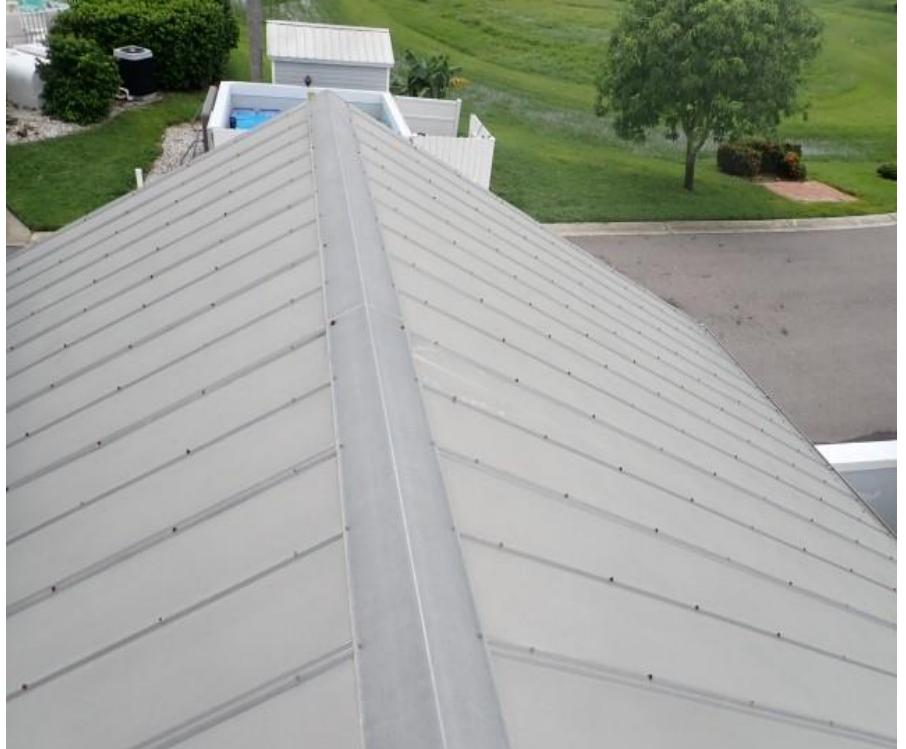
7. Bldg 6 - Garage B roof system overview

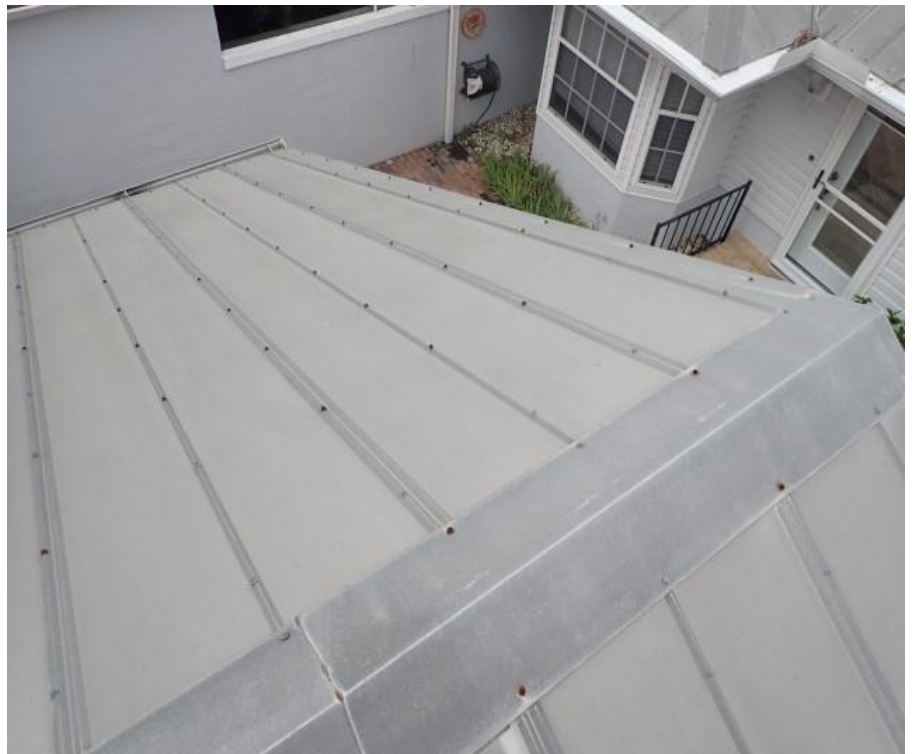
8. Bldg 6 - Garage B roof system overview

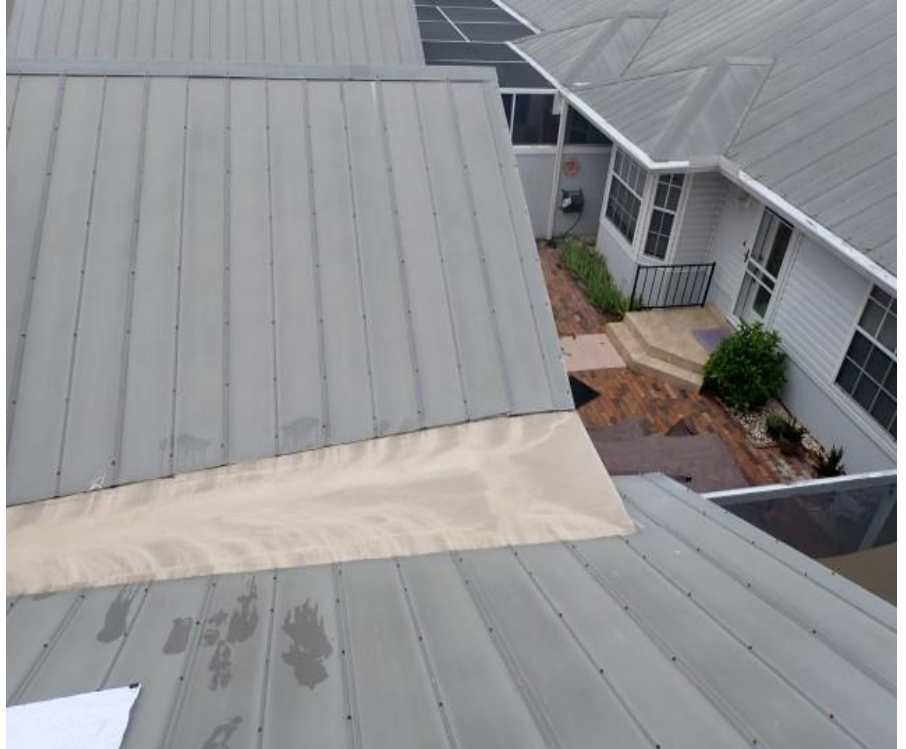
9. Bldg 6 - Garage B roof system overview

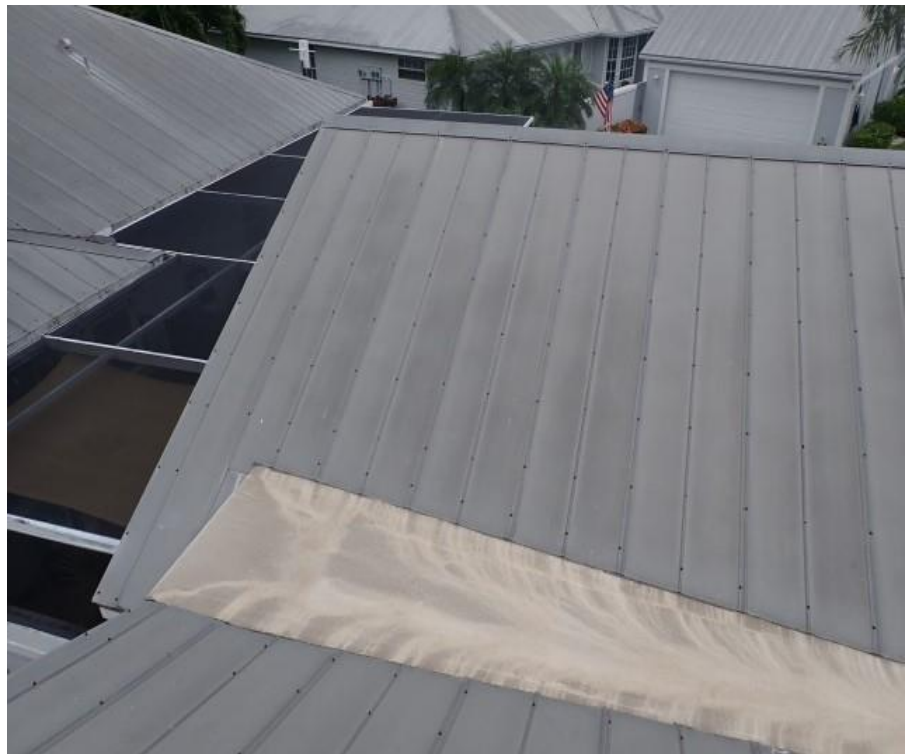
10. Bldg 6 - Garage C roof system overview

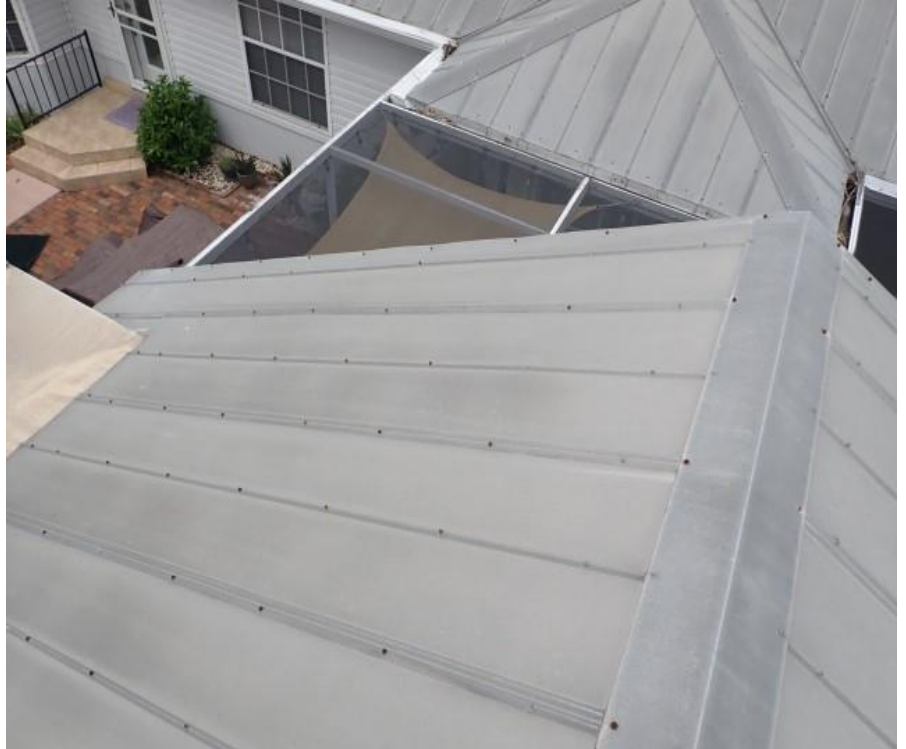
11. Bldg 6 - Garage C roof system overview

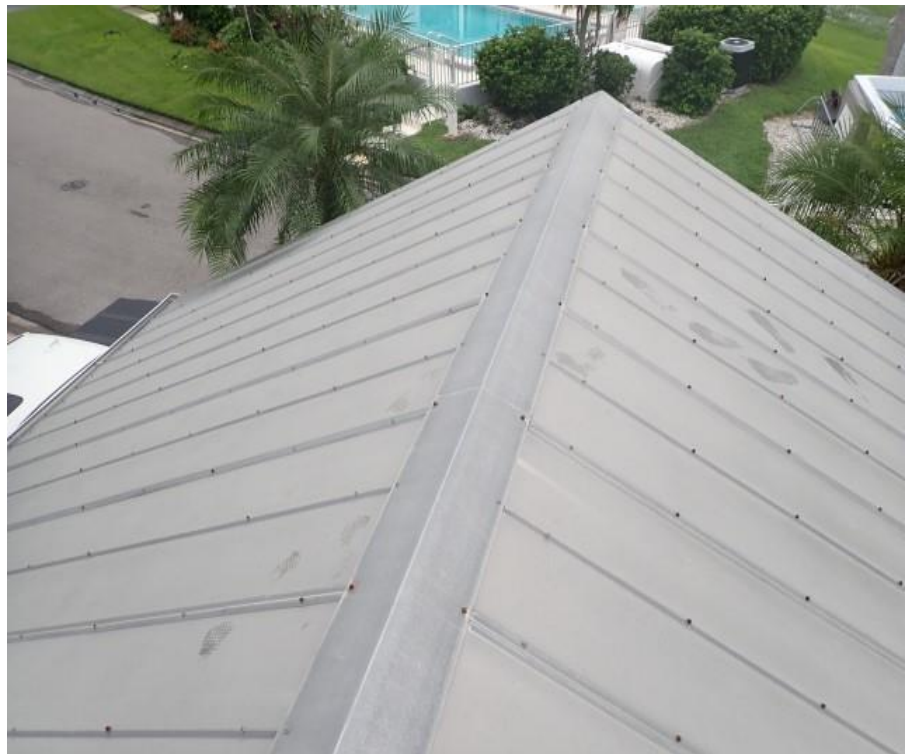
12. Bldg 6 - Garage C roof system overview

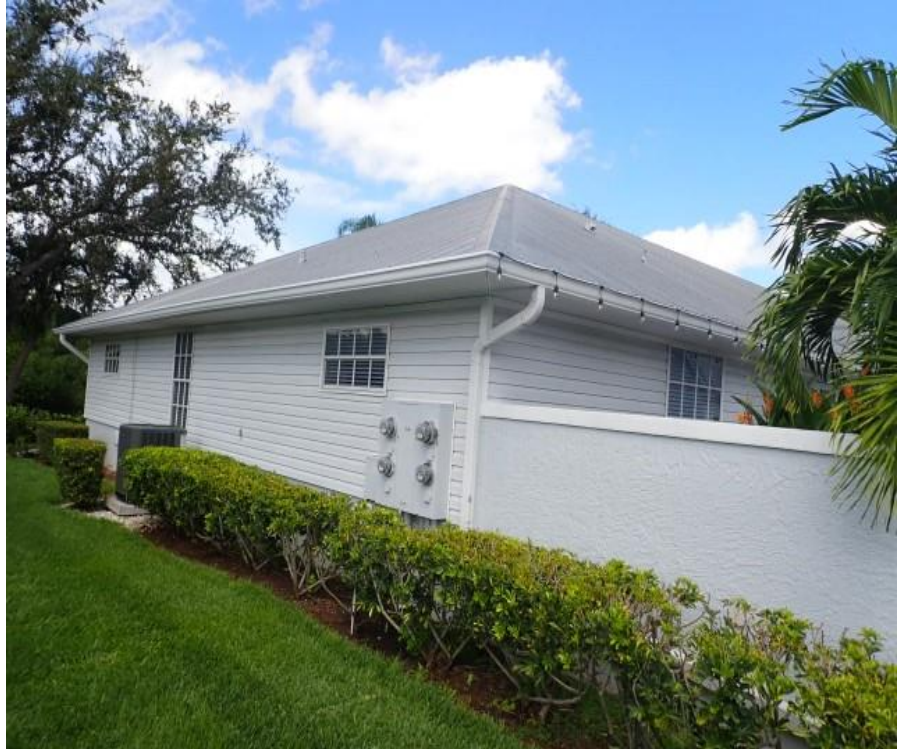
5. Building exterior side elevation overview

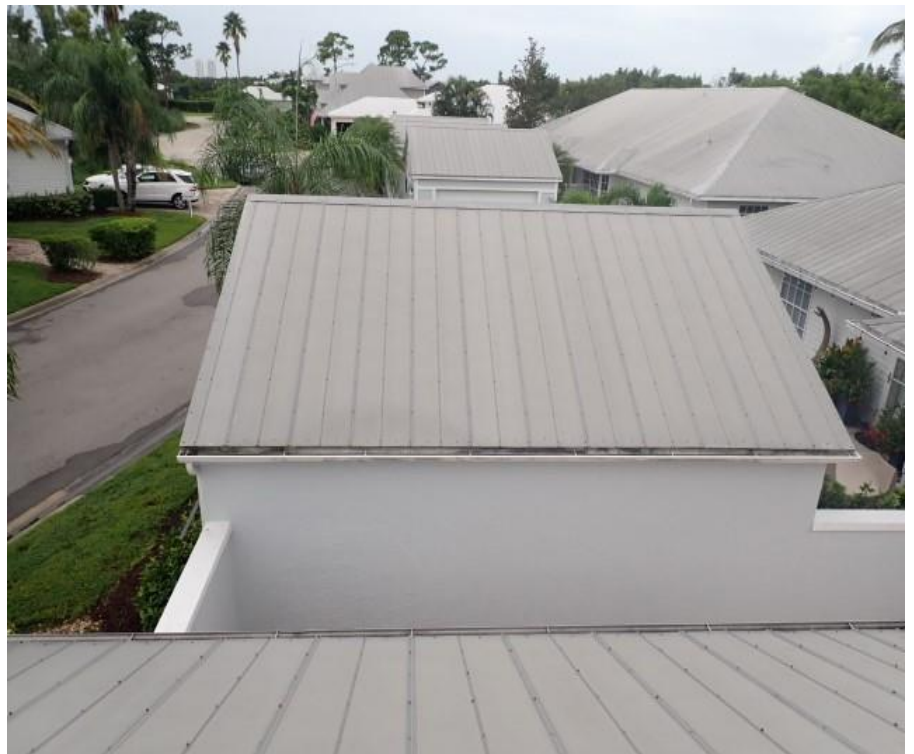
6. Bldg 8 - Garage A roof system overview

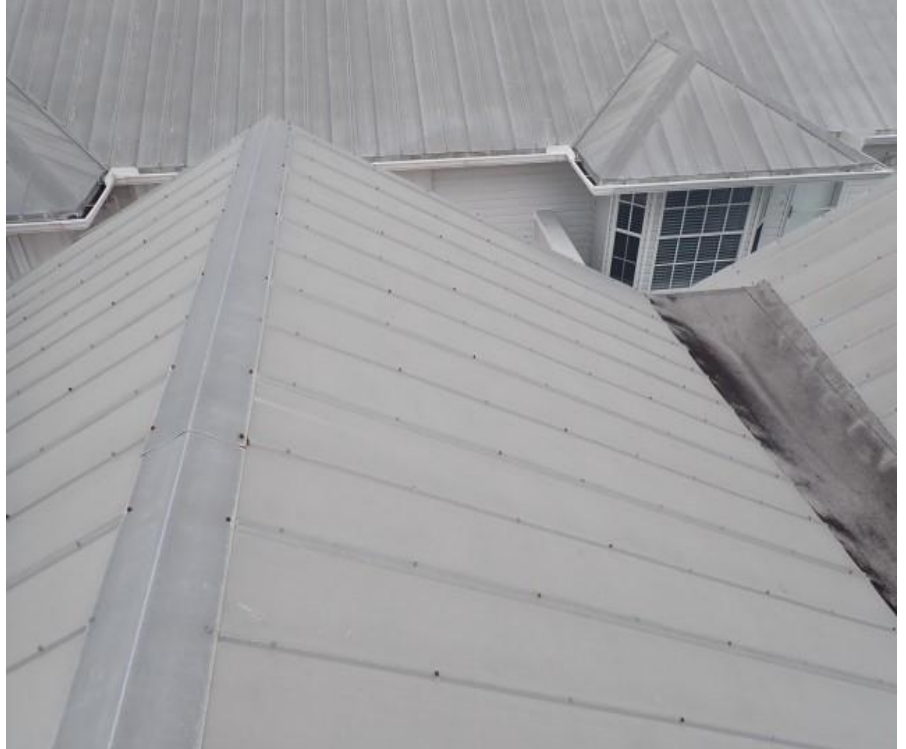
7. Bldg 8 - Garage B roof system overview

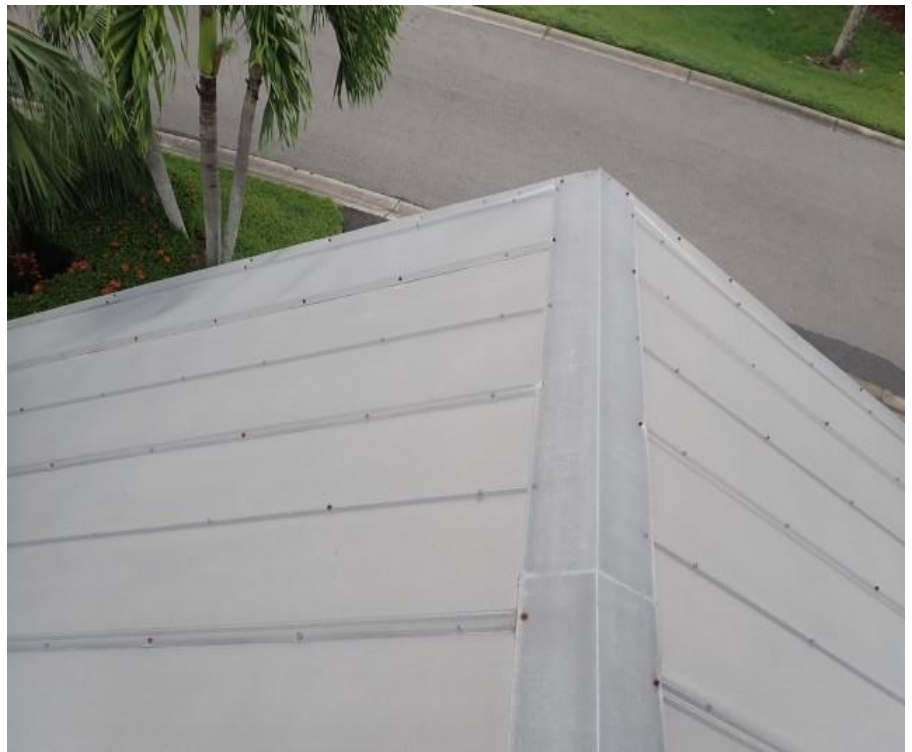
8. Bldg 8 - Garage B roof system overview

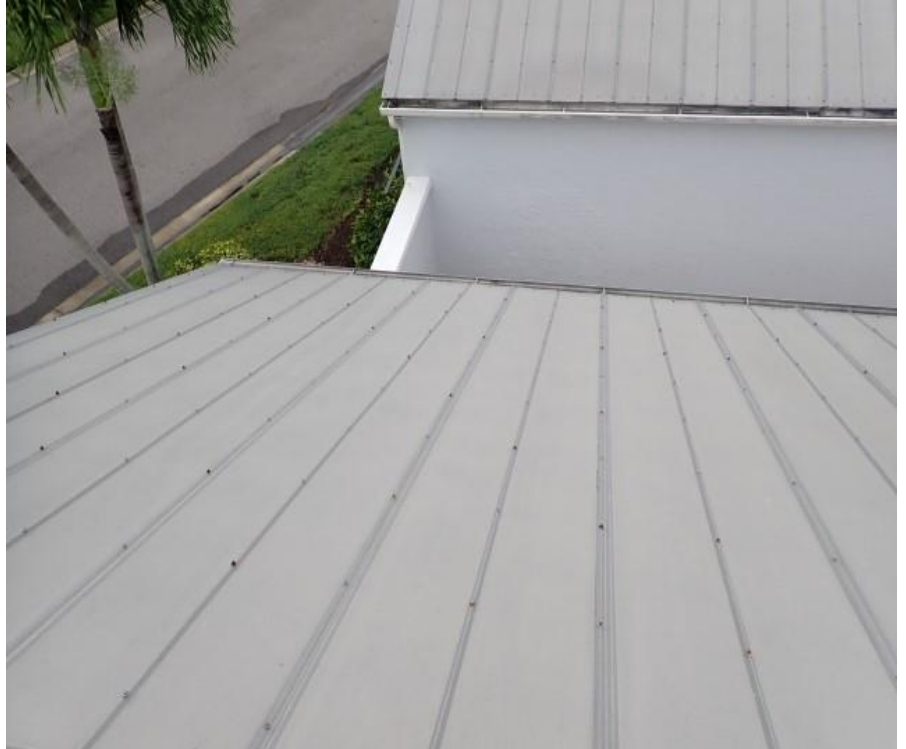
9. Bldg 8 - Garage B roof system overview

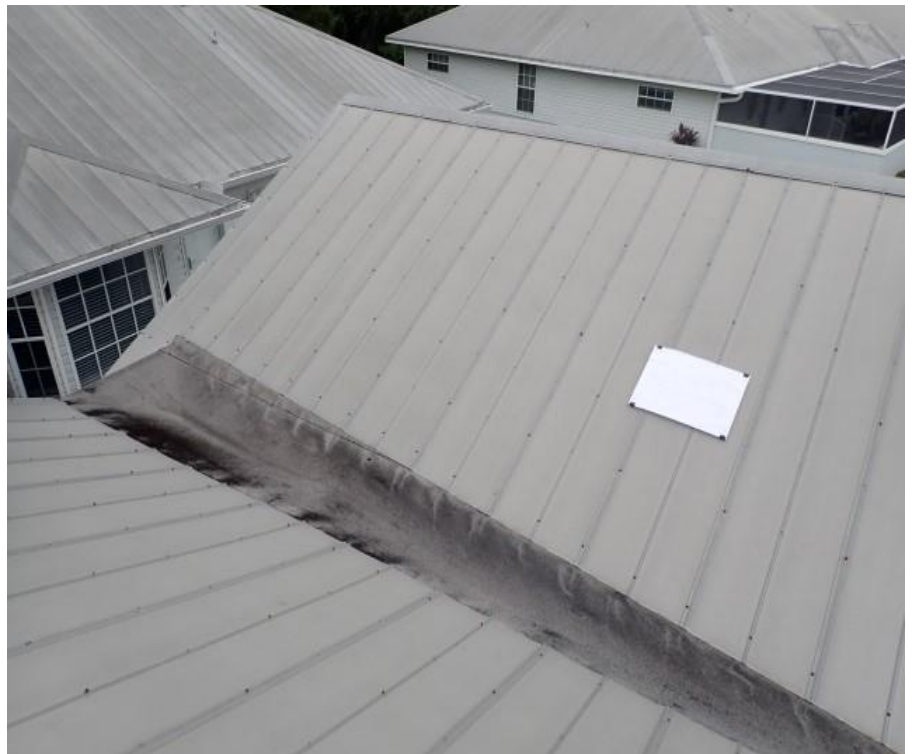
10. Bldg 8 - Garage C roof system overview

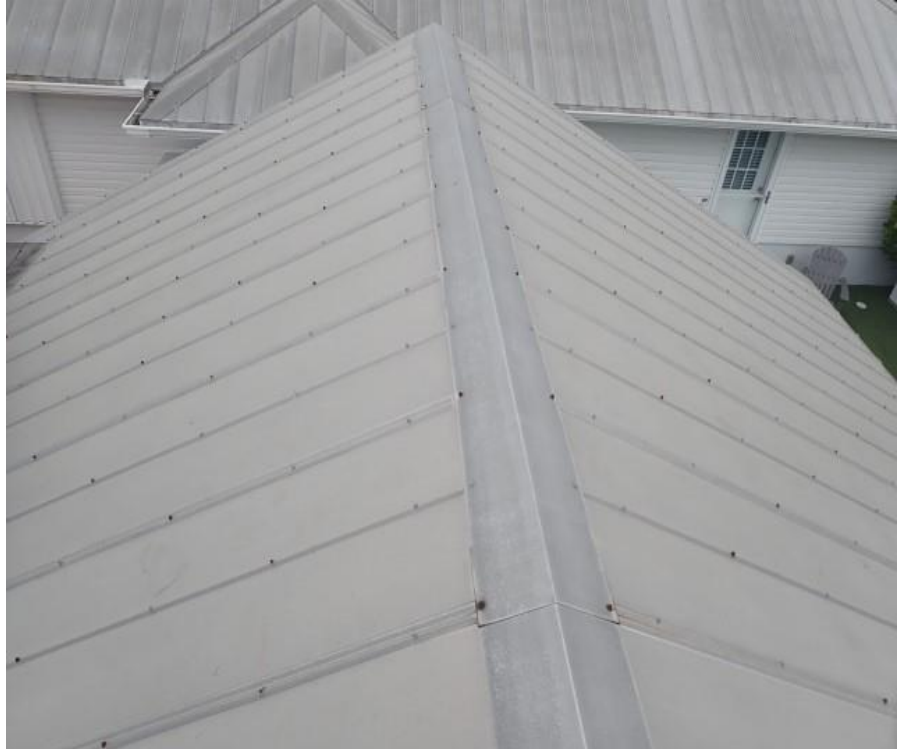
11. Bldg 8 - Garage C roof system overview
