Village at Indian Creek

**15371 River Vista Drive
North Fort Myers, FL**

10/5/2023

Roof System Condition Evaluation Report

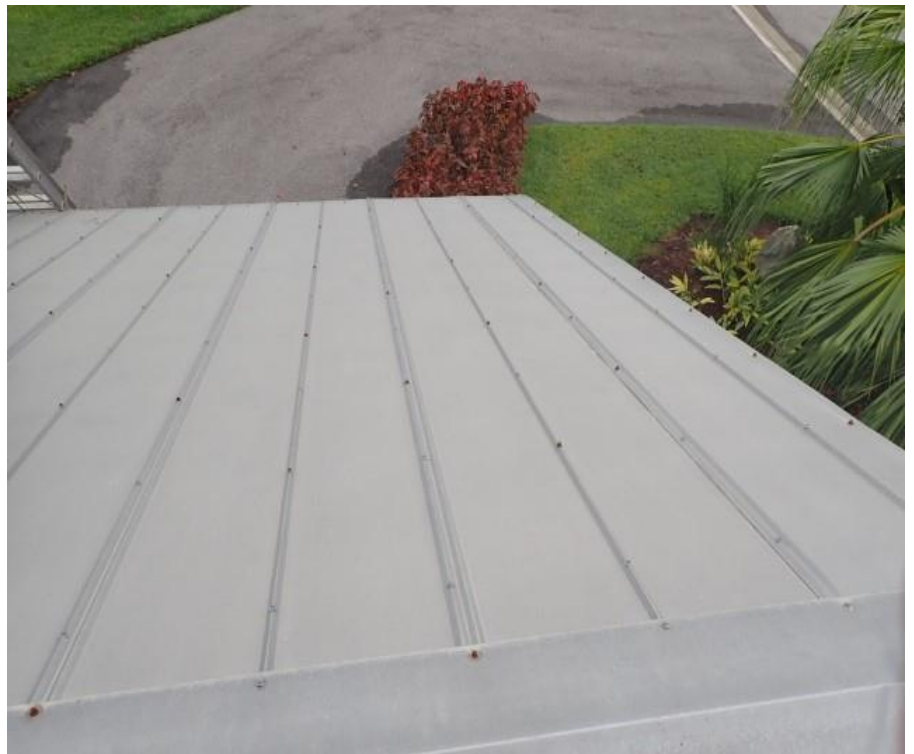
12. Bldg 8 - Garage C roof system overview

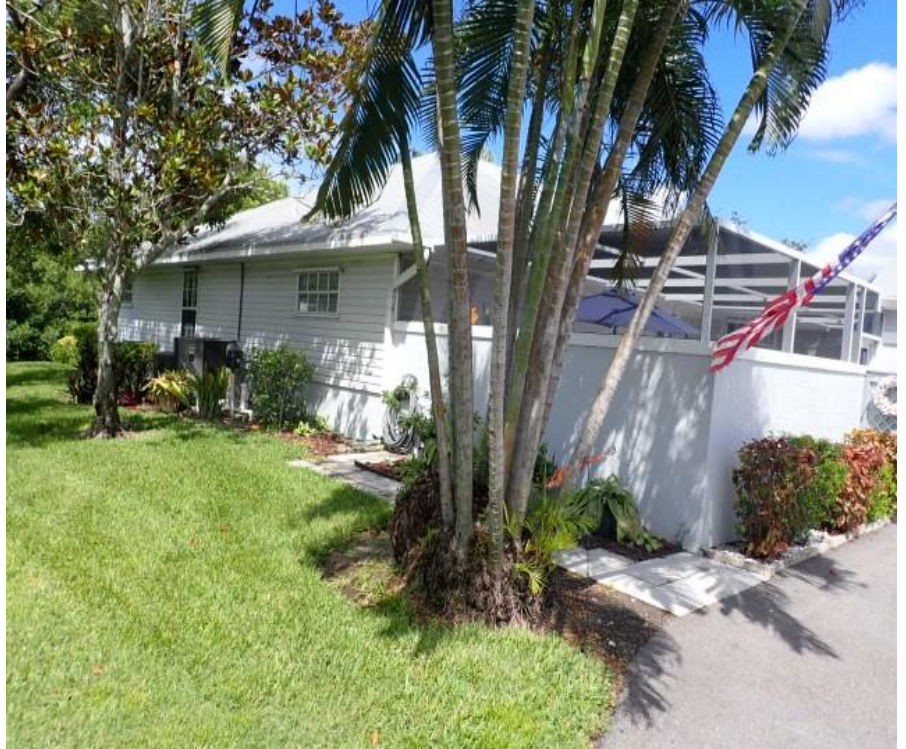
3. Building exterior side elevation overview

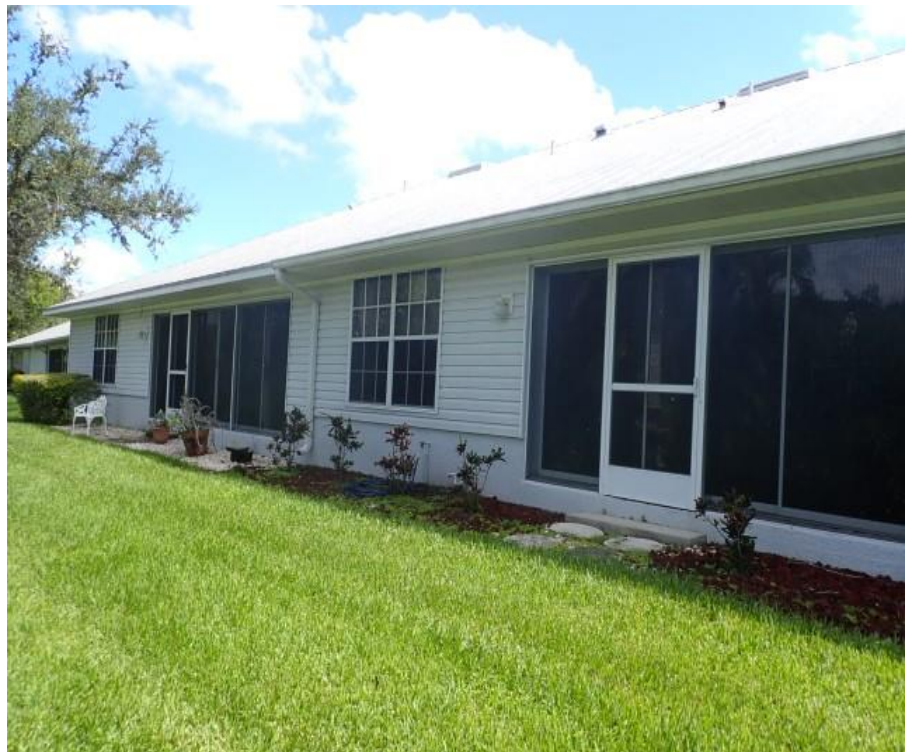
4. Building exterior rear elevation overview

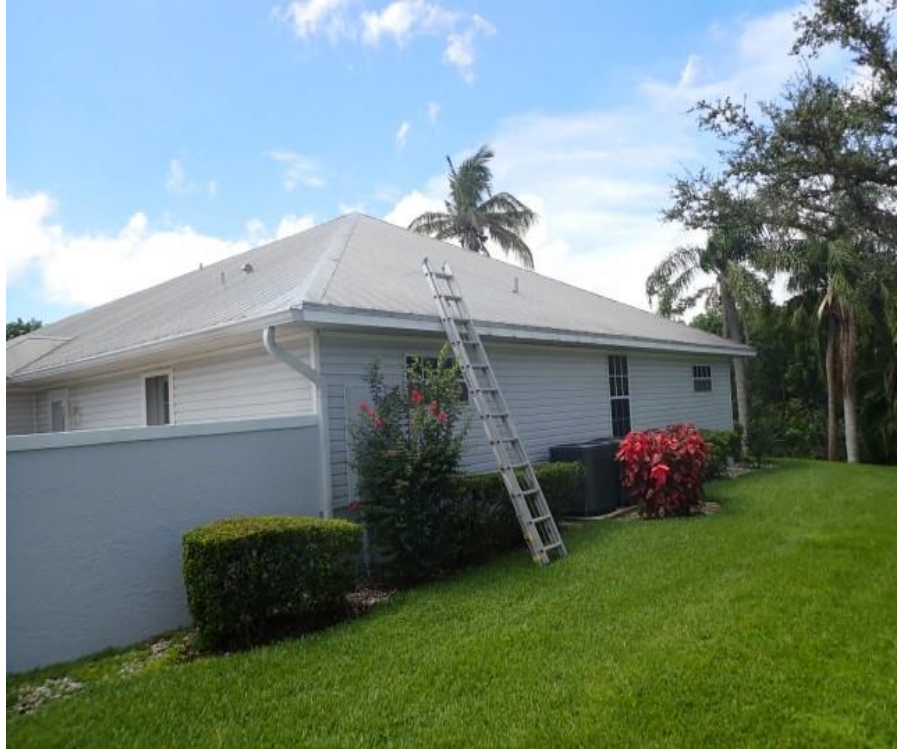
5. Building exterior side elevation overview

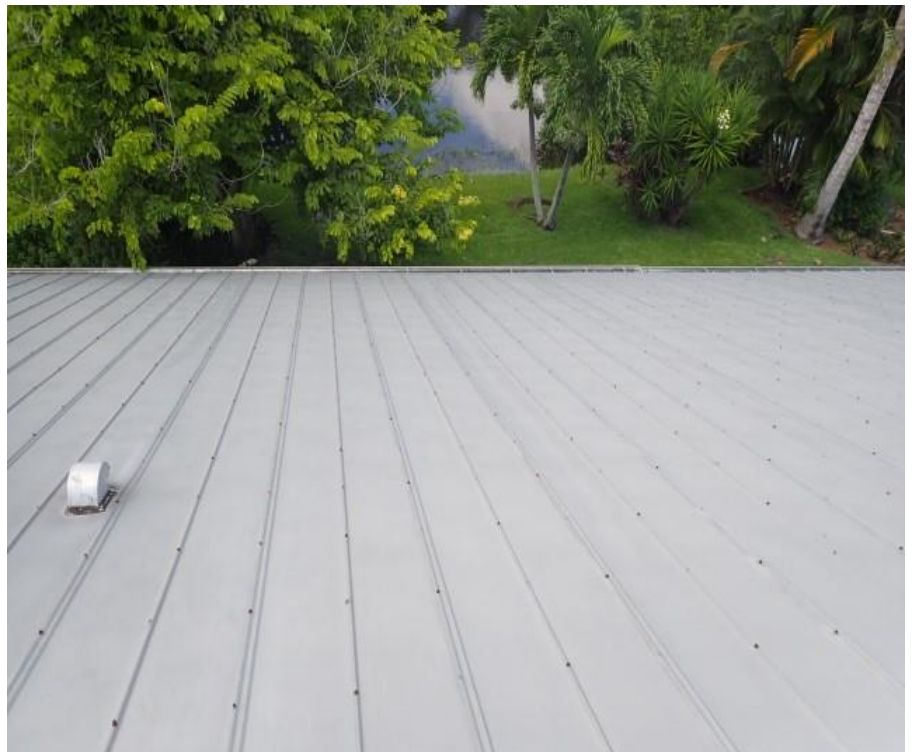
10. Bldg 10 roof system overview

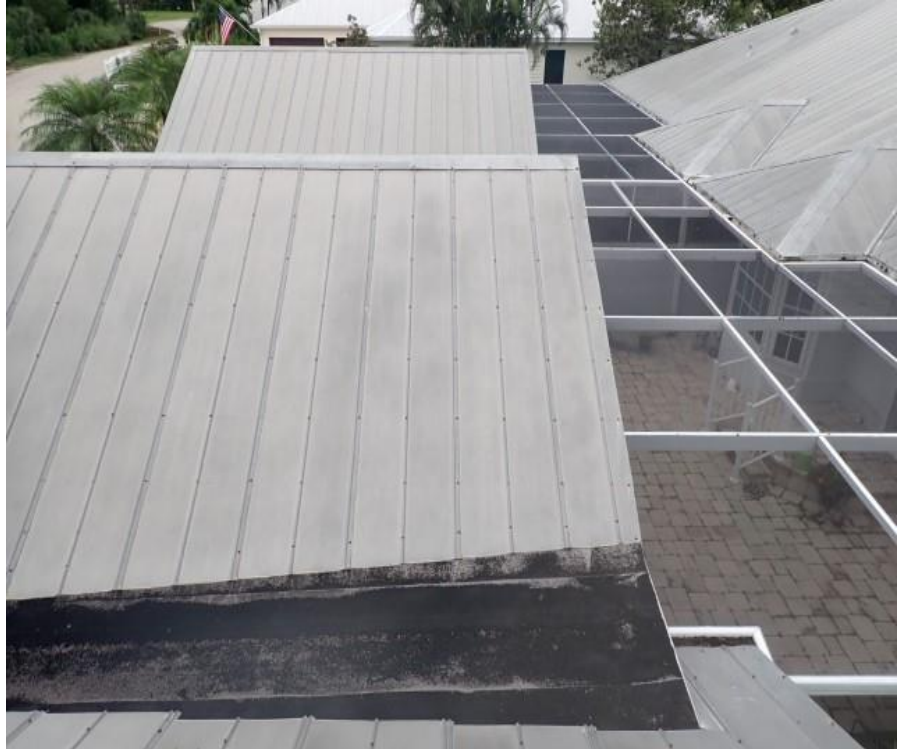
11. Bldg 10 roof system overview

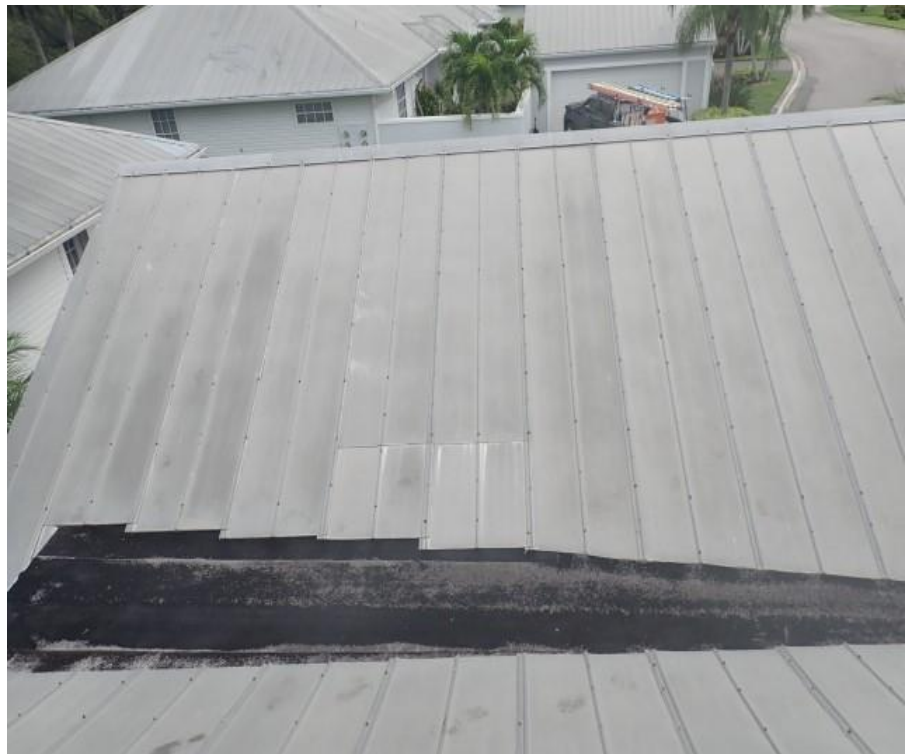
12. Bldg 10 roof system overview
