Village at Indian Creek

**15371 River Vista Drive
North Fort Myers, FL**

10/5/2023

Roof System Condition Evaluation Report

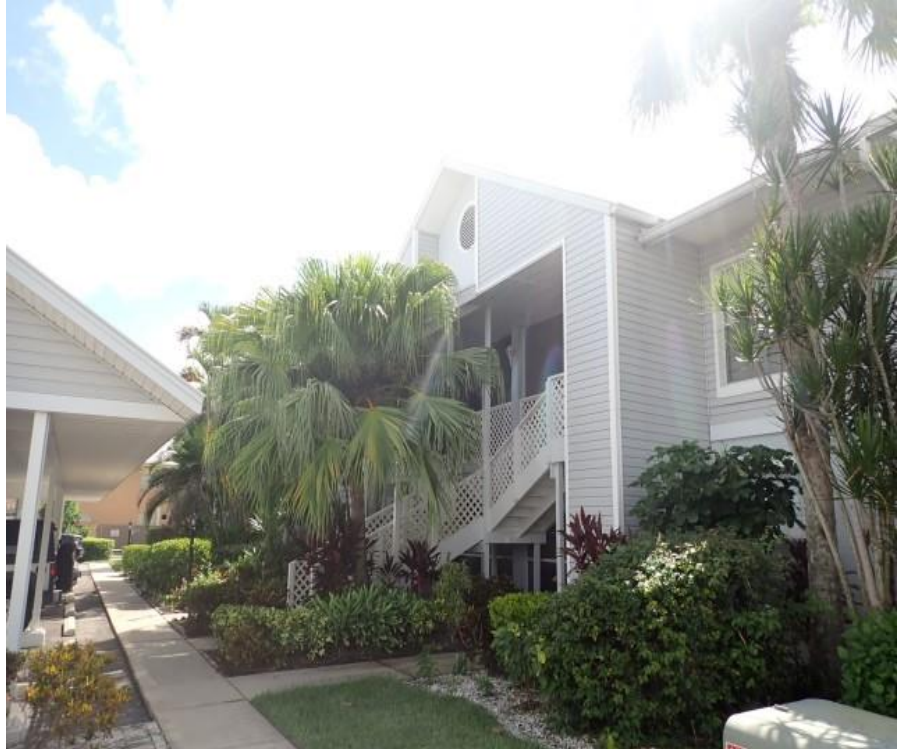
1. Building exterior front elevation overview

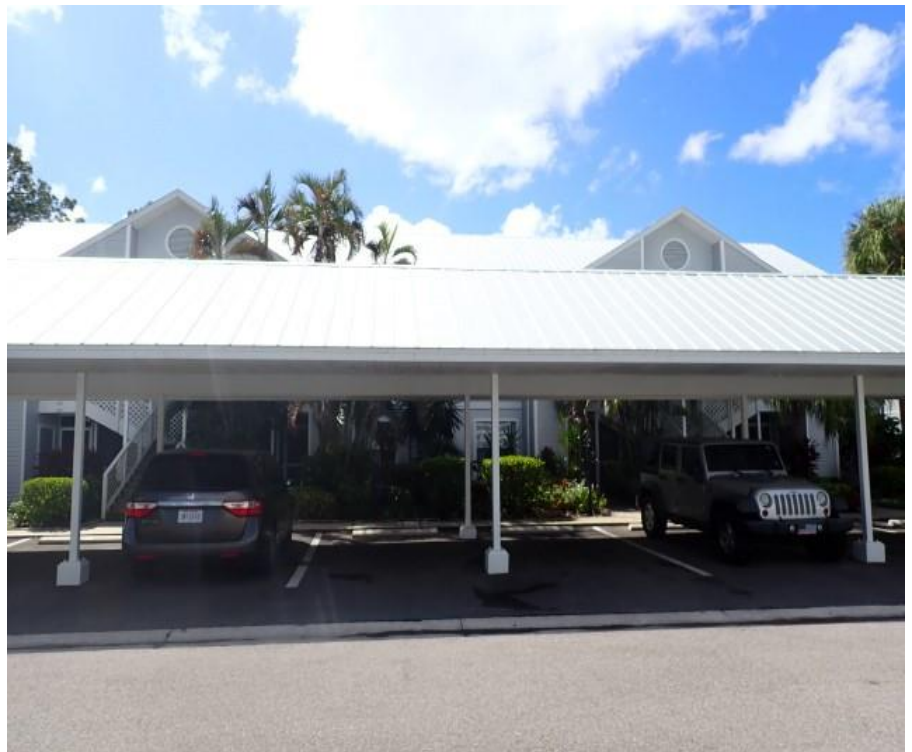
2. Building exterior front elevation overview

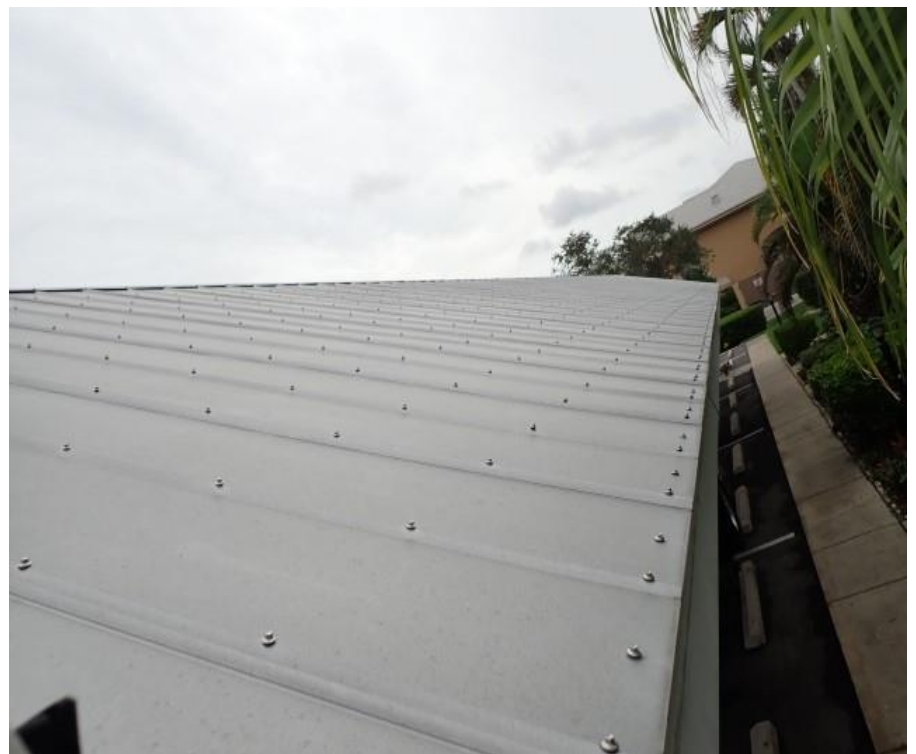
6. Bldg 1 - Garage roof system overview

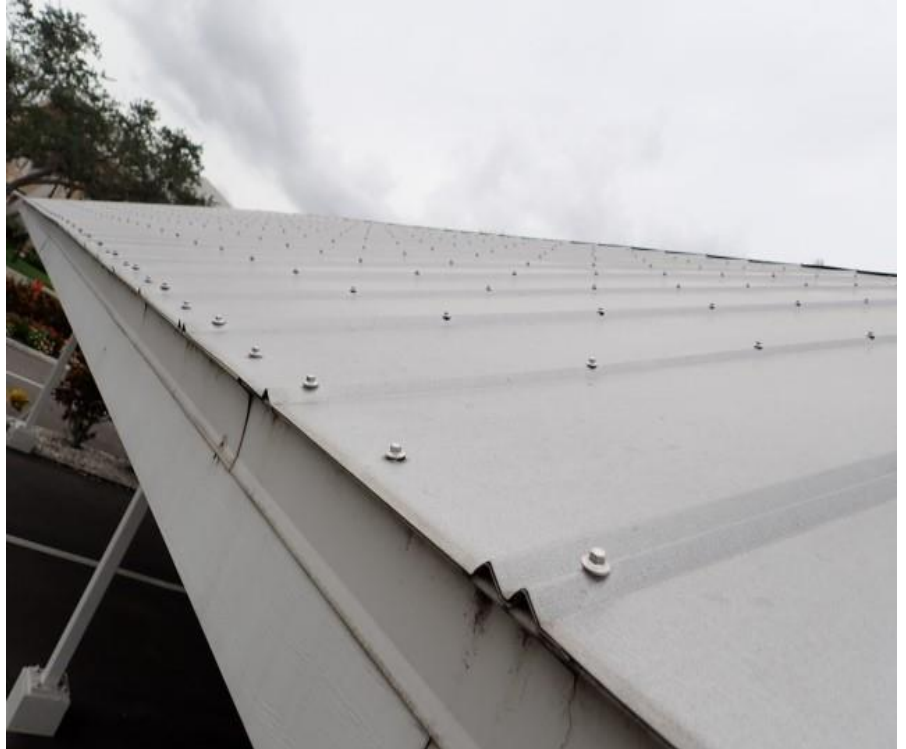
7. Bldg 1 - Garage roof system overview

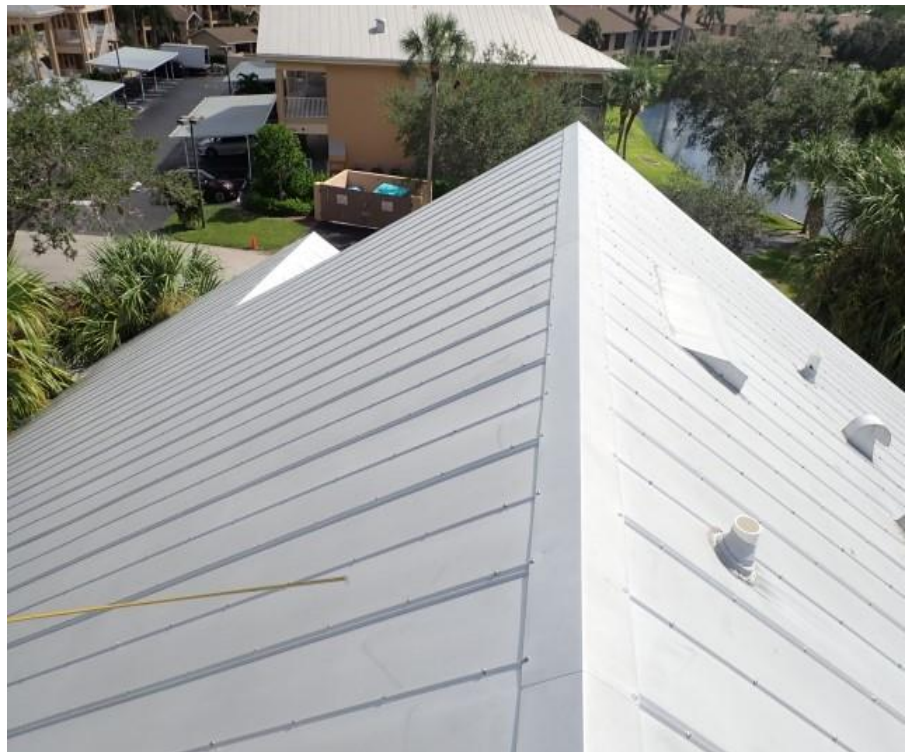
8. Bldg 1 roof system overview

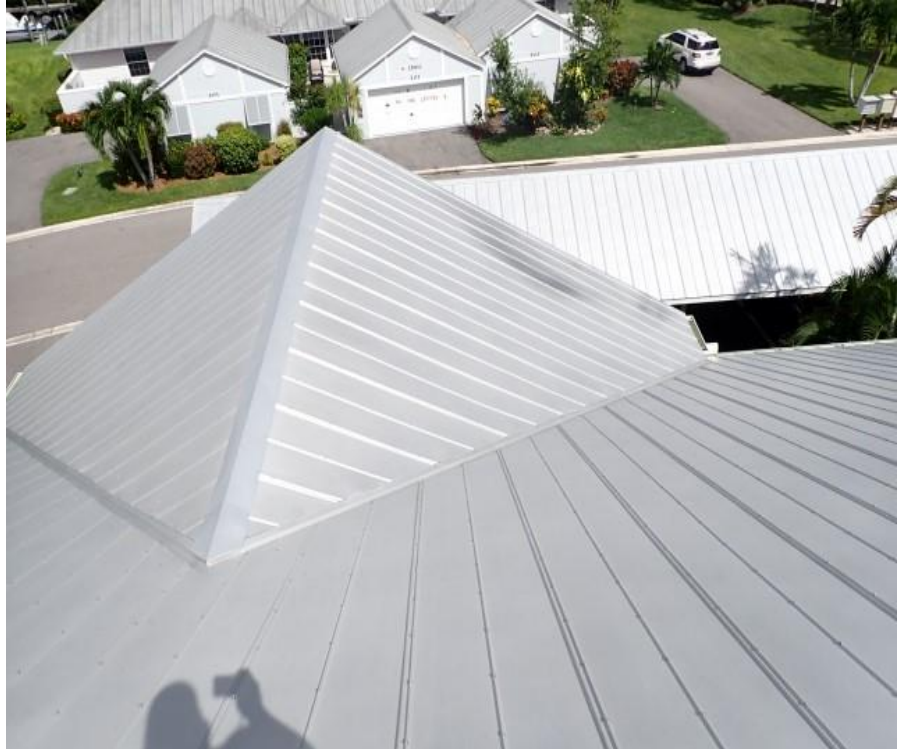
9. Bldg 1 roof system overview

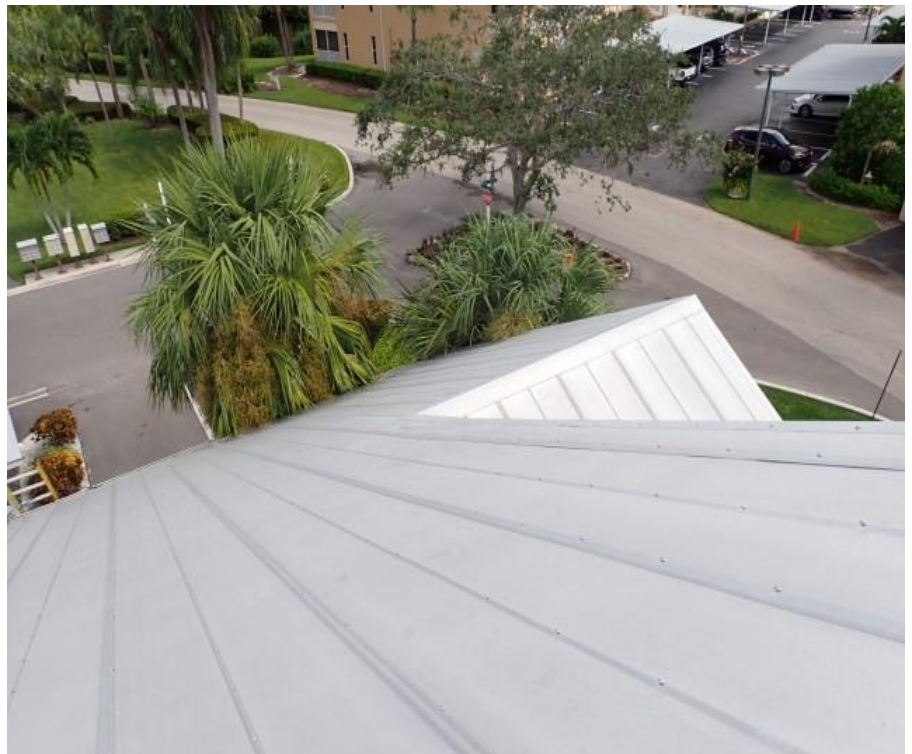
10. Bldg 1 roof system overview

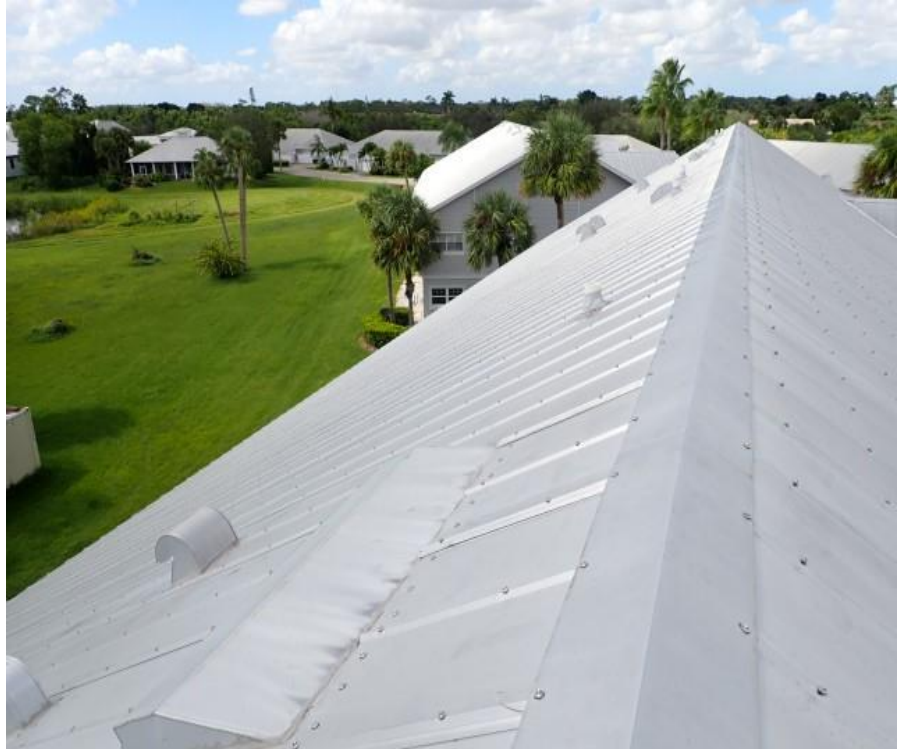
11. Bldg 1 roof system overview

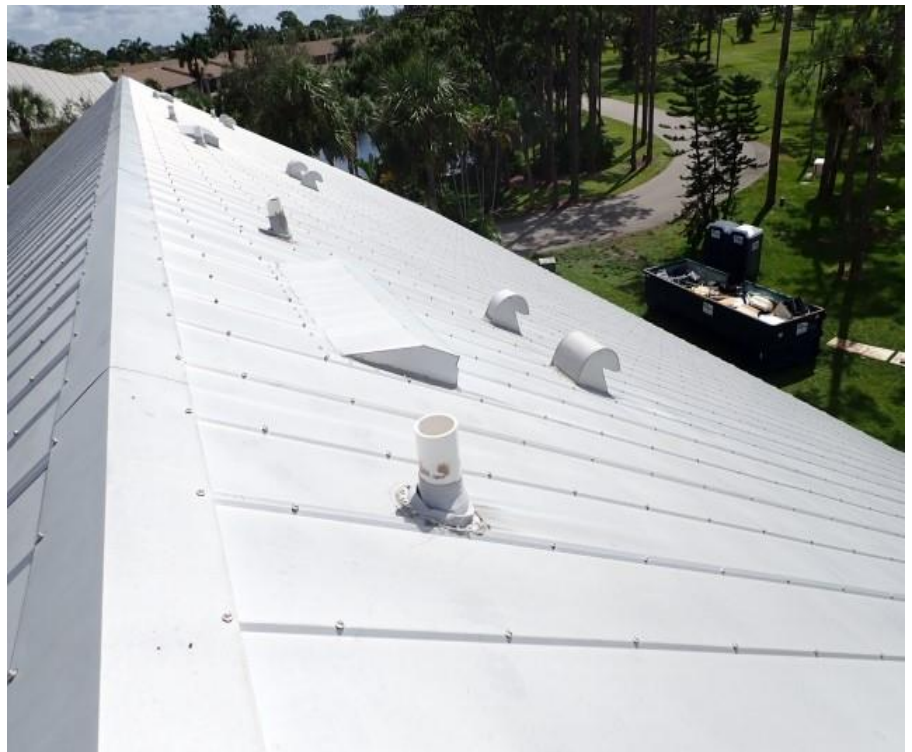
12. Bldg 1 roof system overview

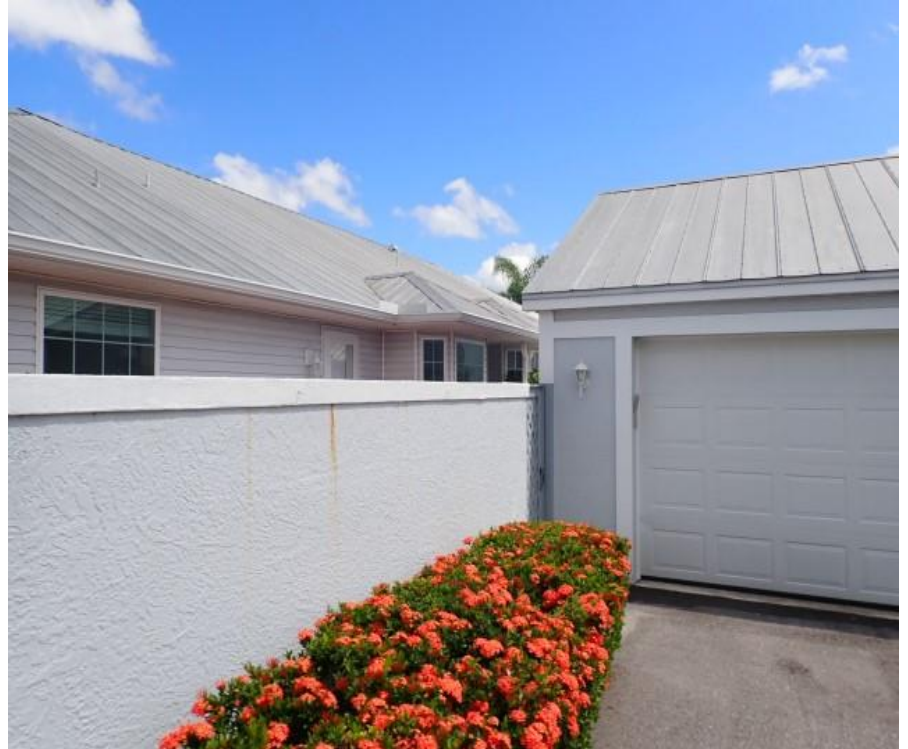
1. Building exterior front elevation overview

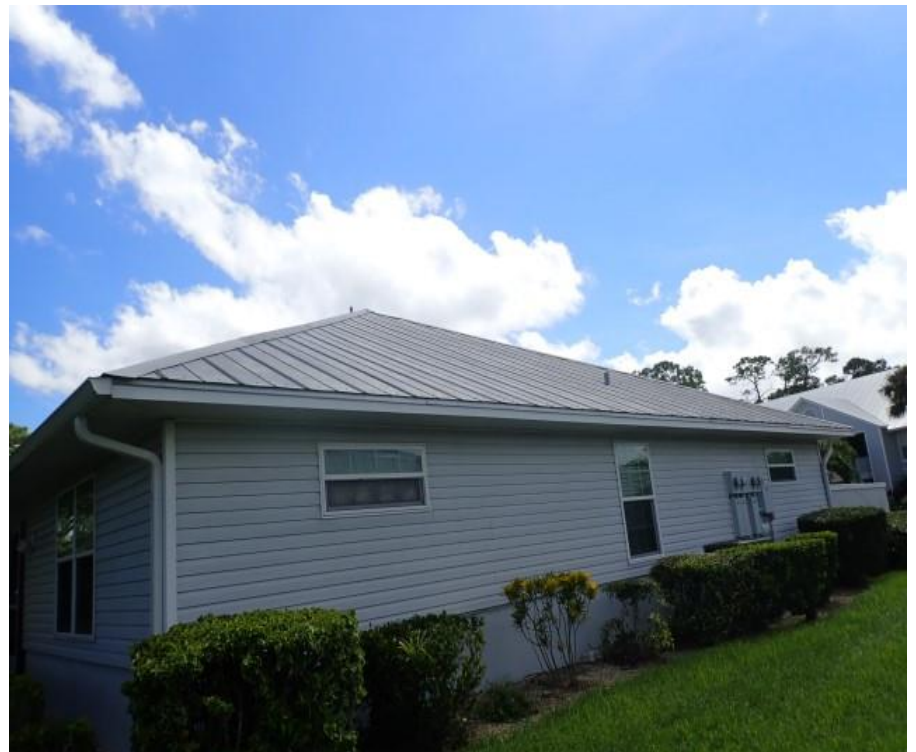
2. Building exterior side elevation overview

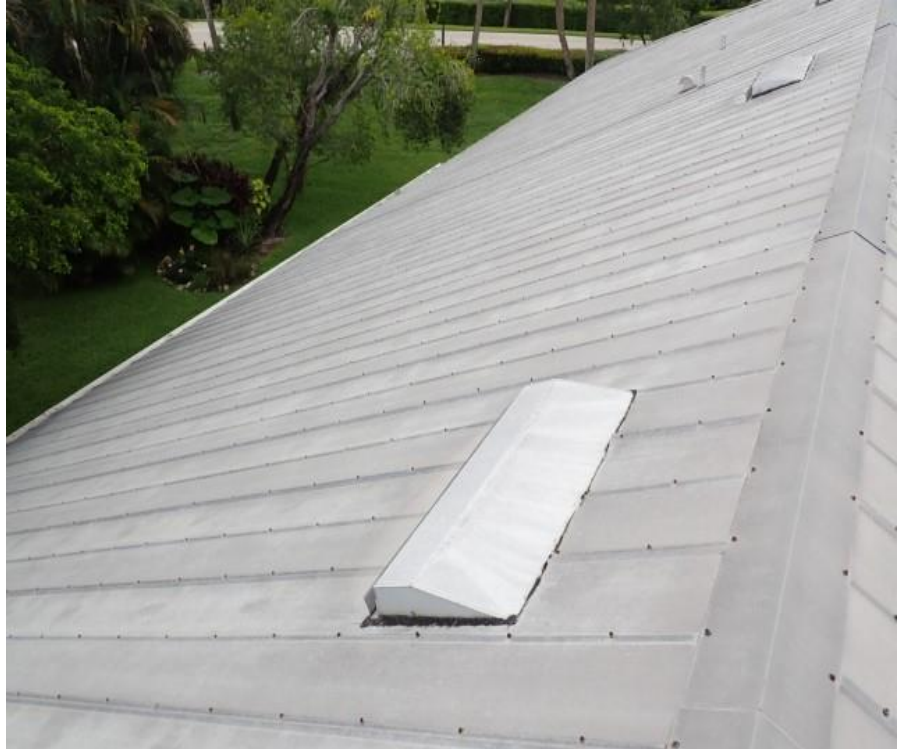
13. Bldg 2 roof system overview

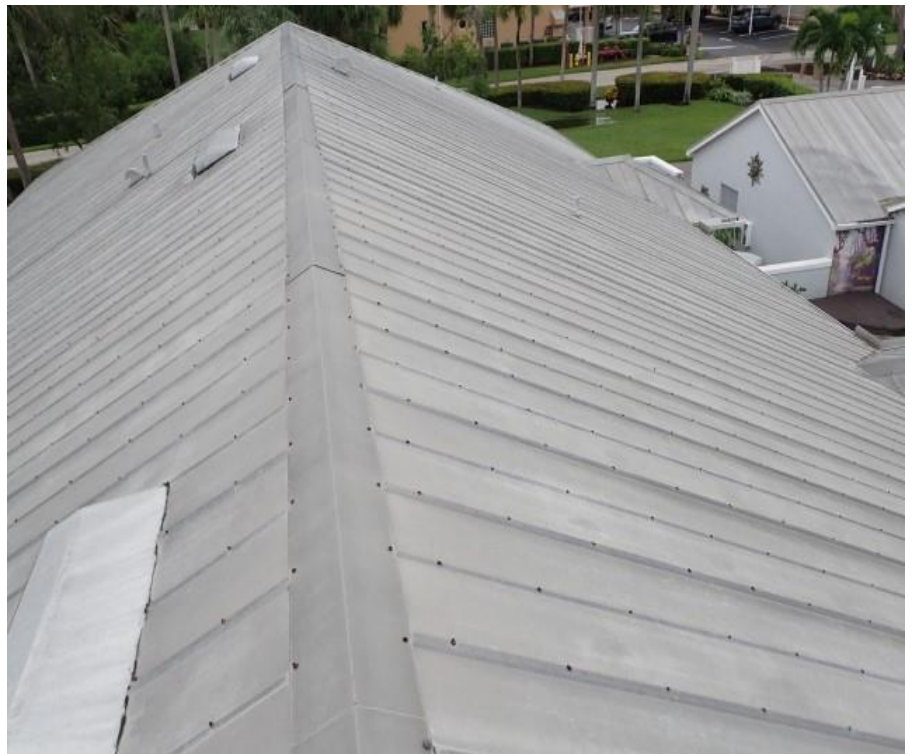
14. Bldg 2 roof system overview

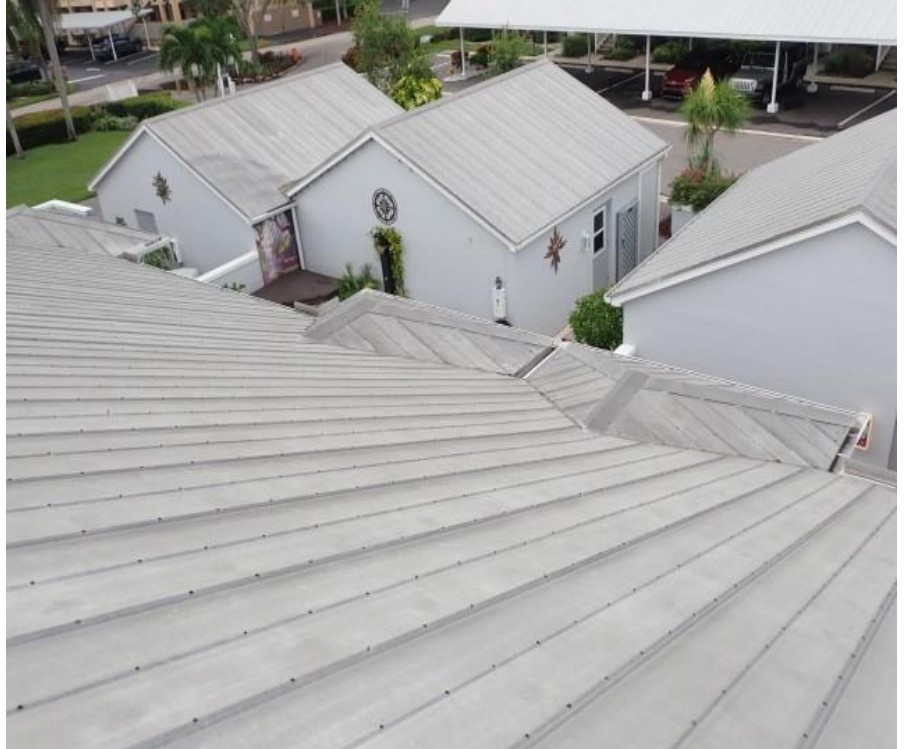
15. Bldg 2 roof system overview

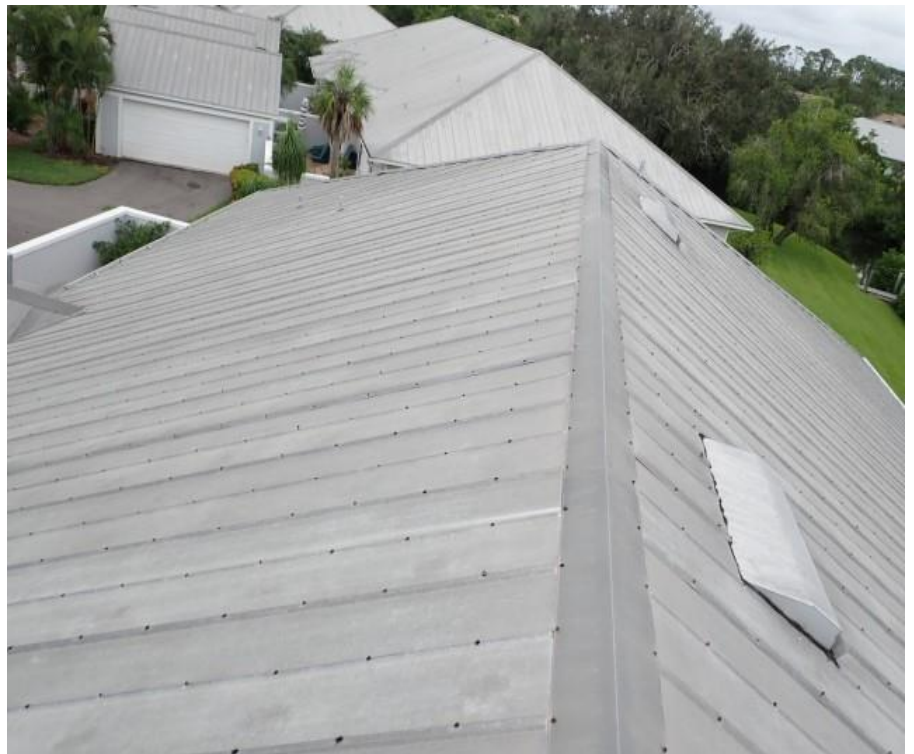
16. Bldg 2 roof system overview

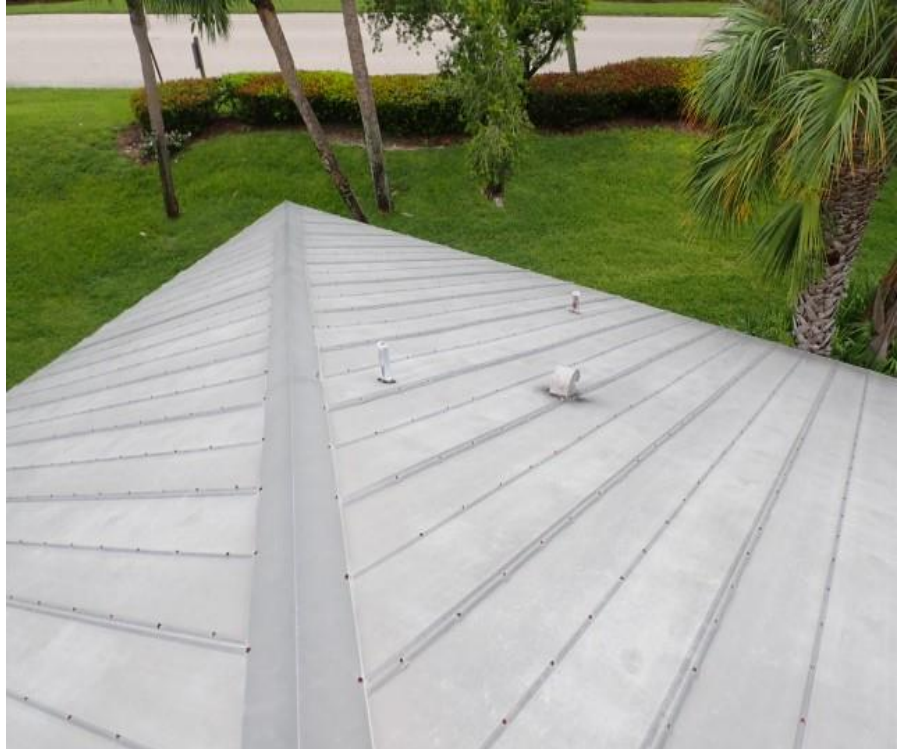
17. Bldg 2 roof system overview

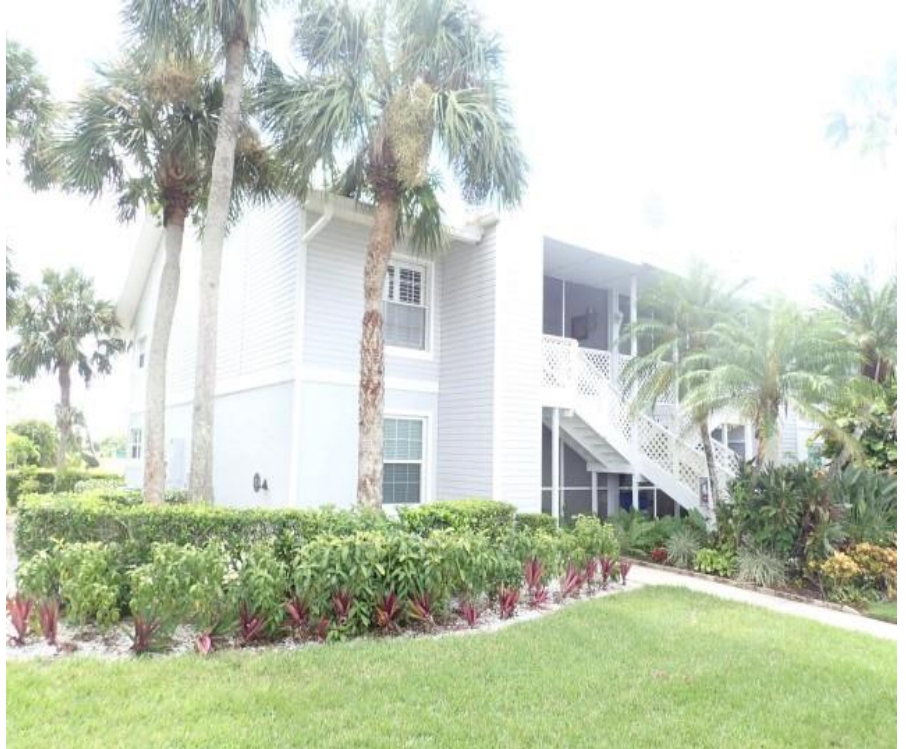
1. Building exterior front elevation overview

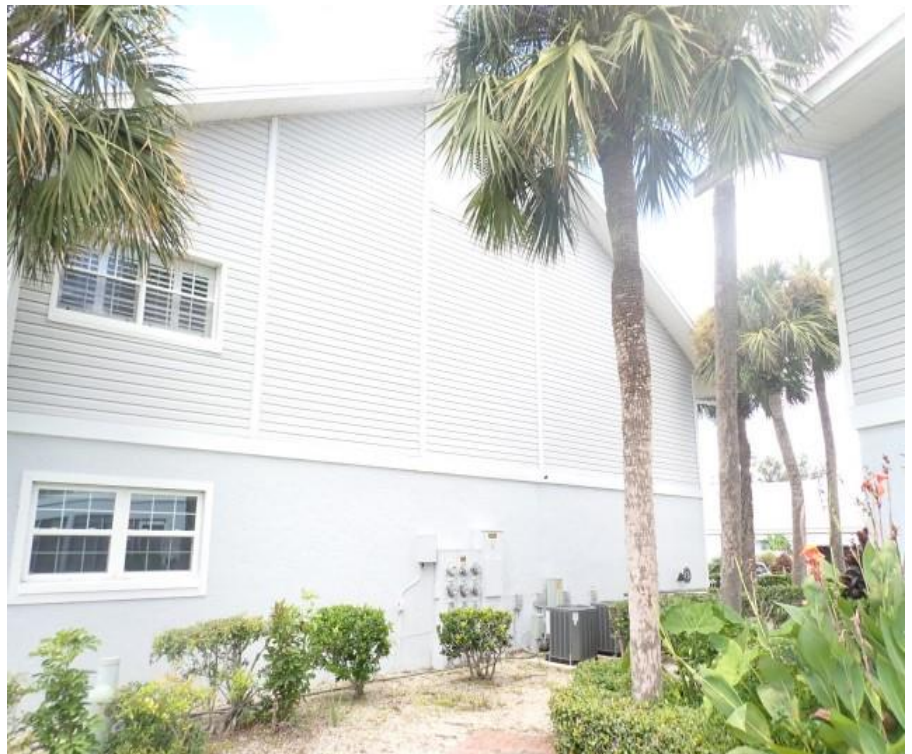
2. Building exterior side elevation overview

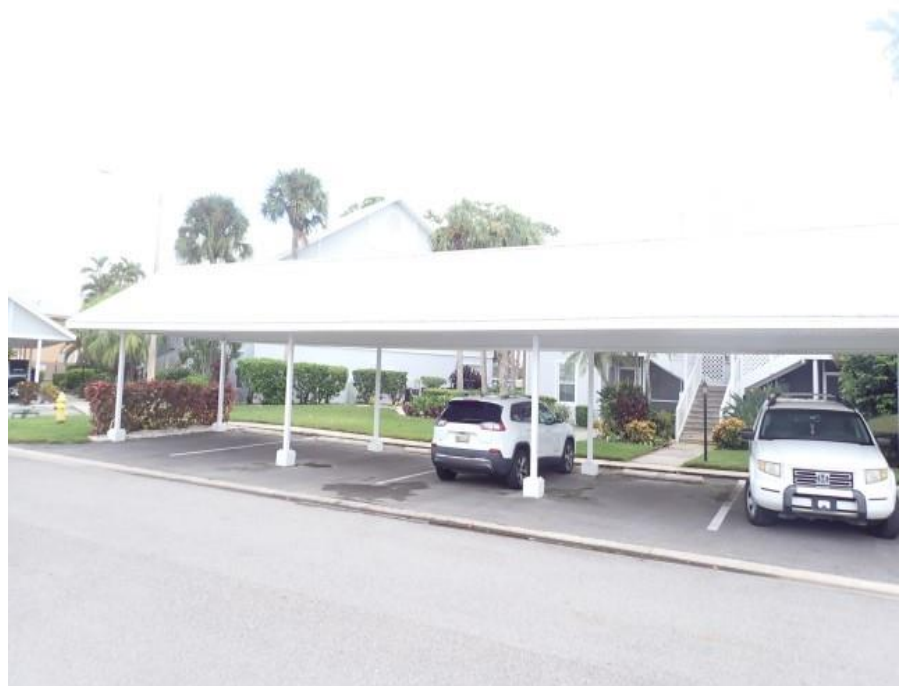
5. Building exterior front elevation overview

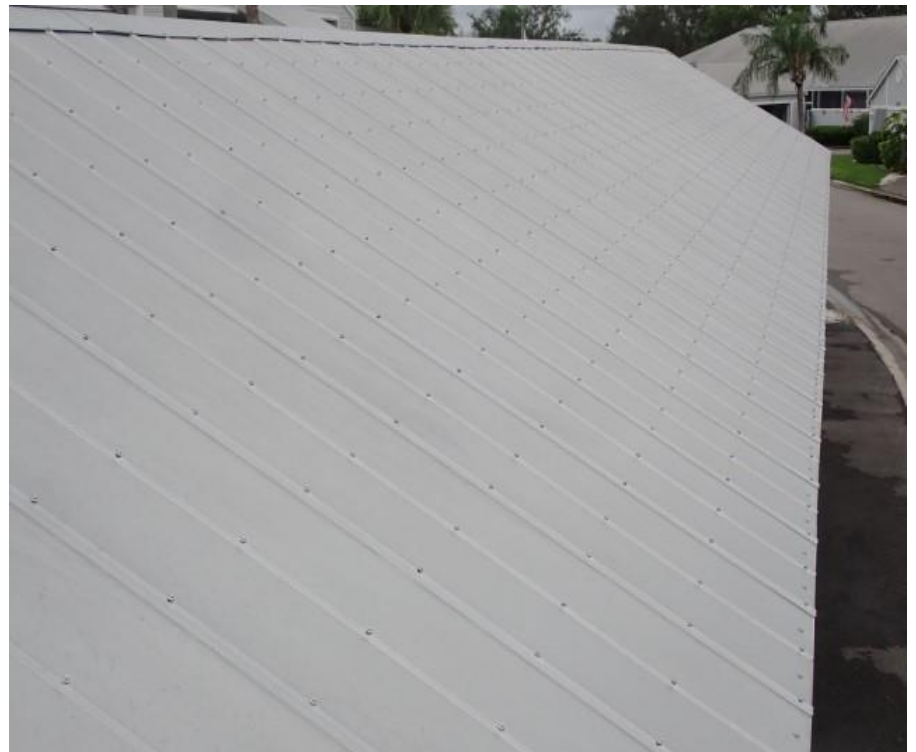
6. Bldg 3 - Garage roof system overview

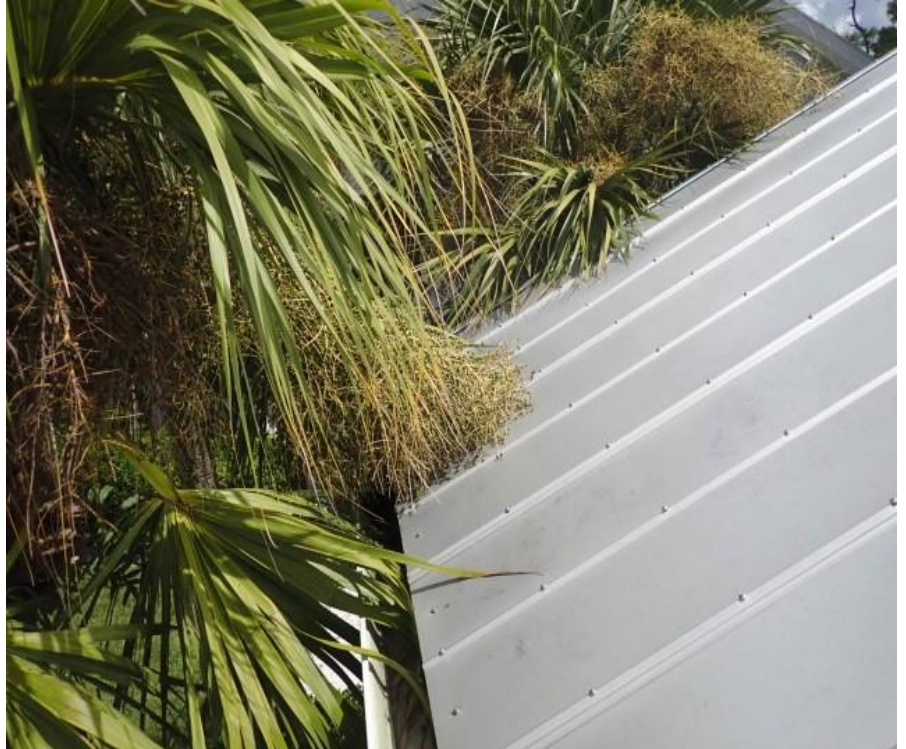
15. Deficiency #3 - Tree limbs /
branches overhanging roof surface

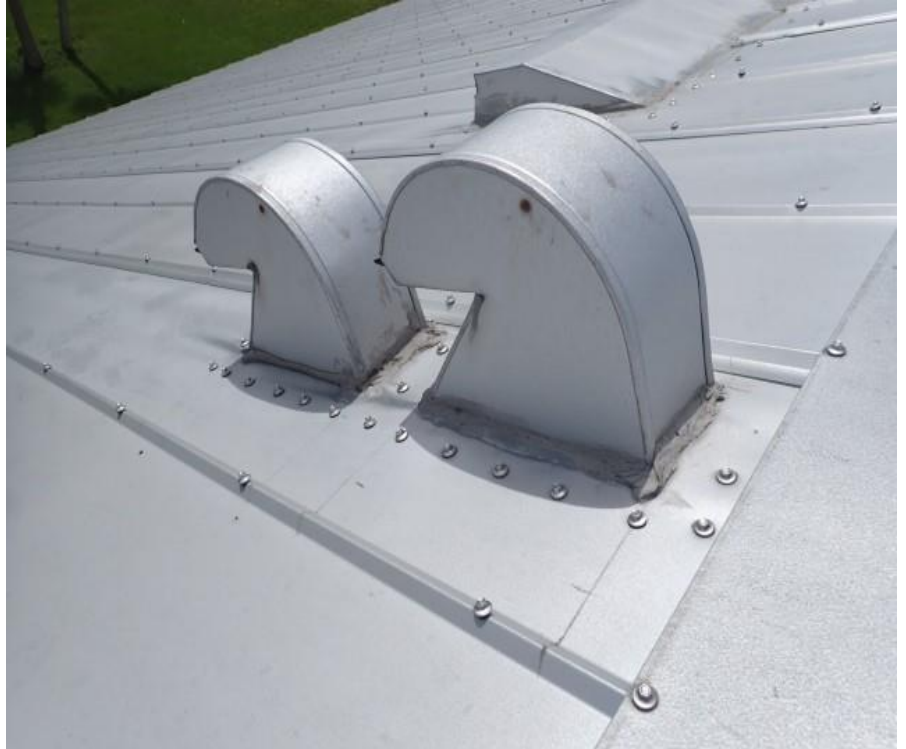
19. Deficiency #5 - Deteriorated previous sealant repairs at penetration flashing

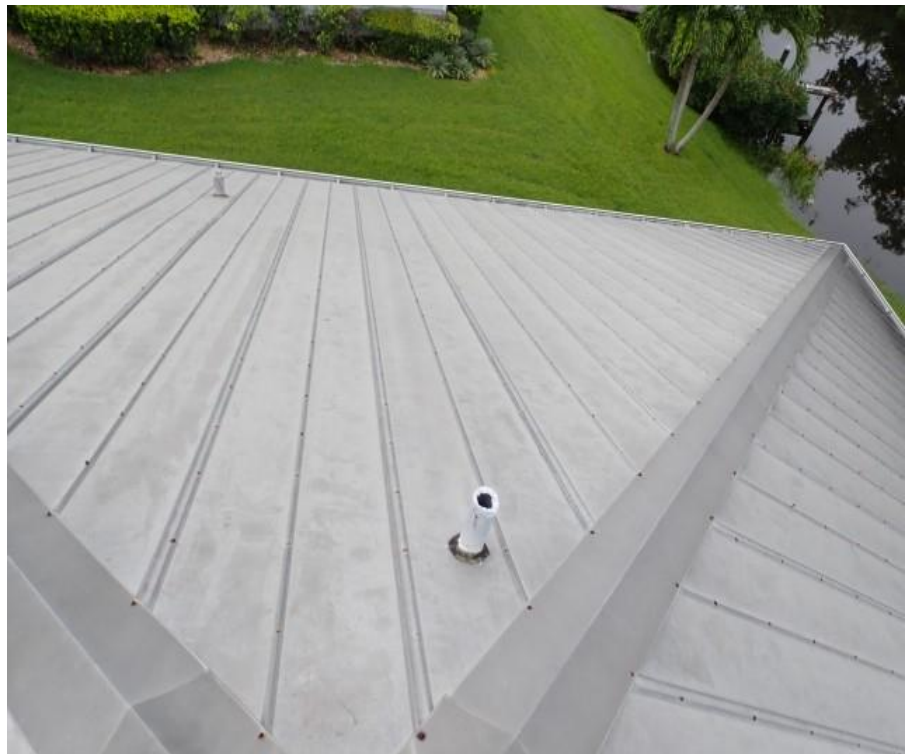
14. Bldg 5 roof system overview

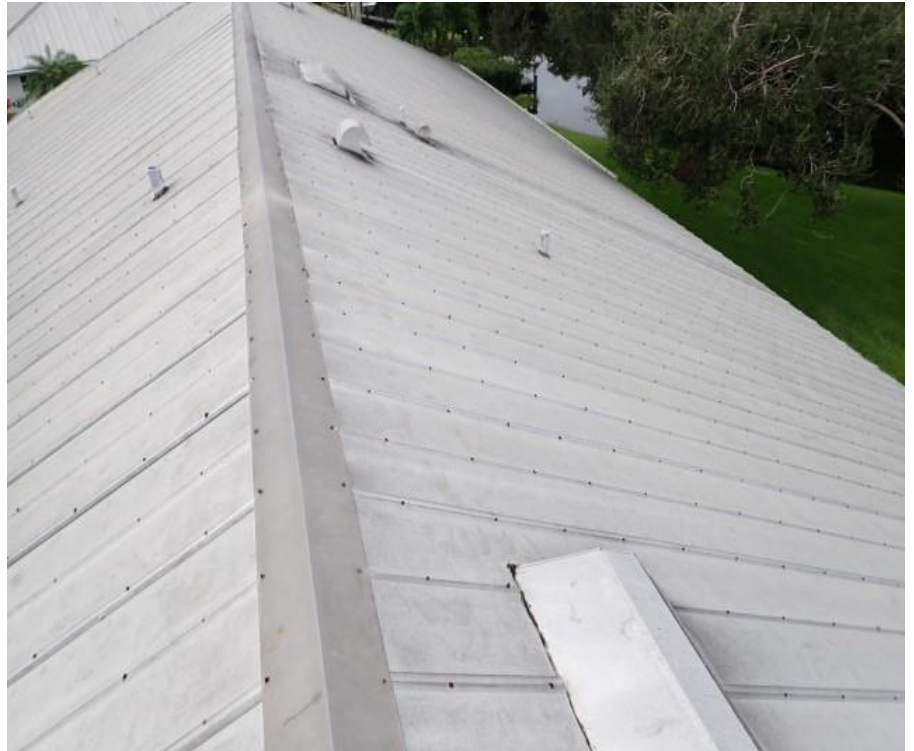
16. Bldg 5 roof system overview

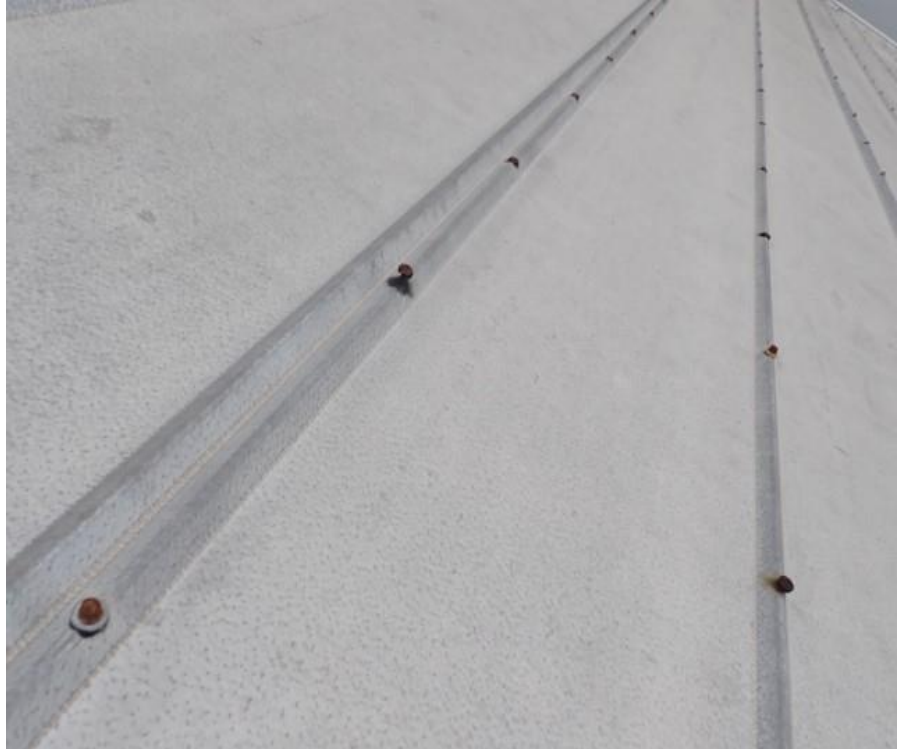
17. Deficiency #1 - Rusted fasteners

Deficiency #2 - Improper fasteners (nails) used for primary securement of metal panel assembly

Deficiency #3 - Loose fasteners

The overall condition of these roof areas is considered failed. The failed condition assignment is based on the observation of deteriorated, rusted, and loose fasteners / primary attachment of roof system typically throughout the roof installation, and the extent of repair expenditure that would be associated to correcting this issue. Due to the age of the existing panels, it is not economically justifiable to repair the existing system. Five (5) types of deficient conditions were observed during the course of this investigation. A comprehensive list of these deficient conditions can be found in the Detailed Deficiency Listing section of this report. With the current overall condition of the existing roof system considered failed, corrections to the noted

NUMBER	PRIORITY CODE	DEFICIENCY DESCRIPTION	QUANTITY	UNIT PRICE	REPAIR COST
		DEFICIENCY SOLUTION	UNITS		
1	MN	Loose fasteners	73		
		Address noted condition by / during recommended roof system replacement	Ea		
2	MN	Rusted fasteners	4		
		Address noted condition by / during recommended roof system replacement	Typical		
3	MN	Deteriorated previous sealant repairs at penetration flashing	13		
		Address noted condition by / during recommended roof system replacement	Locations		
4	M	Debris in gutter	20	\$7.50	\$150.00
		Remove and properly dispose of all debris to provide positive drainage from gutter to downspouts	LnFt		
5	M	Open condition at valley flashing	2	\$175.00	\$350.00
		To mitigate potential of moisture intrusion until time of the roof system replacement, clean area and install multi-course elastomeric repair with embedded polyester reinforcing scrim over the open condition. Permanently address valley detail concurrently with roof system replacement	LnFt

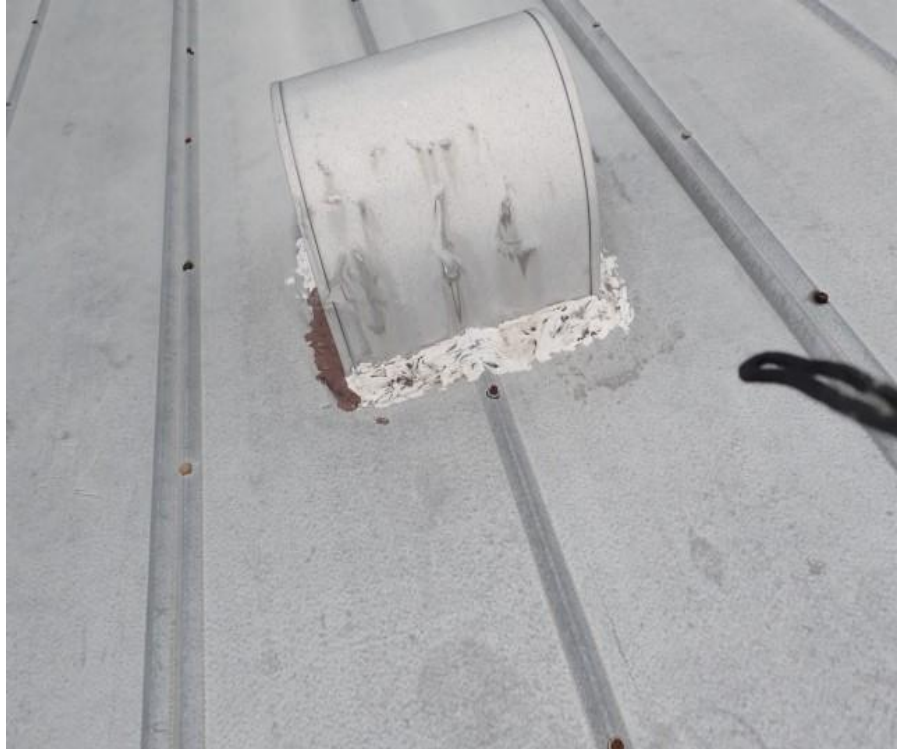
19. Deficiency #4 - Deteriorated previous sealant repairs at penetration flashing

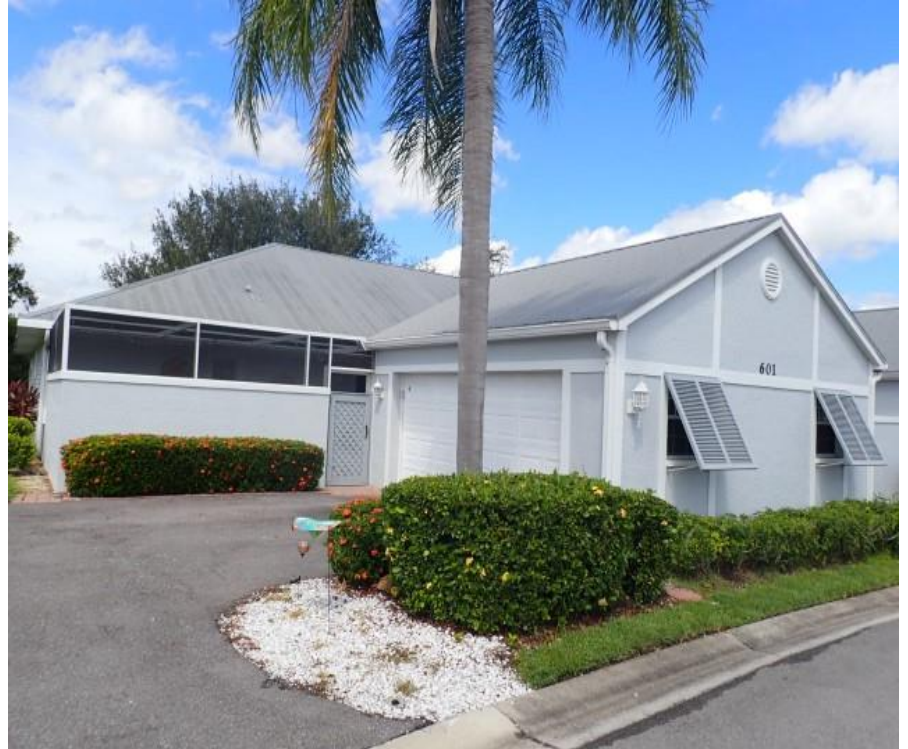
1. Building exterior front elevation overview

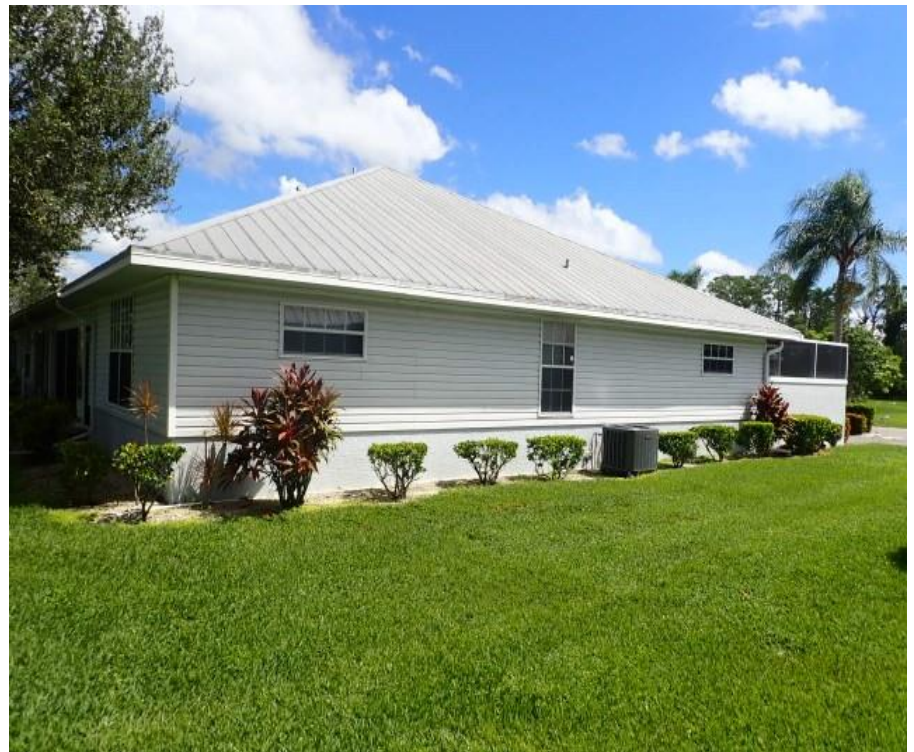
2. Building exterior side elevation overview

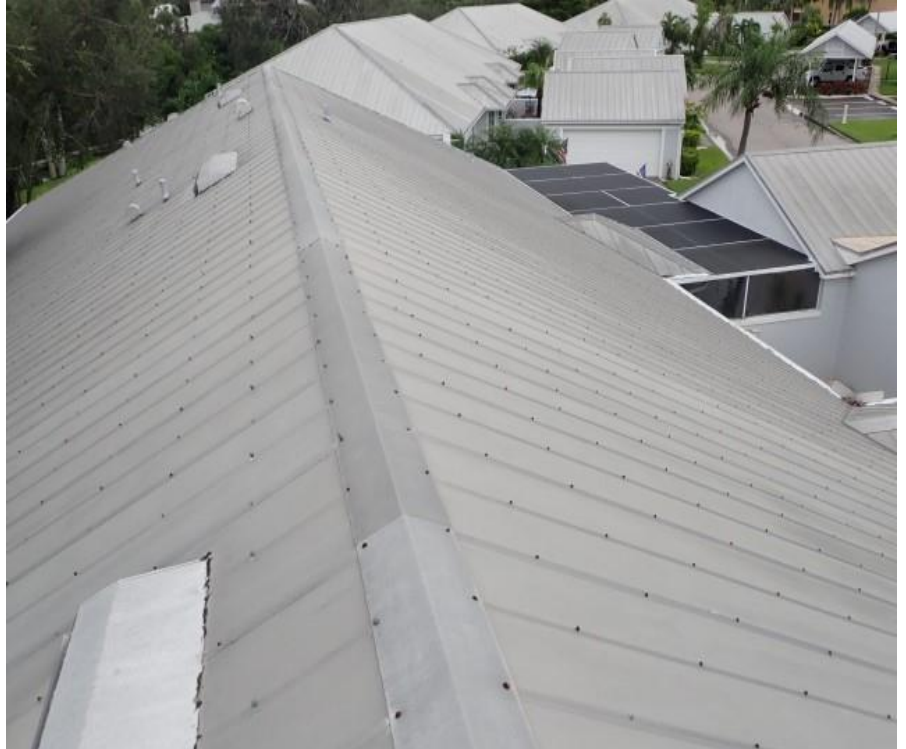
13. Bldg 6 roof system overview

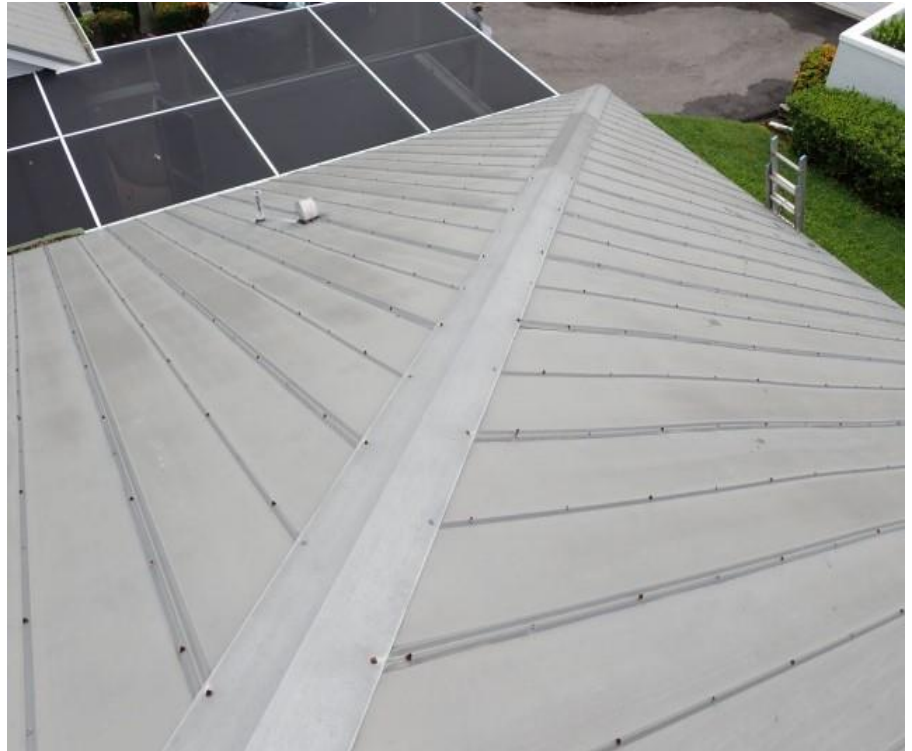
14. Bldg 6 roof system overview

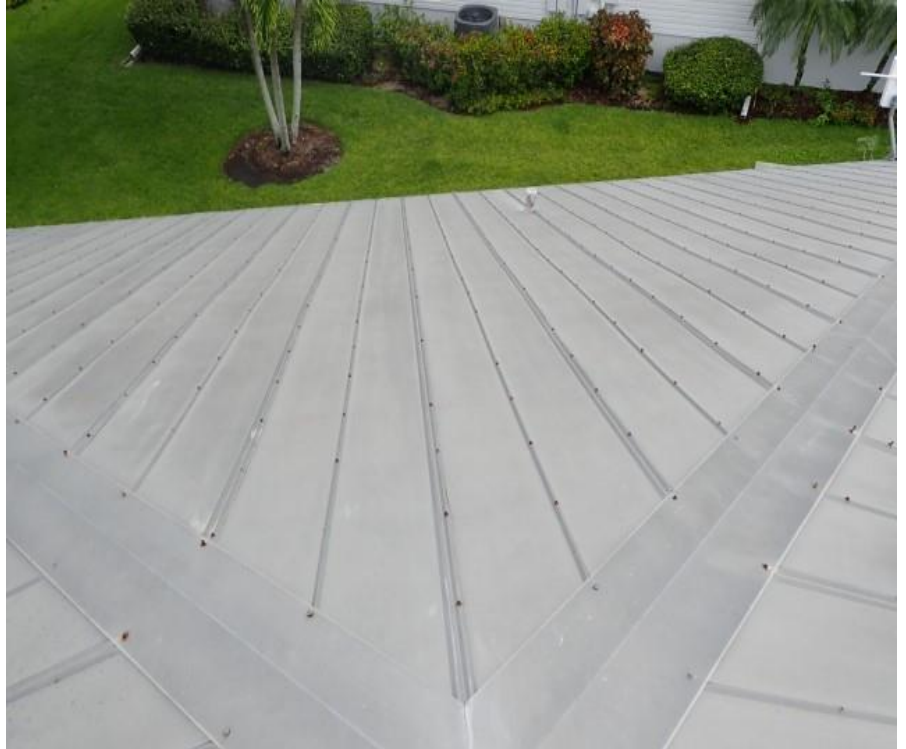
15. Bldg 6 roof system overview

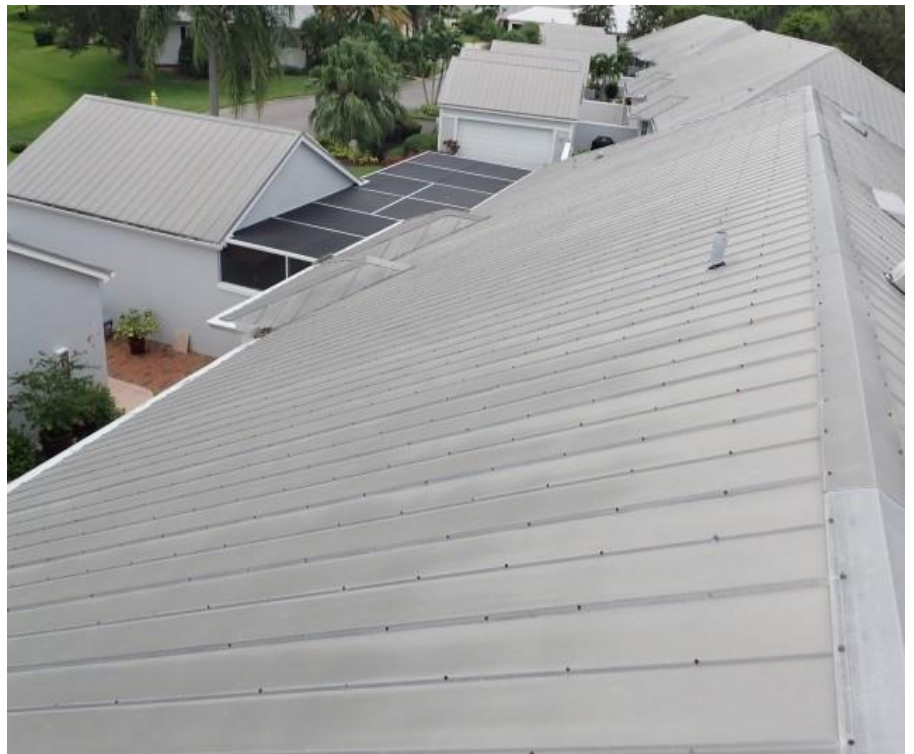
16. Bldg 6 roof system overview
