Village at Indian Creek

**15371 River Vista Drive
North Fort Myers, FL**

10/5/2023

Roof System Condition Evaluation Report

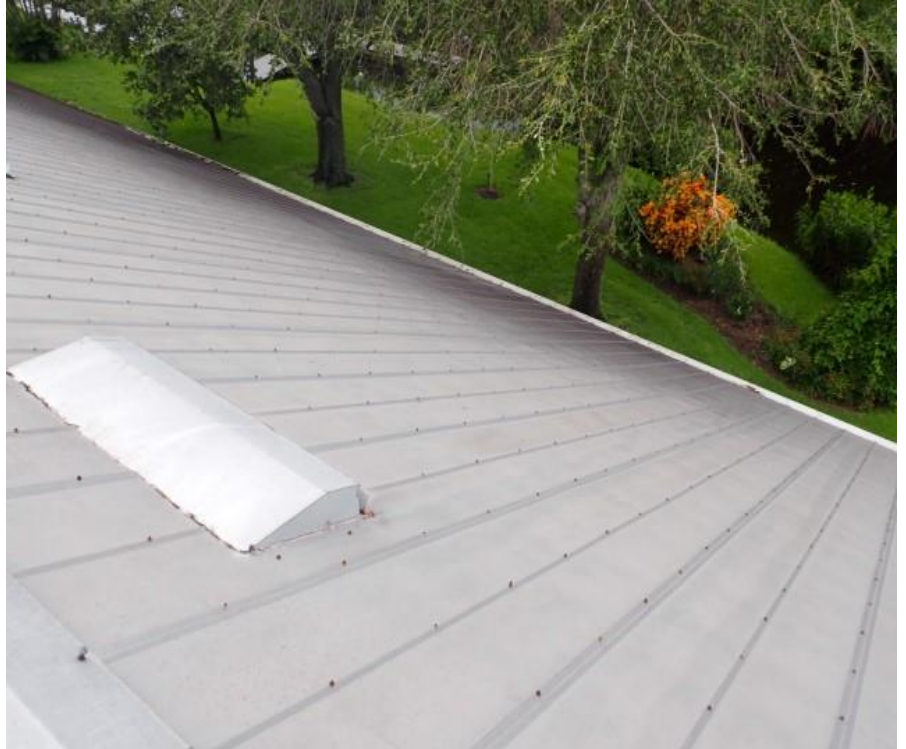
17. Bldg 6 roof system overview

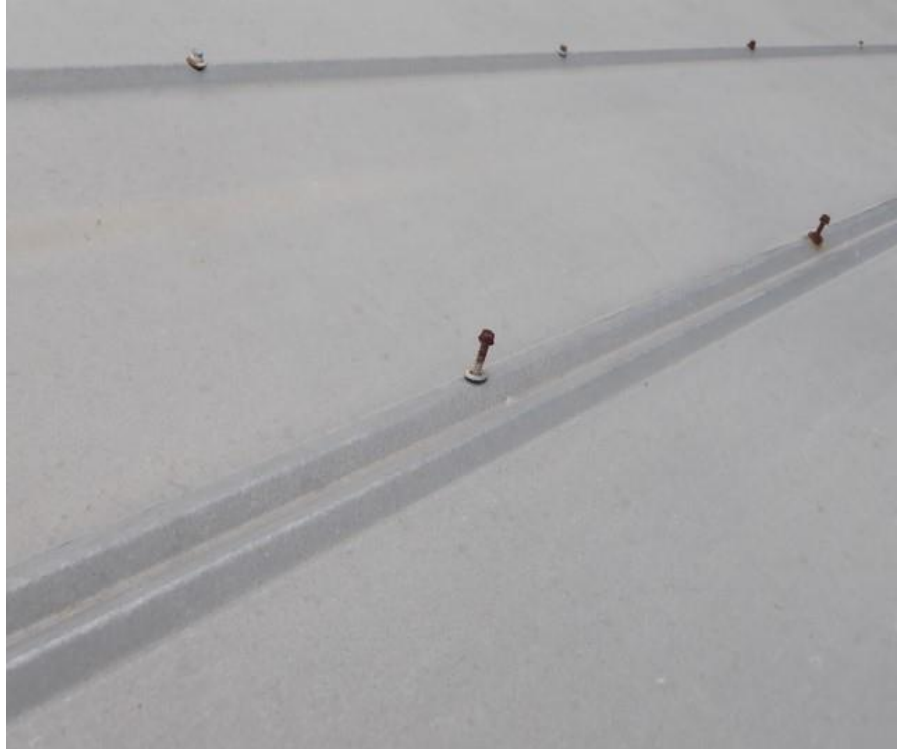
19. Deficiency #1 - Loose fasteners

Deficiency #2 - Rusted fasteners

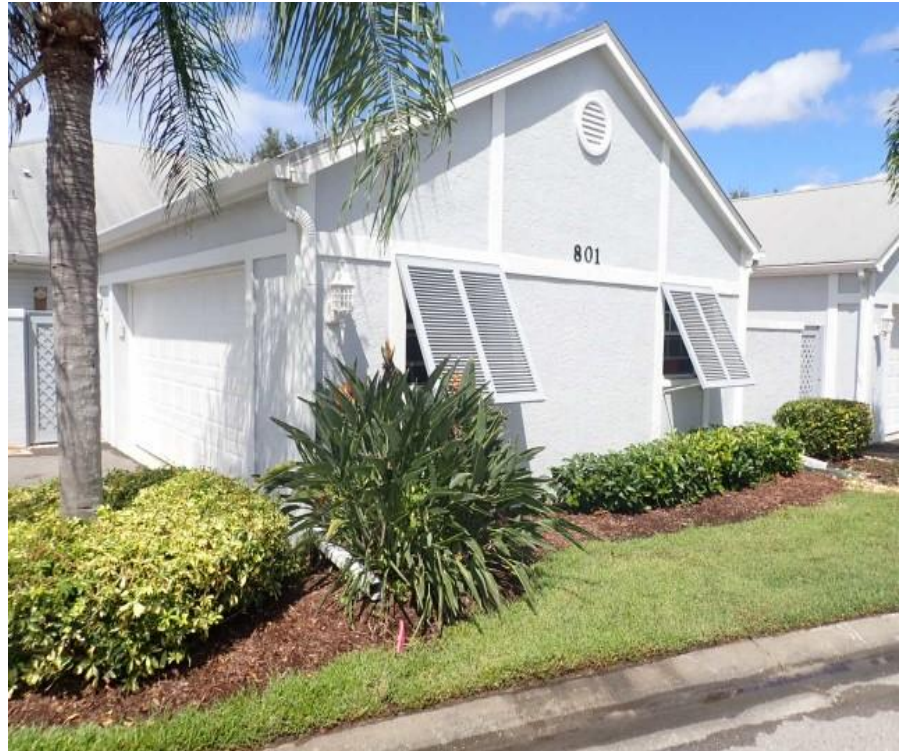
1. Building exterior front elevation overview

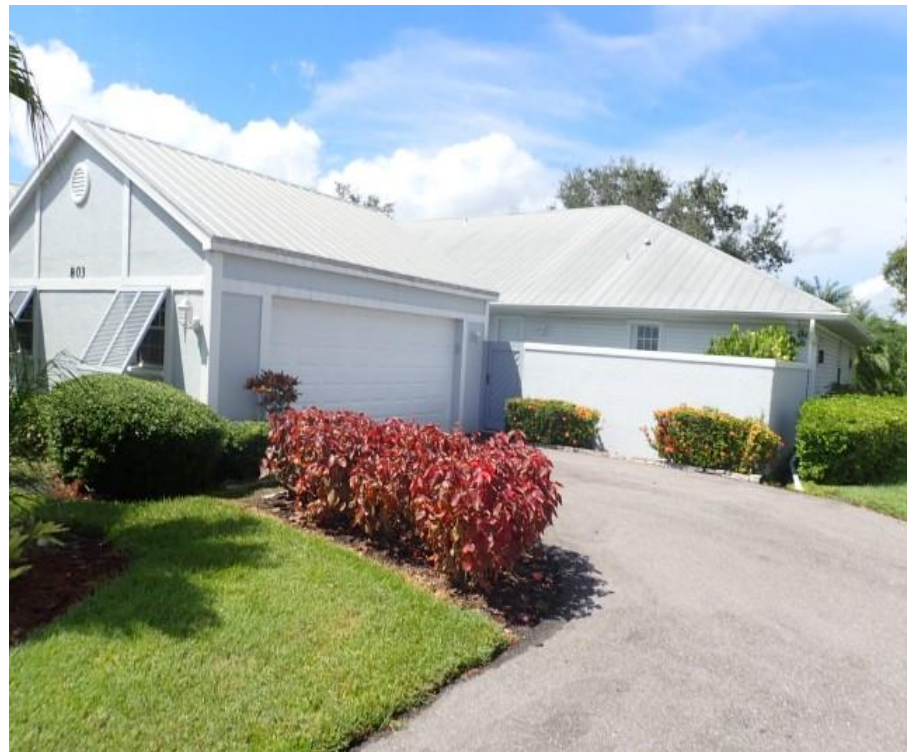
2. Building exterior front elevation overview

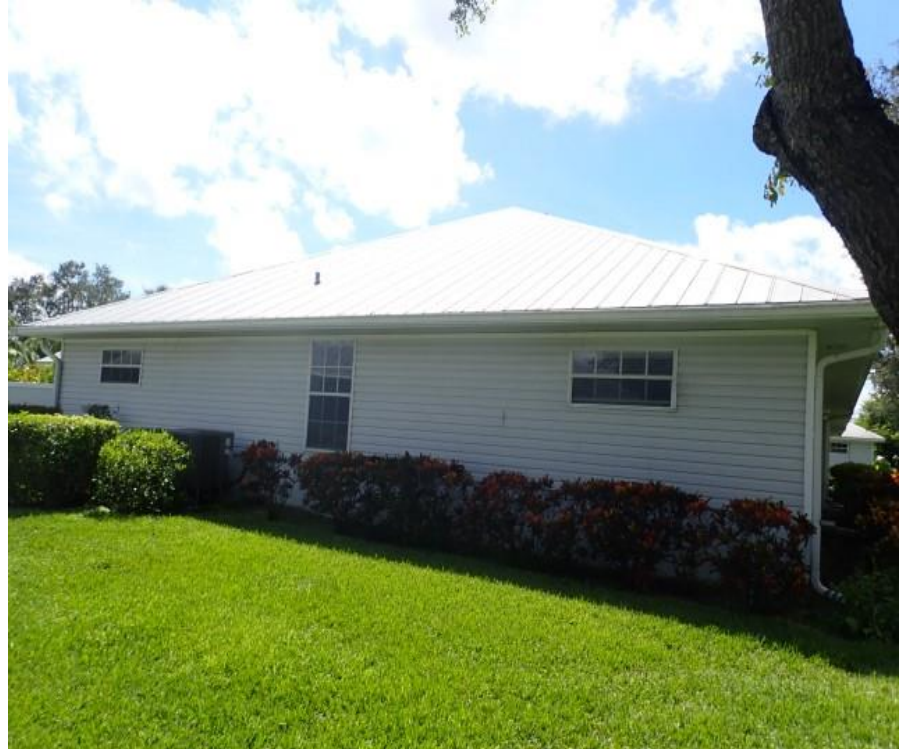
3. Building exterior side elevation
overview

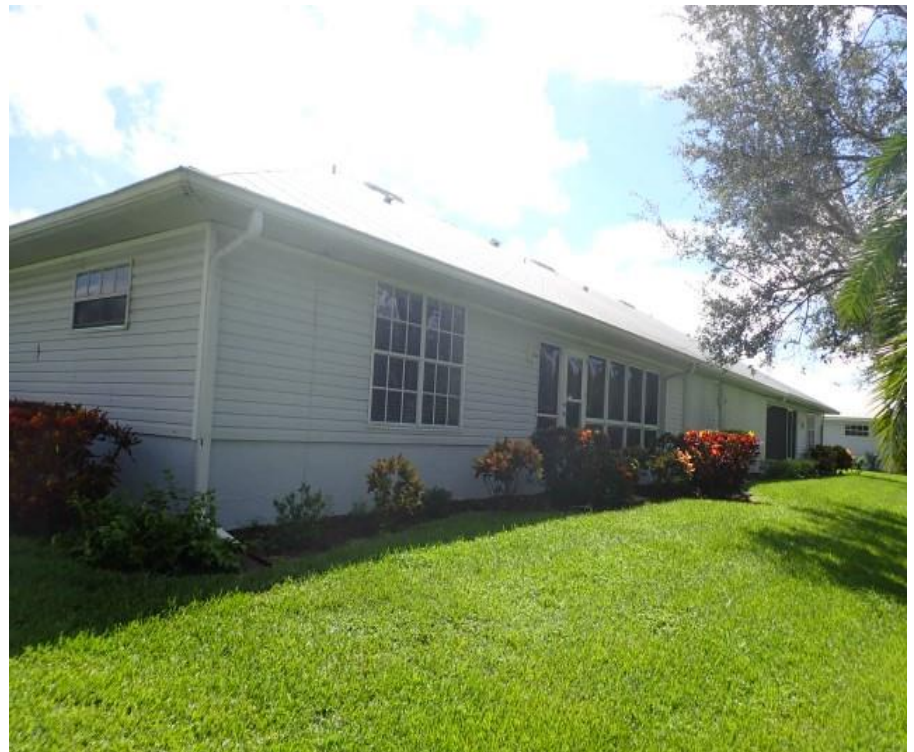
4. Building exterior rear elevation
overview

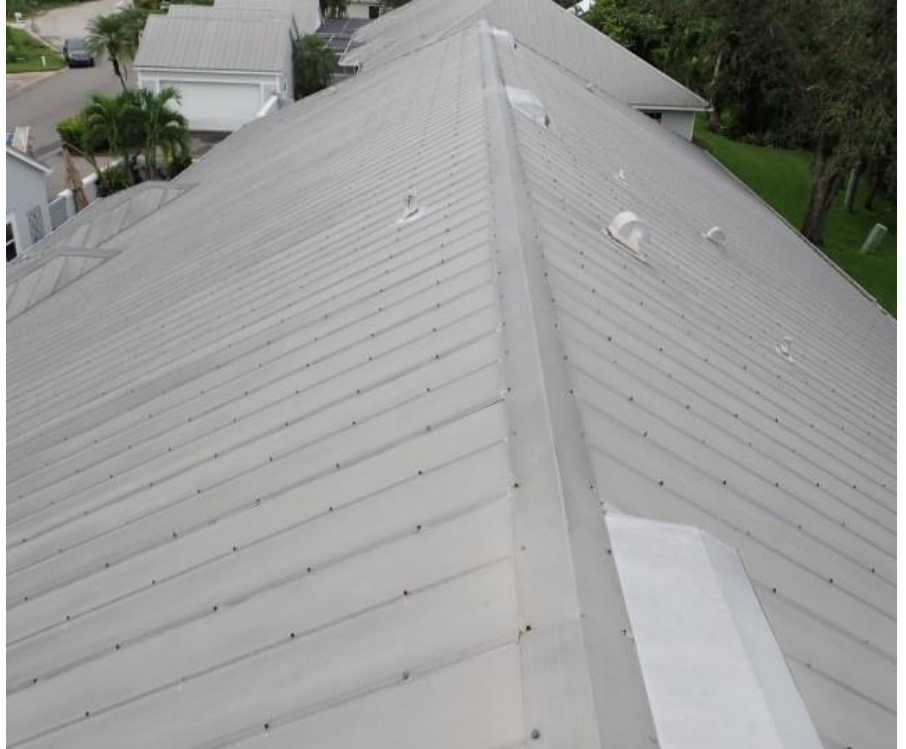
13. Bldg 8 roof system overview

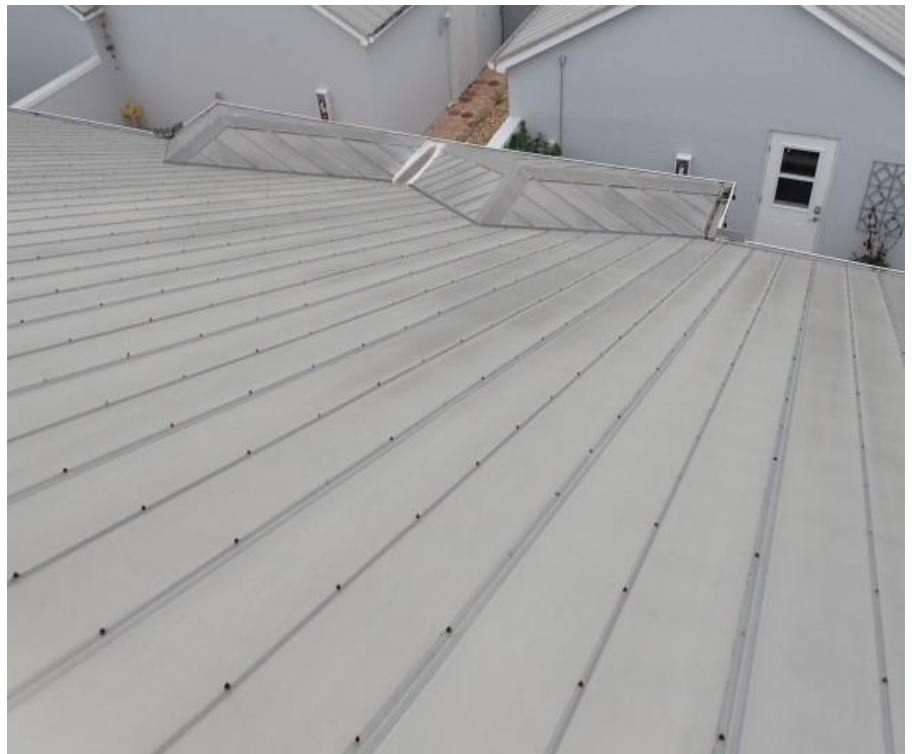
14. Bldg 8 roof system overview

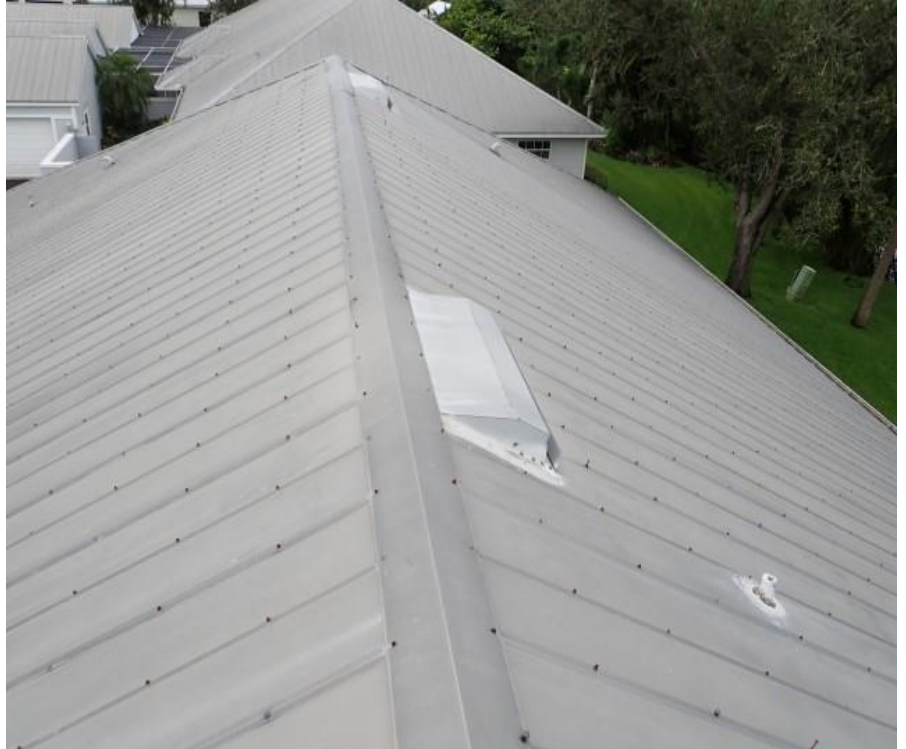
15. Bldg 8 roof system overview

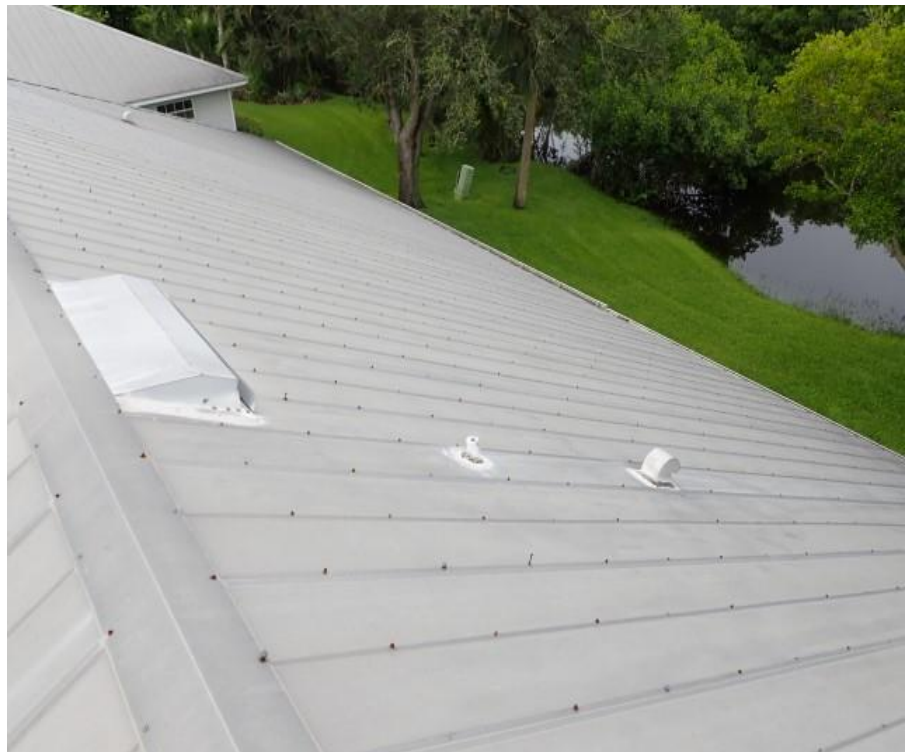
16. Bldg 8 roof system overview

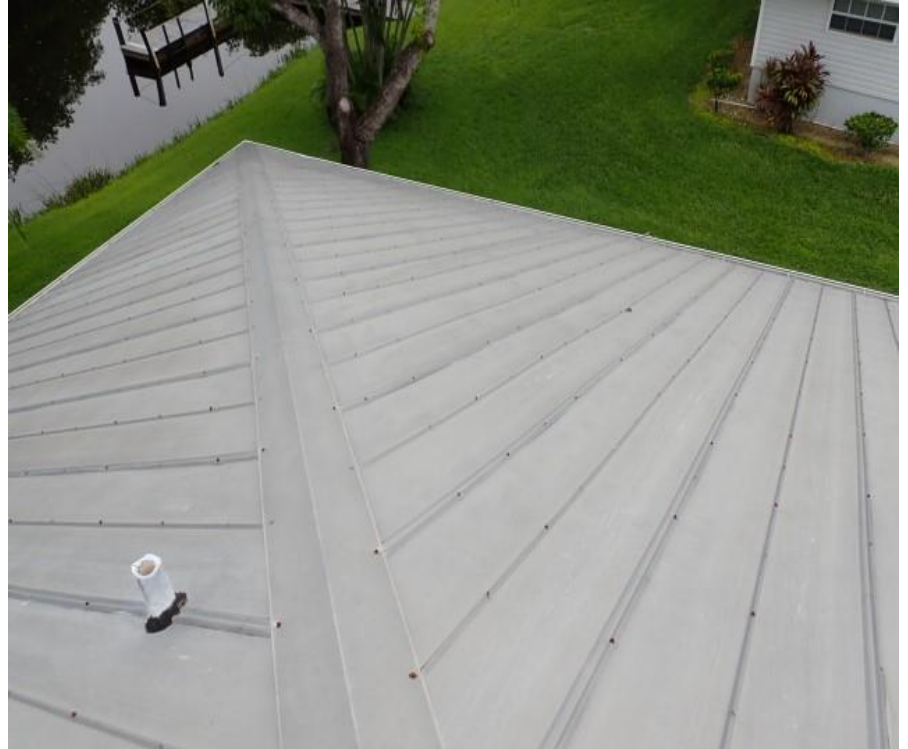
23. Bldg 8 roof system overview

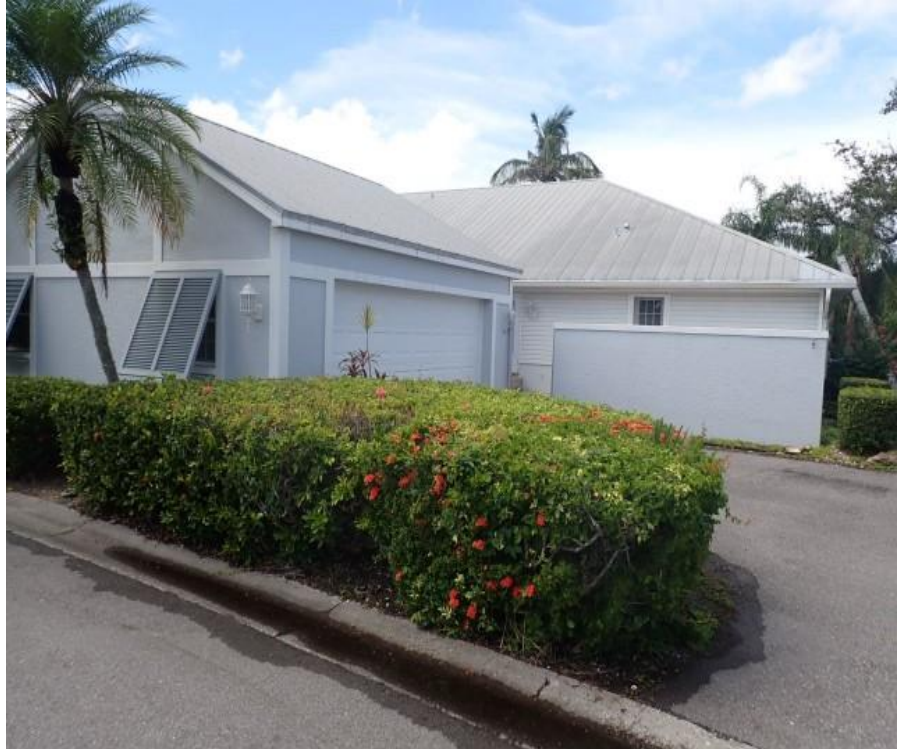
1. Building exterior front elevation overview

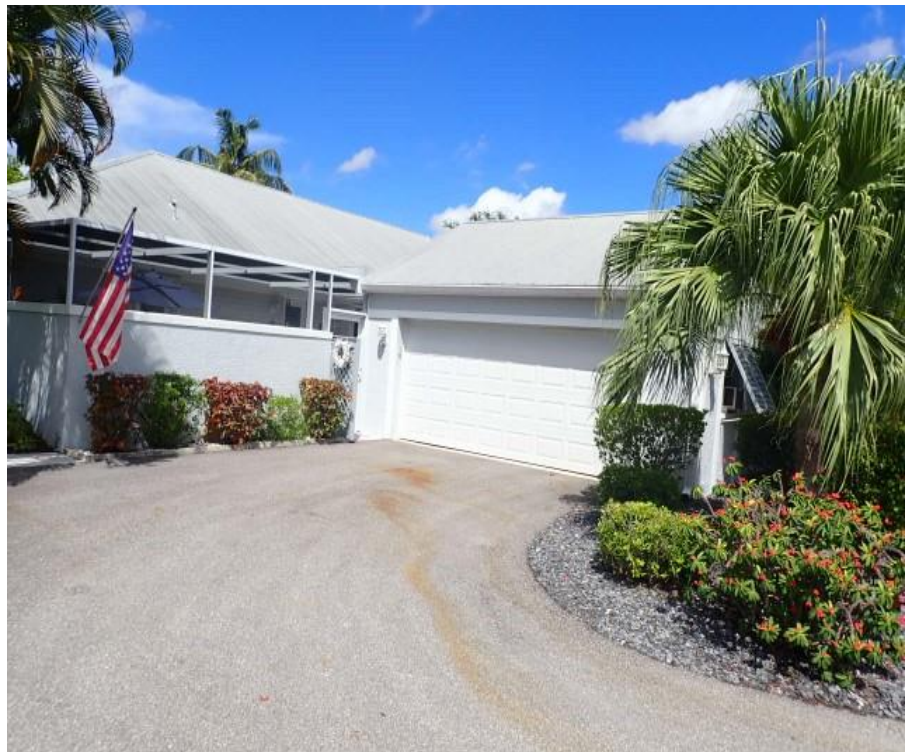
2. Building exterior front elevation overview

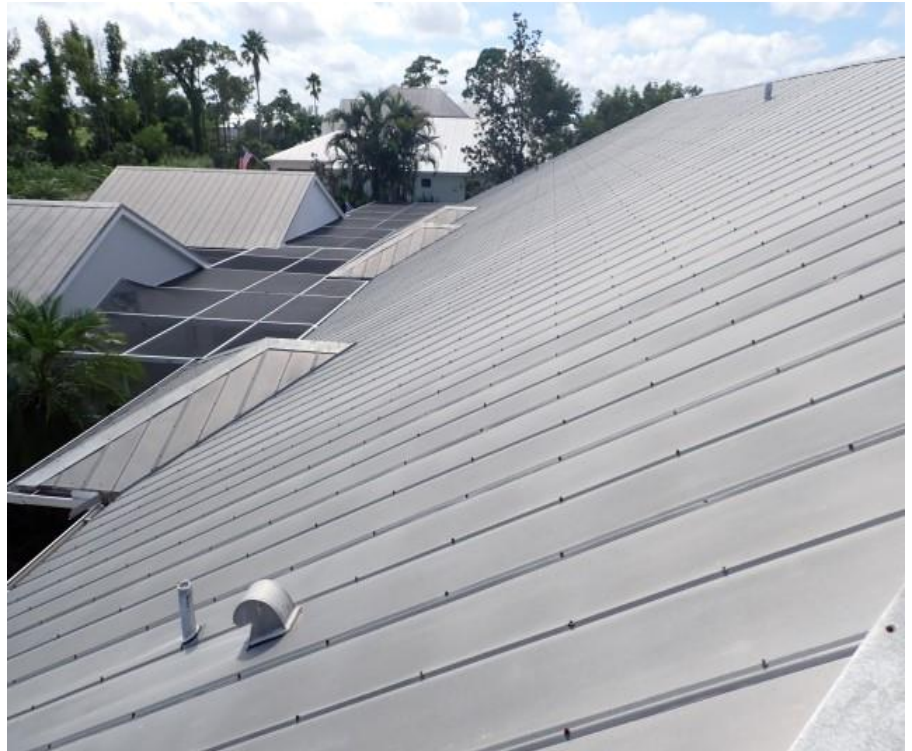
6. Bldg 10 roof system overview

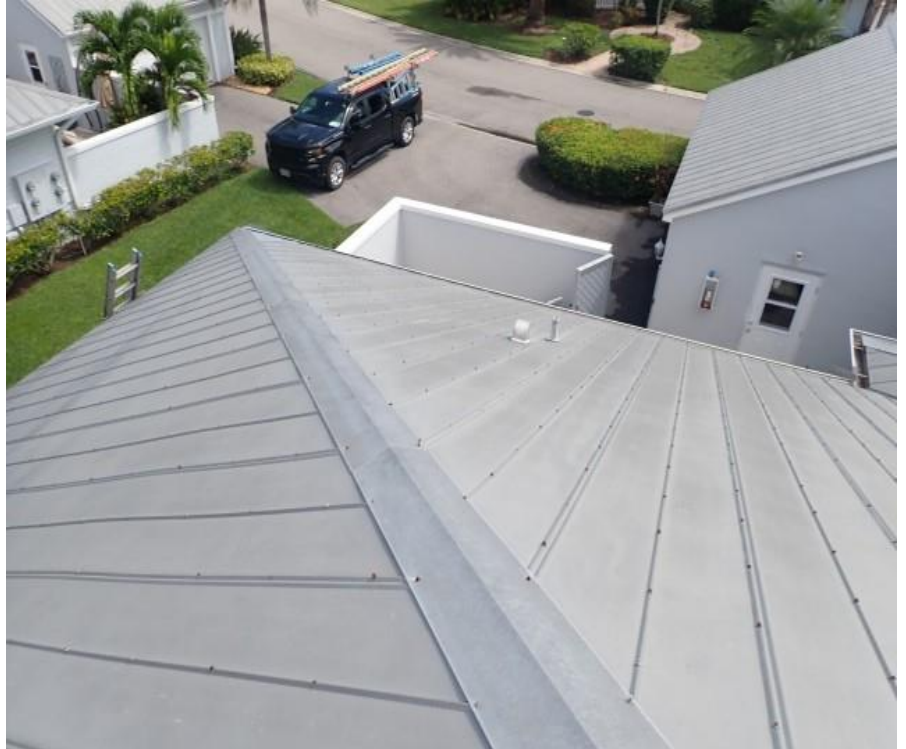
7. Bldg 10 roof system overview

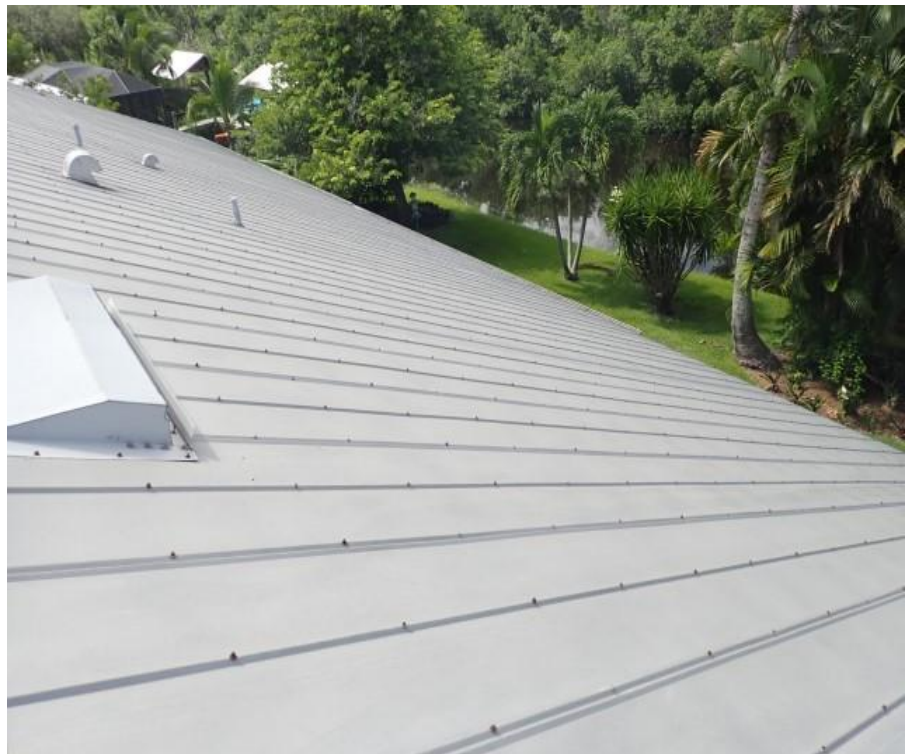
8. Bldg 10 roof system overview

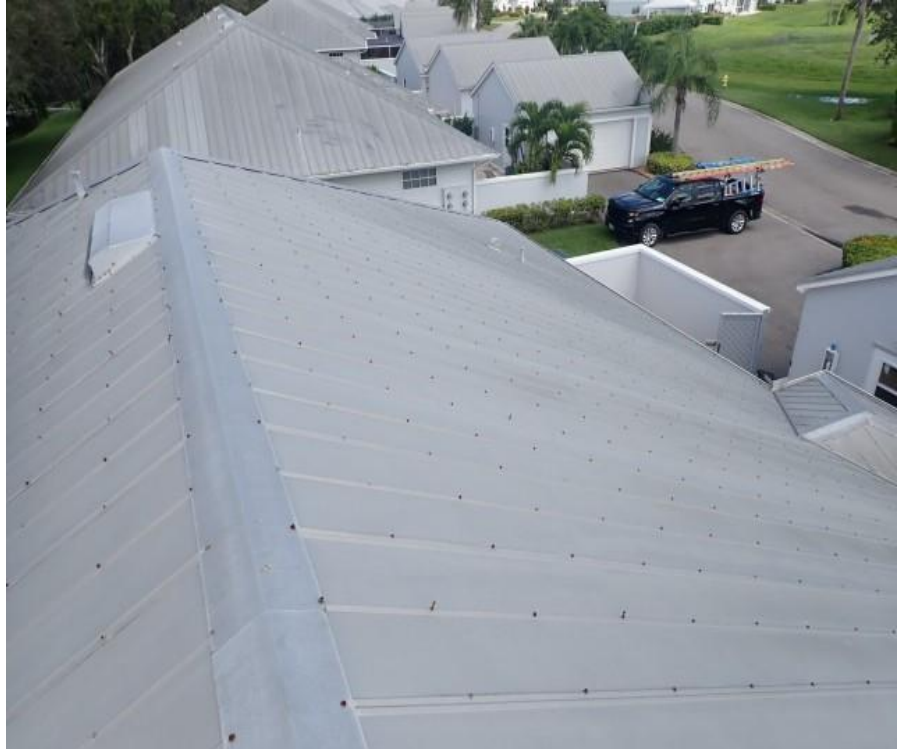
9. Bldg 10 roof system overview

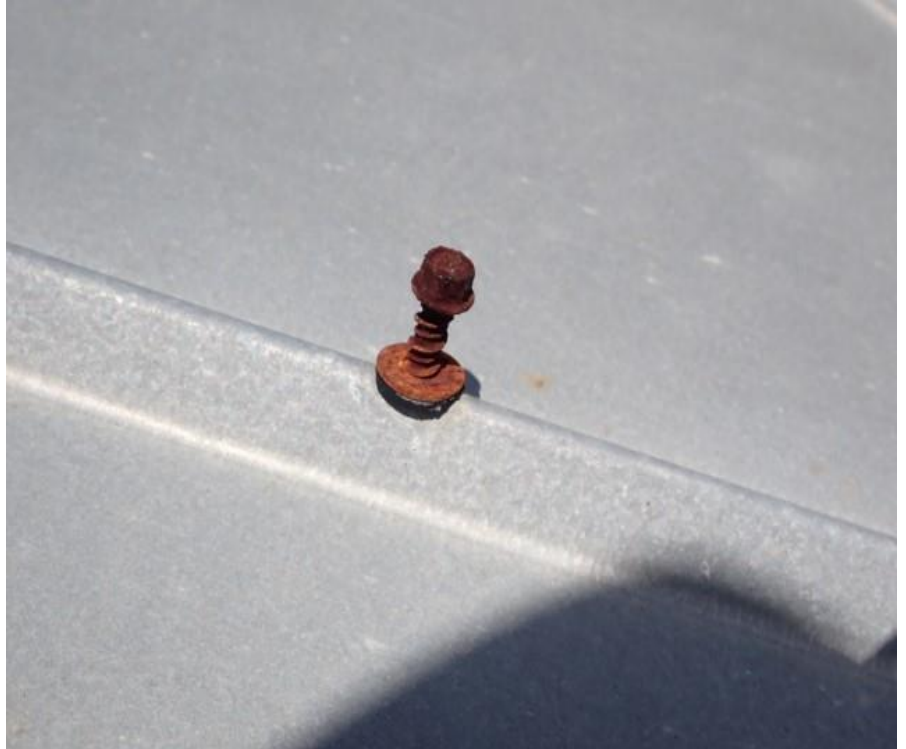
15. Deficiency #2 - Loose fasteners

Deficiency #3 - Rusted fasteners

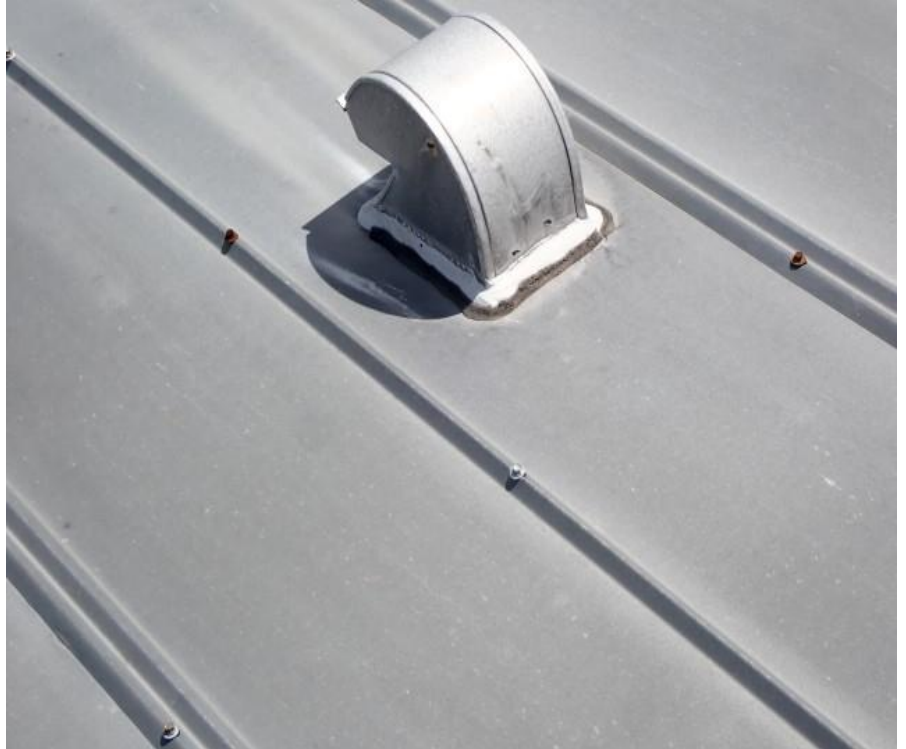
17. Deficiency #4 - Deteriorated
previous sealant repairs at
penetration flashing

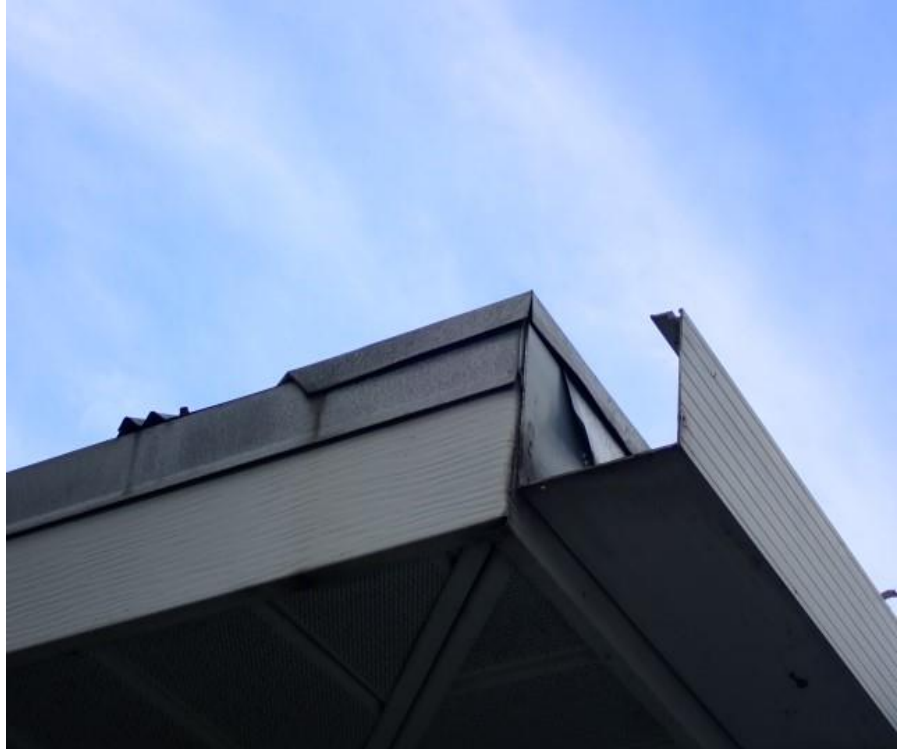
19. Deficiency #5 - Missing end cap on gutter
